APPENDIX C
2004 AERIAL PHOTO REVIEW AND FIELD SOURCE ASSESSMENT,
UPPER JEFFERSON RIVER WATERSHED

1.1 Upper Jefferson Watershed 2004 Aerial Photo Review and Field Source Assessment

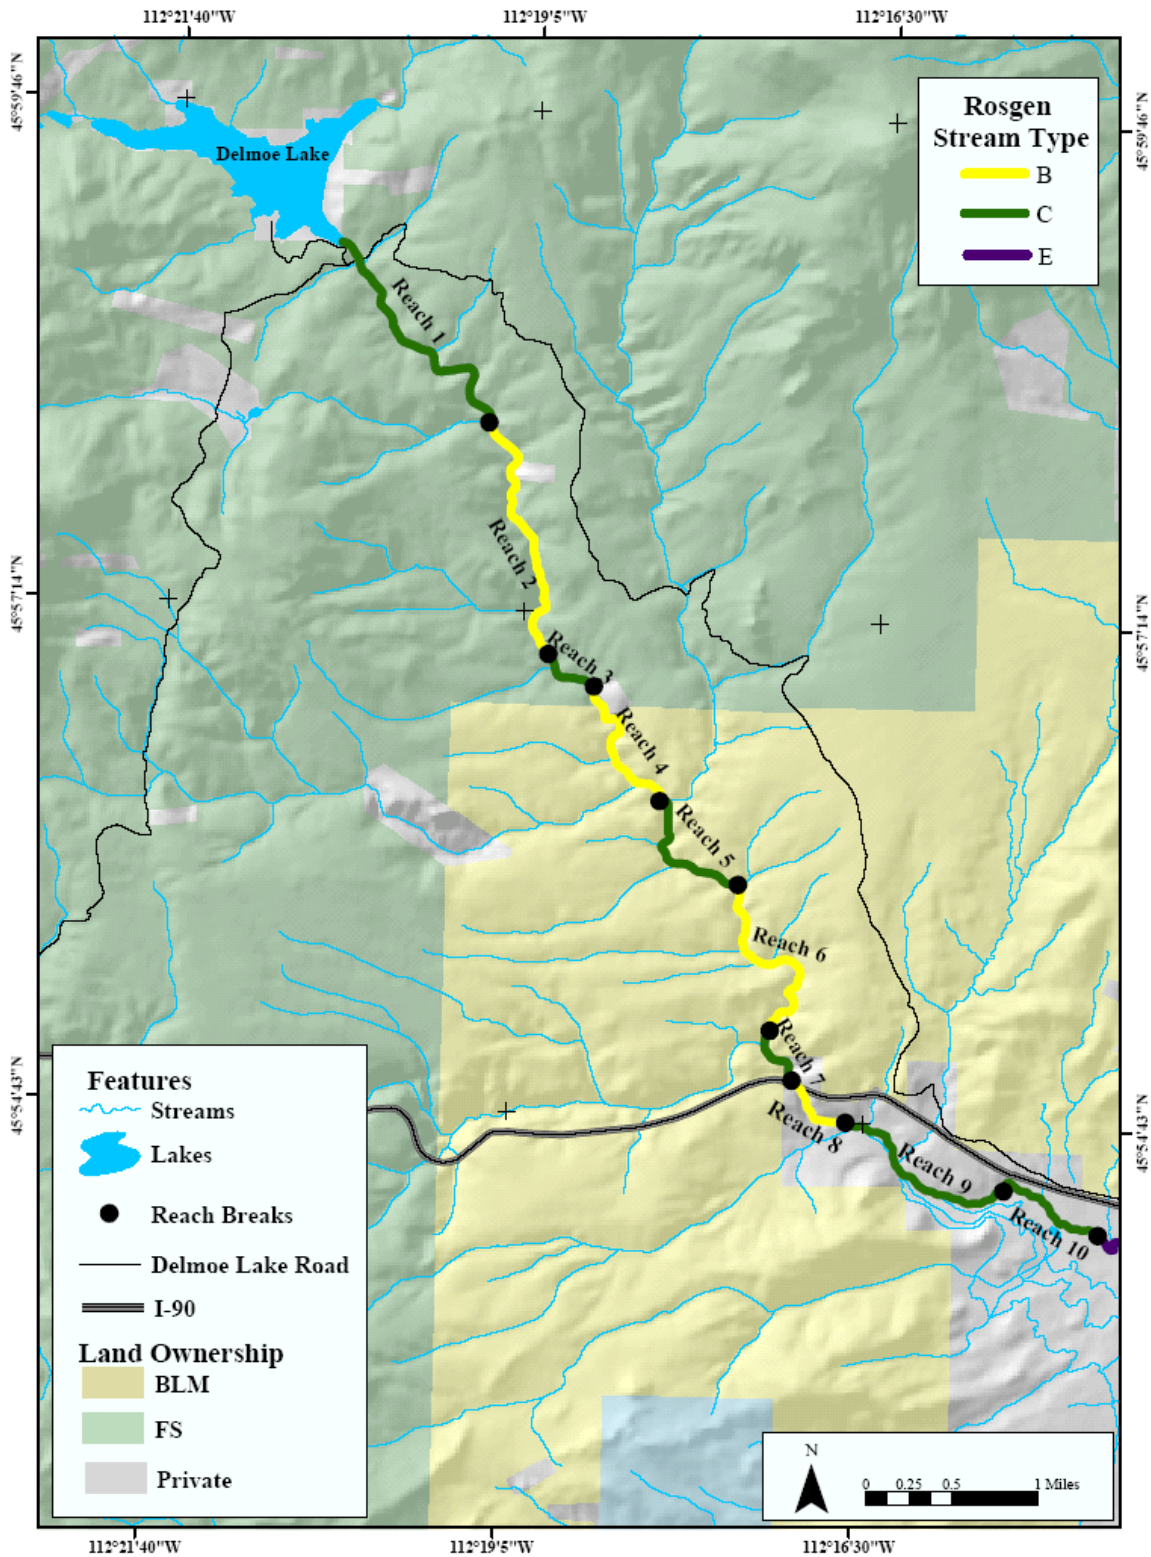
Figure 2-7. Upper Big Pipestone Creek Rosgen Stream Types

The channel forms of Big Pipestone Creek above Interstate 90 are predominantly controlled by landform structure, as well as reservoir releases from Delmoe Lake (**Figure 2-7**). The prominent landform geology, the Boulder Batholith, has resulted in valley bottom formation along weathered joints. Narrow valley bottoms dominated by granitic boulders (B-type reaches), as well as less confined valley bottom areas are found (C-type reaches). Portions of Reaches 1 and 2 viewed during the field survey exhibited B and F channel types. B-type sections were found

where the stream was more structurally controlled (lower W/D ratio and less entrenched). After the field review, it was noted that Reach 1 could probably have been broken into 2 reaches as most of the reach appeared unconfined on the air photos, but only the upper 10 percent of the reach was viewed in the field (mostly F-type). The portion of Reach 7 viewed in the field exhibited a C-type channel. Delmoe Lake releases have greatly increased the flow of the creek. It is the professional opinion of the surveyor that without the lake releases natural channel form would alternate between B and Eb stream types. There were no significant changes in channel form between 1983 and 2001.

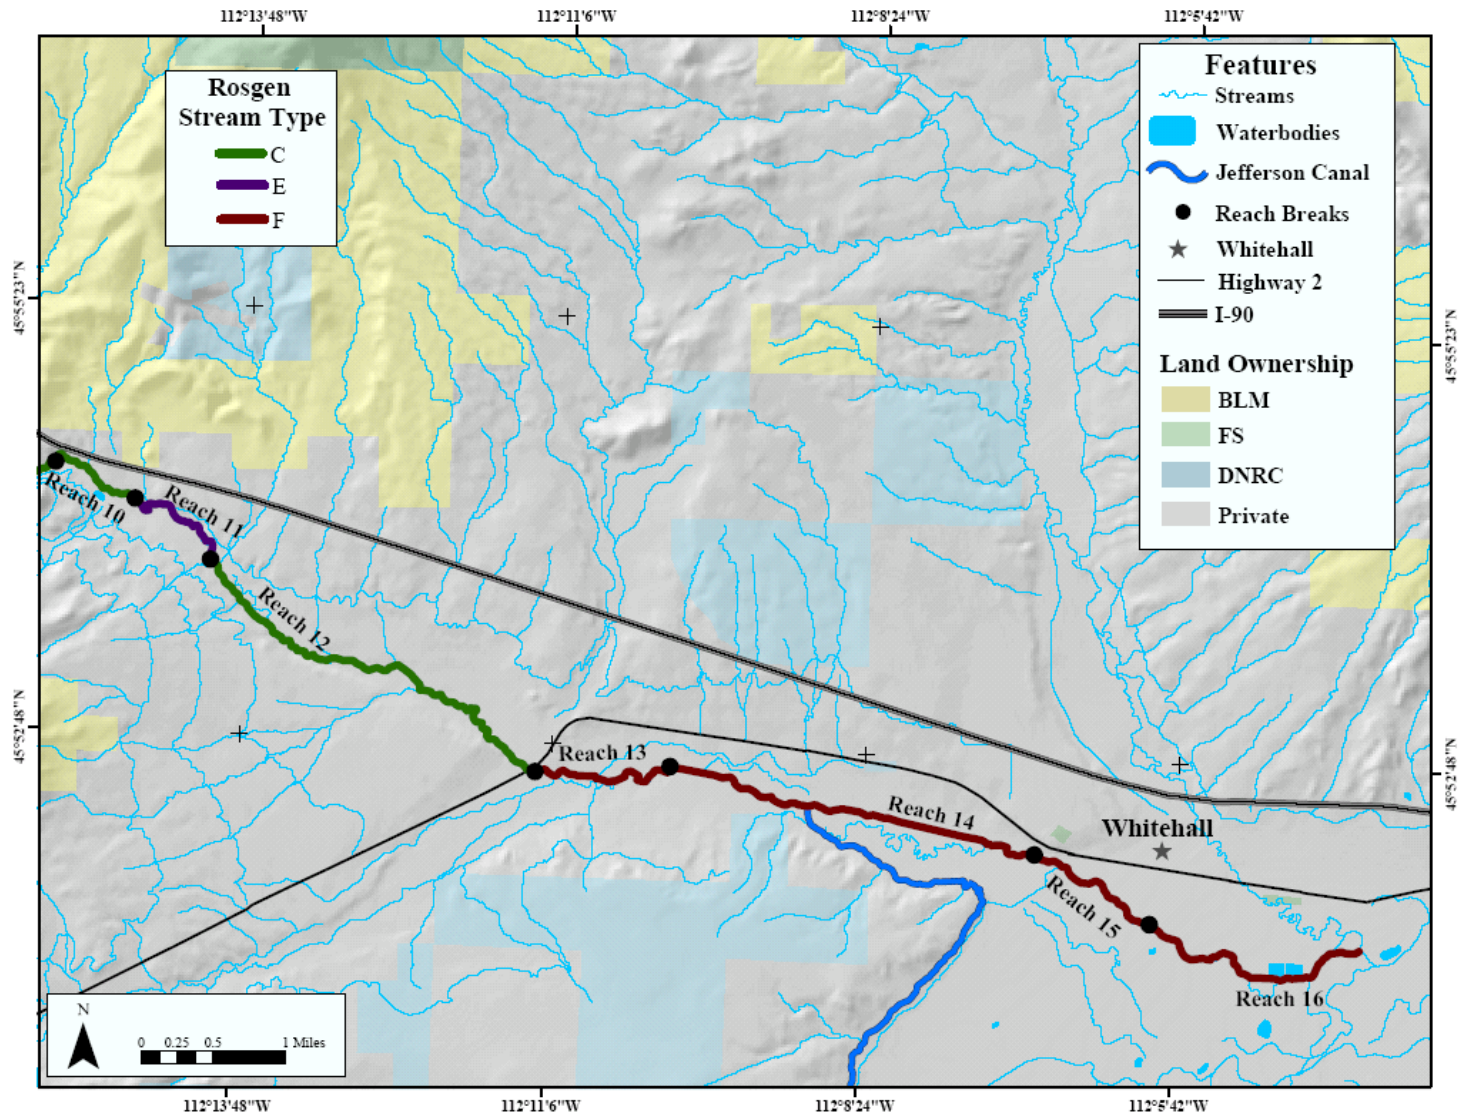
Figure 2-8. Lower Big Pipestone Creek Rosgen Stream Types

Many of the channel forms of Big Pipestone Creek below Interstate 90 are controlled by historical and current landuse activities (**Figure 2-8**). The predominant valley type (VIII) would typically result in an unconfined stream type (C or E), yet water level alterations for flow diversions and channelization have resulted in stream types out of balance with the valley type. Portions of Reaches 10, 12, and the upper part of Reach 13 viewed during the field survey exhibited C-type channels, while the portion of Reach 11 viewed, and some areas of Reach 12 exhibited E-type stream channels. Channel form in the valley was variable, with many areas observed as incised. Remnants of beaver dams were found in Reaches 10, 11, 12 and 13. From about the middle of Reach 13 to the mouth, numerous alterations to the channel have occurred, such that Rosgen stream typing is somewhat inapplicable (constructed channel versus alluvial channel). However, F-type sections were noted in Reaches 13 and 14. Reach 14 is where the stream was channelized for the railway. The channelization was probably the cause of extreme headcutting observed in this reach. At Reach 15, the stream appeared to return to its natural channel, while over half of Reach 16 appeared to be a constructed channel. The portion of Reach 16 viewed in the field appeared to be more of an E-type channel (low W/D ratio, no point bars), however stream type was classified as an F due to the large area of the reach not observed in proximity to the channelized reach (14). For the valley portion of Big Pipestone Creek, only one time period was analyzed so significant changes in channel form since 1983 could not be determined.

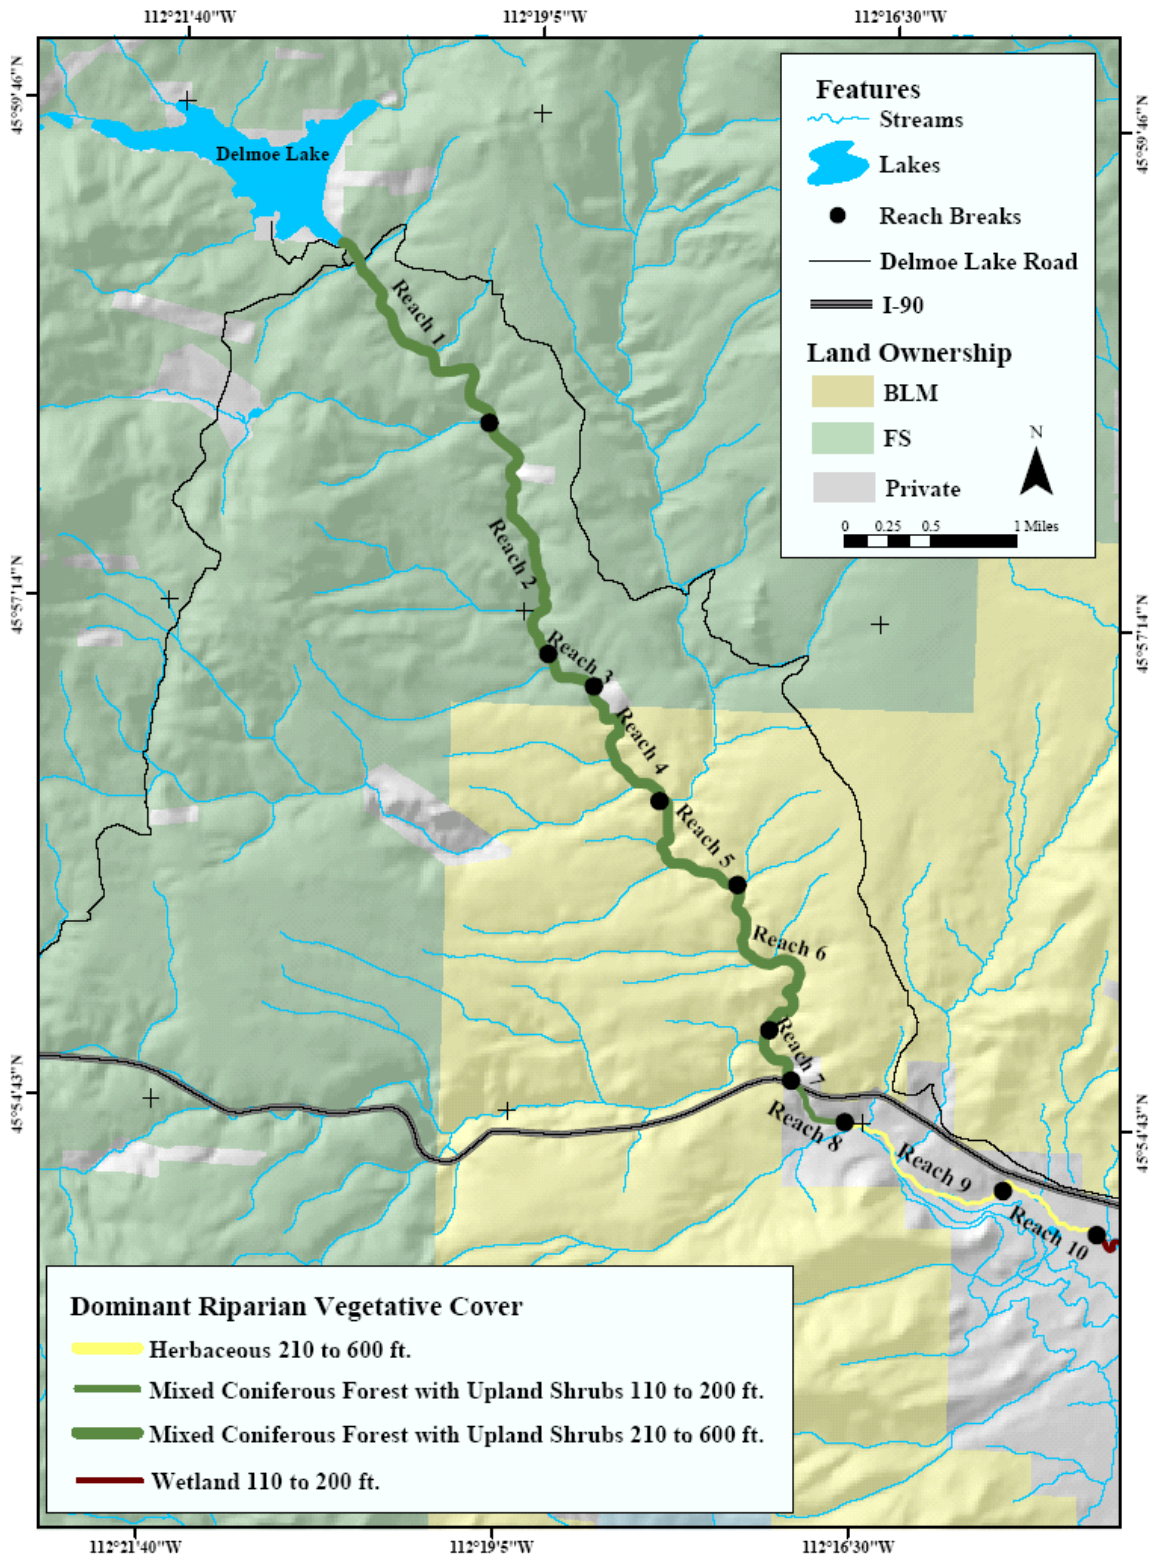
Figure 2-9. Upper Big Pipestone Creek Riparian Vegetation

The dominant riparian cover along Big Pipestone Creek above Interstate 90 was mixed coniferous forest with upland shrubs (**Figure 2-9**). Buffer widths were generally greater than 100 feet wide along both sides of the stream. The buffer widths represented the distance of vegetation surrounding the stream before any disturbance was observed, as opposed to the actual width of 'wet' vegetation (alders, willows, etc.). The relative health category assigned to all of the upper reaches was: 'Fair. Vegetation appears healthy, but some disturbance is present.' During the field review, willows, alders, rose, red osier, and grasses were noted as extending to a maximum of 30 feet from the channel within the conifer forest. Some areas of thistle infestation were present. Between 1983 and 2001, the riparian buffer widths in Reaches 4 and 7 appeared to increase by an average of 25 percent.

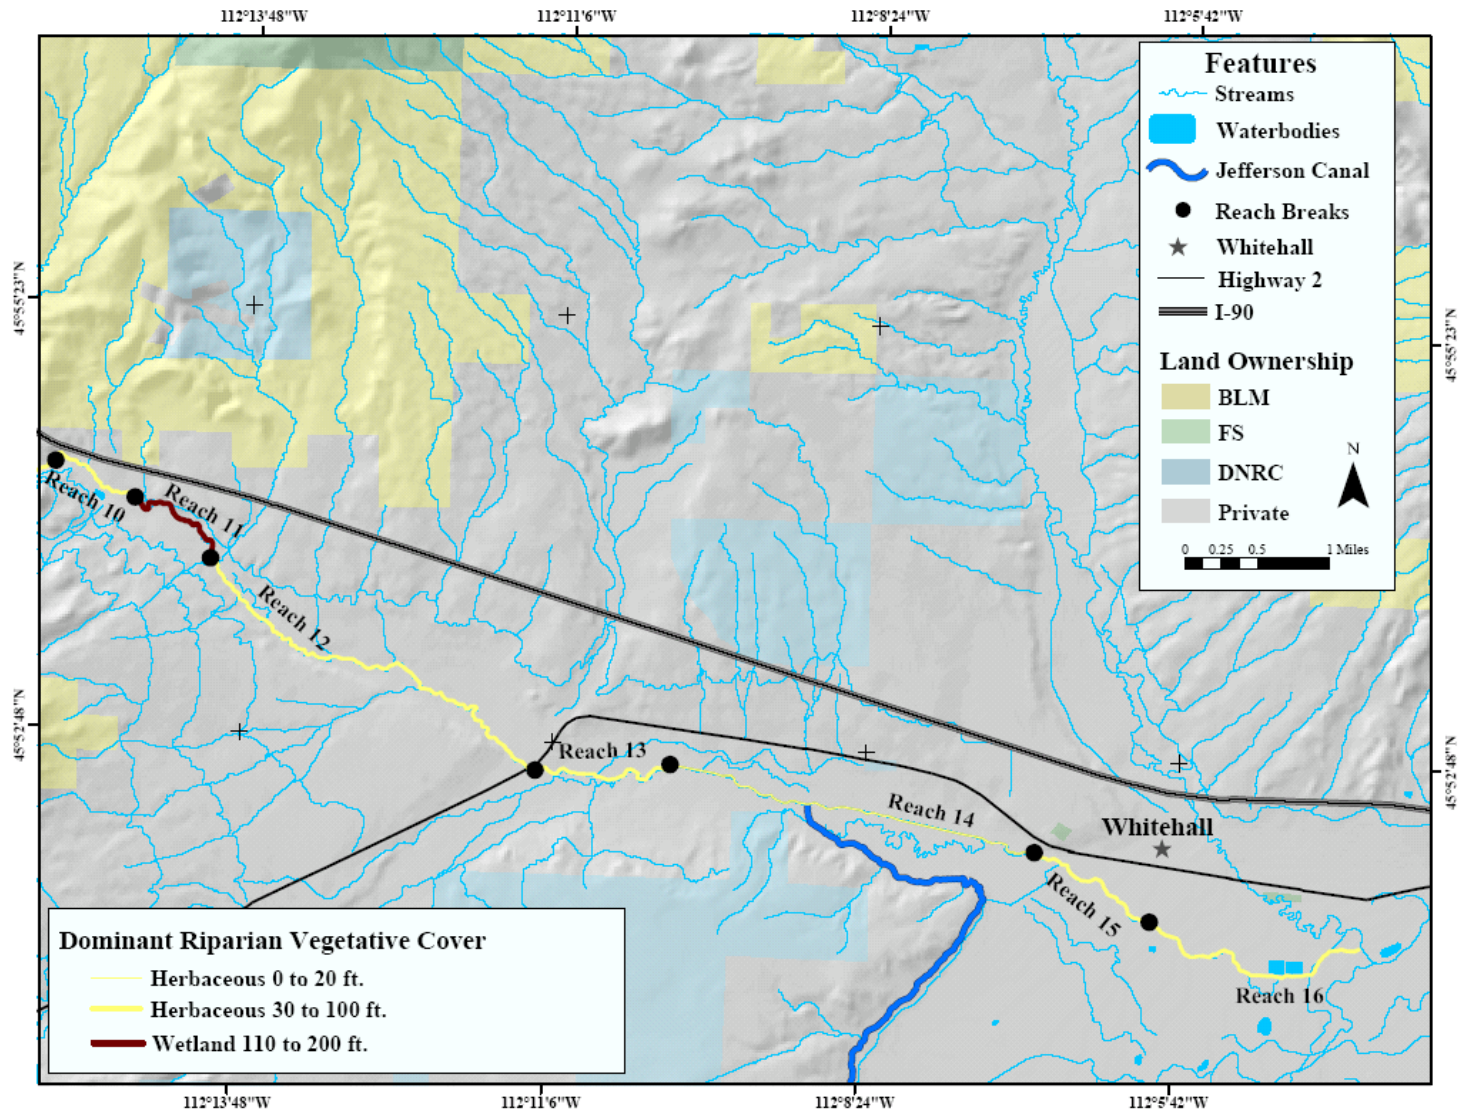
Figure 2-10. Lower Big Pipestone Creek Riparian Vegetation

The dominant riparian cover along Big Pipestone Creek below Interstate 90 was herbaceous; whereby, the grasses or forbs were being grown into the riparian and almost no woody vegetation was present (**Figure 2-10**). The one exception to this was Reach 11, which dominantly exhibited wetland characteristics. The buffer widths of these lower reaches represented the actual width of 'wet' vegetation (alders, willows, etc.). Buffer widths were generally less than 100 feet wide along both sides of the stream. The relative health category assigned to most of the valley reaches was: 'Fair. Vegetation appears healthy, but some disturbance is present.' Reaches 13, 14, and 16 were assigned a rating of 'Poor' due to notable disturbance. During the field review, willows, cottonwood, rose, and grasses were noted as extending generally to a maximum of 40 feet from the channel in Reaches 10 and 12. In Reaches 13 and 14, grasses, decadent willows, and roses were the predominant vegetation. Some areas of thistle and knapweed infestations were present. For the valley portion of Big Pipestone Creek, only one time period was analyzed so significant changes in riparian vegetation since 1983 could not be determined.

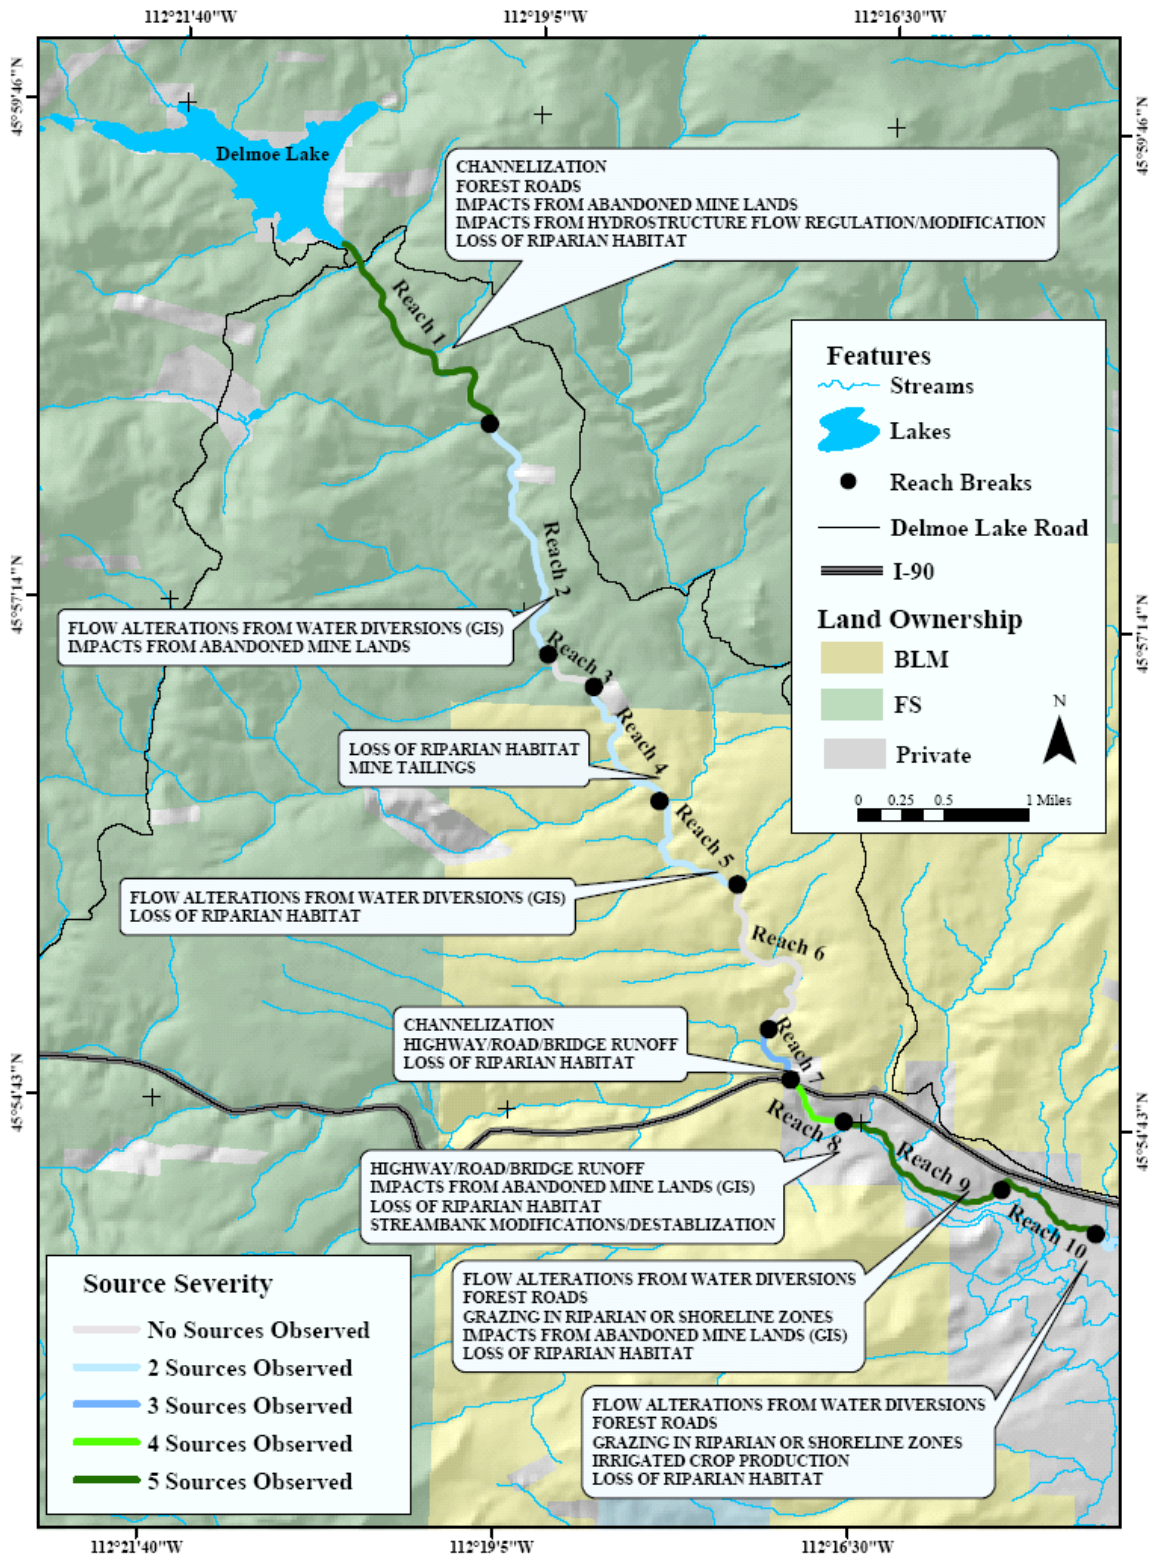
Figure 2-11. Upper Big Pipestone Creek Pollution Sources

Figure 2-11 displays the pollution sources assigned to the upper reaches of Big Pipestone Creek. Many pollution sources observed along Big Pipestone Creek above Interstate 90 were related to the operation of Delmoe Lake Dam, and unpaved roads and trails. In many instances, the sources of flow alterations from water diversions and impacts from abandoned mine lands were taken from GIS layers which located water rights claims and abandoned mines. The GIS identified sources have generally not been field verified. During the field source assessment, heavy algal growth just below the Delmoe lake outlet, road sediment delivery sites, and channelization from rock walls were observed in Reach 1. In Reach 2, sediment delivery sites from ATV/motorcycle trails, and trash from an old mining operation (wood, metal, tires, furniture) were observed in the stream. The portion of Reach 7 that was surveyed looked fairly healthy, with vigorous riparian vegetation. There were no significant changes in pollution sources between 1983 and 2001.

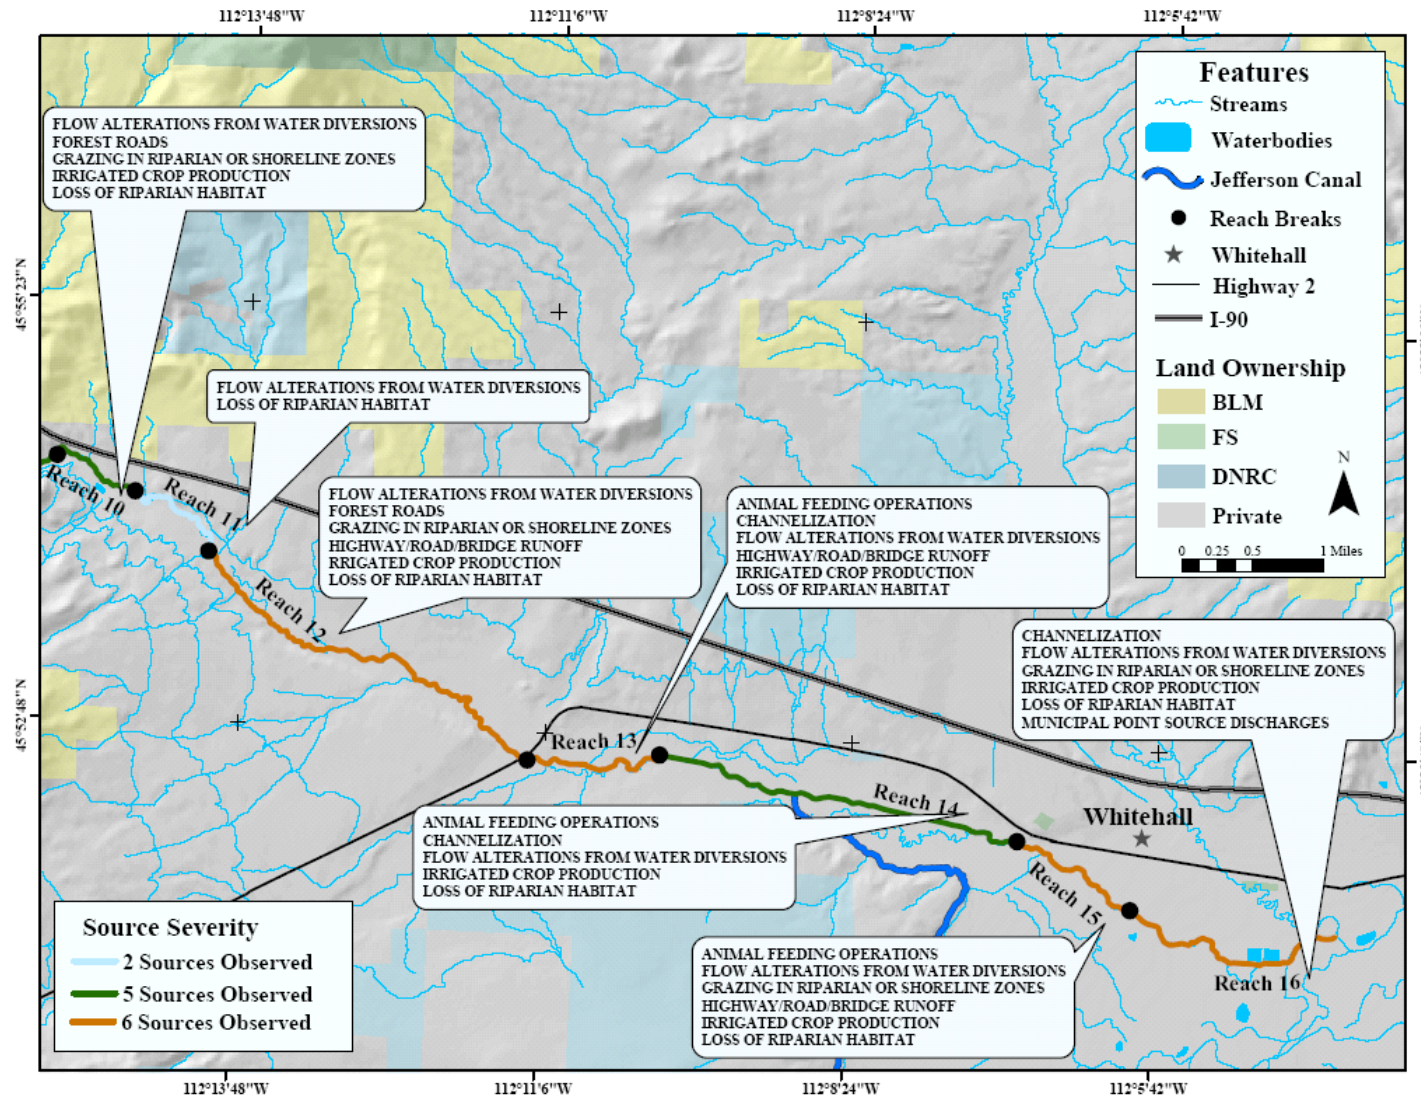
Figure 2-12. Lower Big Pipestone Creek Pollution Sources

Figure 2-12 displays the pollution sources assigned to the lower reaches of Big Pipestone Creek. Many pollution sources observed along Big Pipestone Creek below Interstate 90 were related to agricultural operations. During the field source assessment, grazing impacts (trampled banks, overwidened channel, channel braids) were observed in all of the field surveyed reaches, except for Reach 11. Alterations for irrigation diversions were observed in Reaches 11, 13, 14, and 16. In general, stream condition deteriorates in a downstream manner from Reach 10 to Reach 14. For the valley portion of Big Pipestone Creek, only one time period was analyzed so significant changes in pollution sources since 1983 were not determined.

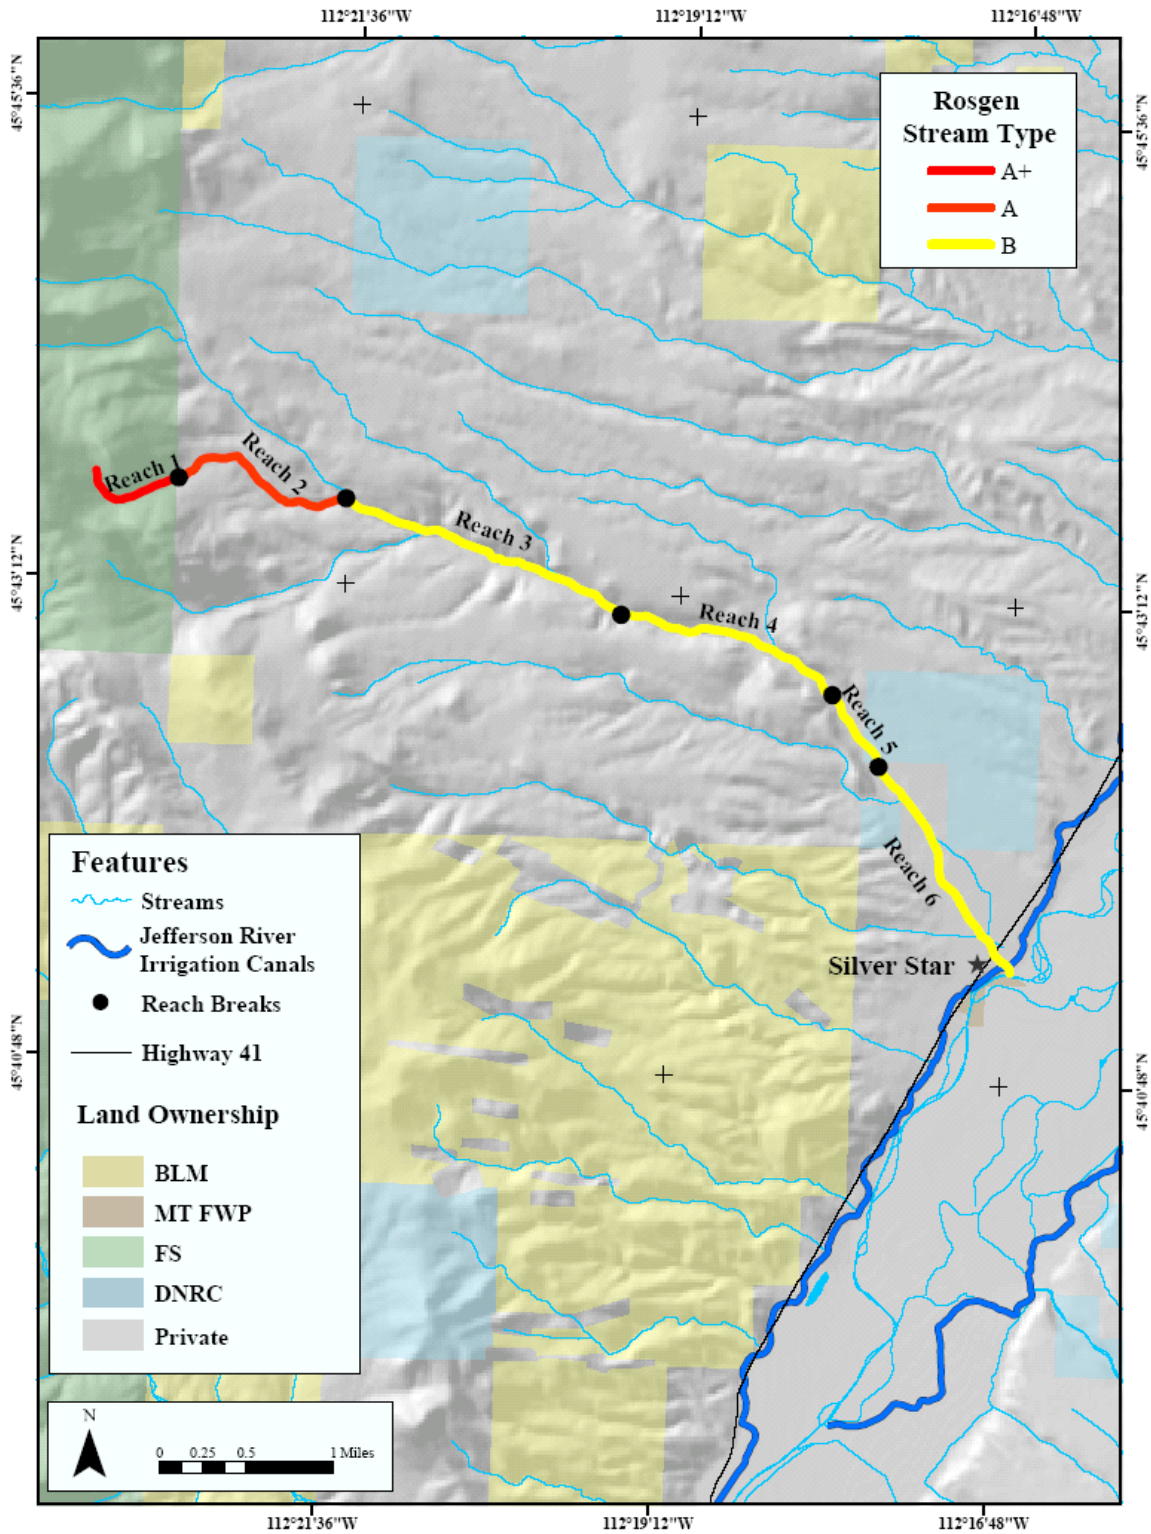
Figure 2-13. Cherry Creek Rosgen Stream Types

The channel forms of Cherry Creek are primarily controlled by landform structure (**Figure 2-7**). The prominent landform geology, the Boulder Batholith, has resulted in valley bottom formation along weathered joints. The stream headwaters on relatively steep slopes (A-type) and then progresses downstream to more moderate slopes. The valley bottom is fairly confined (B-type reaches) until exiting the canyon to the alluvial fan (B and Eb reaches). The portion of Reach 2 viewed during the field survey exhibited A, Ea, and G channel types. The Ea section was observed in a steep aspen meadow area, while the stream alternated between G (grazing impacts) and A type sections where the stream was more confined. Reach 3 was surveyed from the confluence of the North Fork of Cherry Creek downstream. Reach 3 exhibited B and Ba-type sections. The portion of Reach 6 viewed in the field exhibited an Eb-type channel. The section of Reach 6 surveyed was below a large irrigation diversion, but diminished flow effects were not observed. According to the property owner, flow is fairly constant; however a landowner further downstream reported that the stream often goes dry during the irrigation season (section not observed). There were no significant changes in channel form between 1983 and 2001.

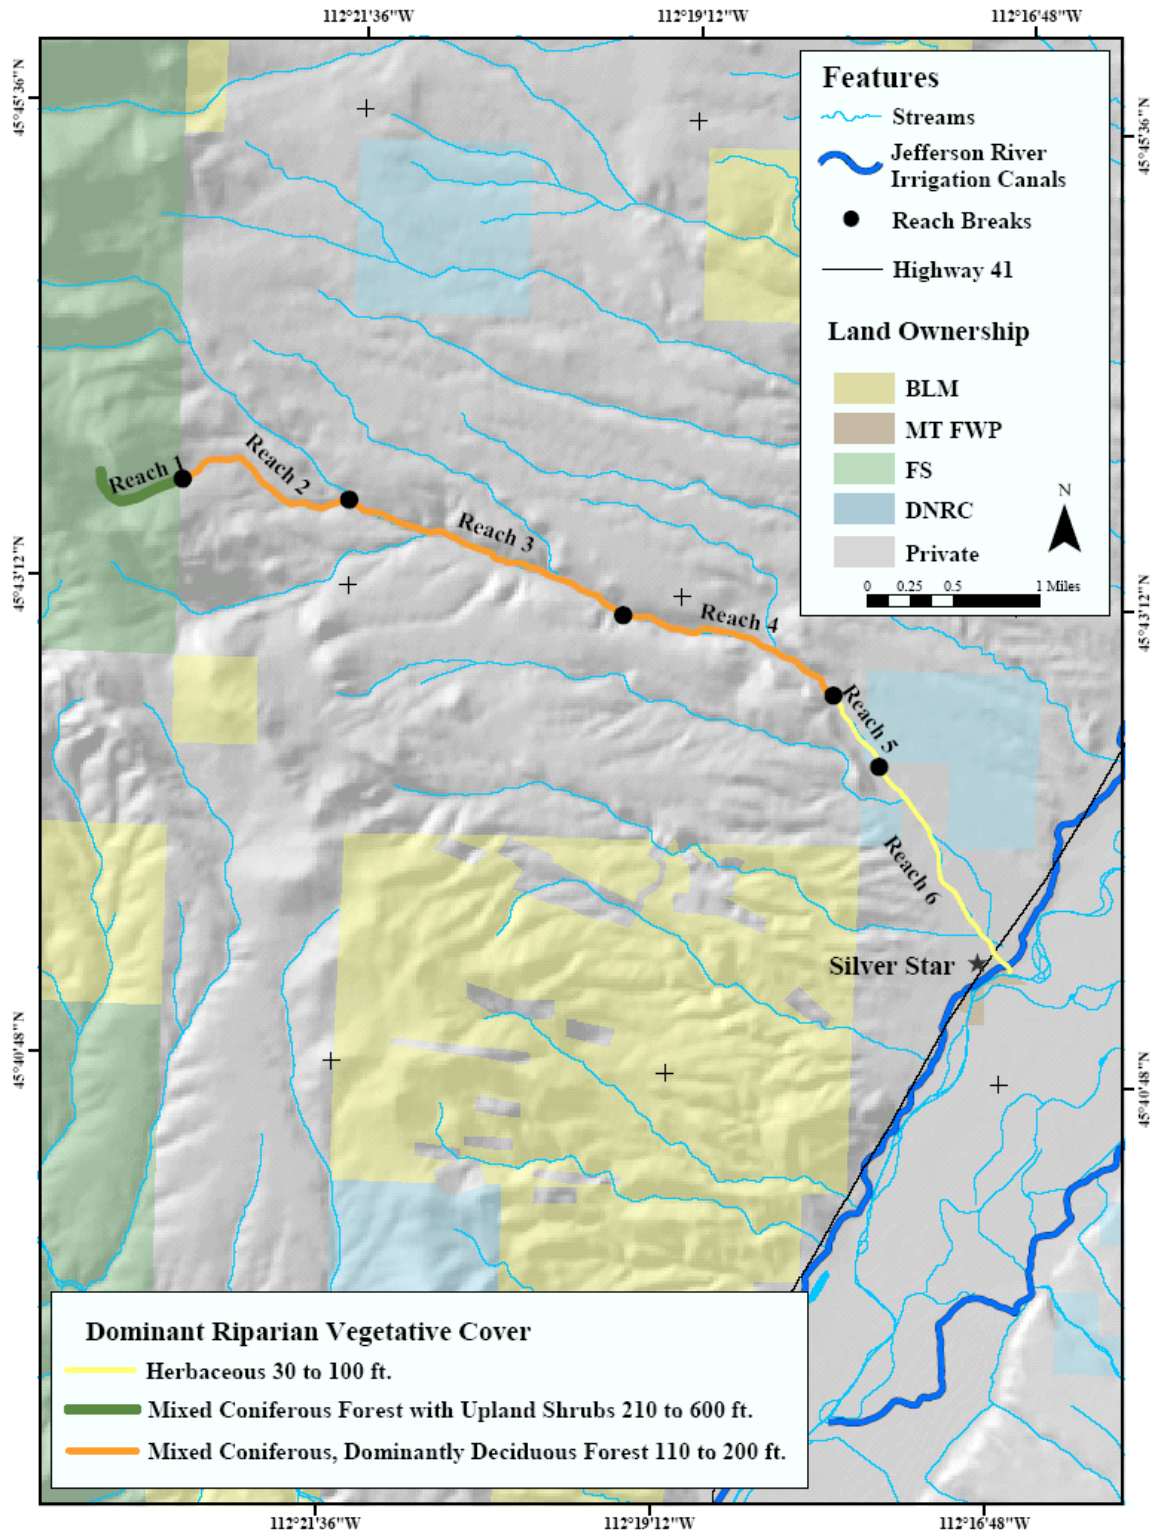
Figure 2-14. Cherry Creek Riparian Vegetation

The dominant riparian cover in the headwaters of Cherry Creek was mixed coniferous forest with upland shrubs (**Figure 2-14**). Buffer widths were generally greater than 300 feet wide along both sides of the stream. The buffer widths represented the distance of vegetation surrounding the stream before any disturbance was observed, as opposed to the actual width of 'wet' vegetation (alders, willows, etc.). The relative health category assigned to Reach 1 was: 'Excellent. Vegetation appears to be vigorous, with various age classes present (little or no disturbance).'

The dominant riparian cover along the canyon sections of Cherry Creek was mixed coniferous, dominantly deciduous forest. Buffer widths were generally greater than 60 feet wide along both sides of the stream. The buffer widths represented the distance of vegetation surrounding the stream before any disturbance was observed, or vegetation type changed. Buffer widths were generally limited by valley bottom width, as opposed to unnatural factors. During the field review, willows, aspen, current, alder, and sedges were noted as extending to a maximum of 20 feet from the channel. Some areas of thistle, leafy spurge, and mullein were present. The relative health category assigned to Reaches 2 to 4 was: 'Fair. Vegetation appears healthy, but some disturbance is present.' Between 1983 and 2001, the riparian buffer widths in Reaches 3 and 4 appeared to increase by an average of 40 percent and 25 percent respectively.

The dominant riparian cover along the alluvial fan portion of Cherry Creek was herbaceous, whereby, the grasses or forbs were being grown into the riparian and almost no woody vegetation was present (**Figure 2-14**). The buffer widths of these lower reaches represent the actual width of 'wet' vegetation. Buffer widths were generally less than 50 feet wide along both sides of the stream. The relative health category assigned to Reach 5 was 'Fair'; while the relative health category assigned to Reach 6 was 'Poor' due to notable disturbance. During the field review in Reach 6, cottonwood (regenerating), willows, alder, rose, and sedges were noted as extending generally to a maximum of 20 feet from the channel. Between 1983 and 2001, the riparian buffer width in Reach 6 appeared to increase by an average of 25 percent.

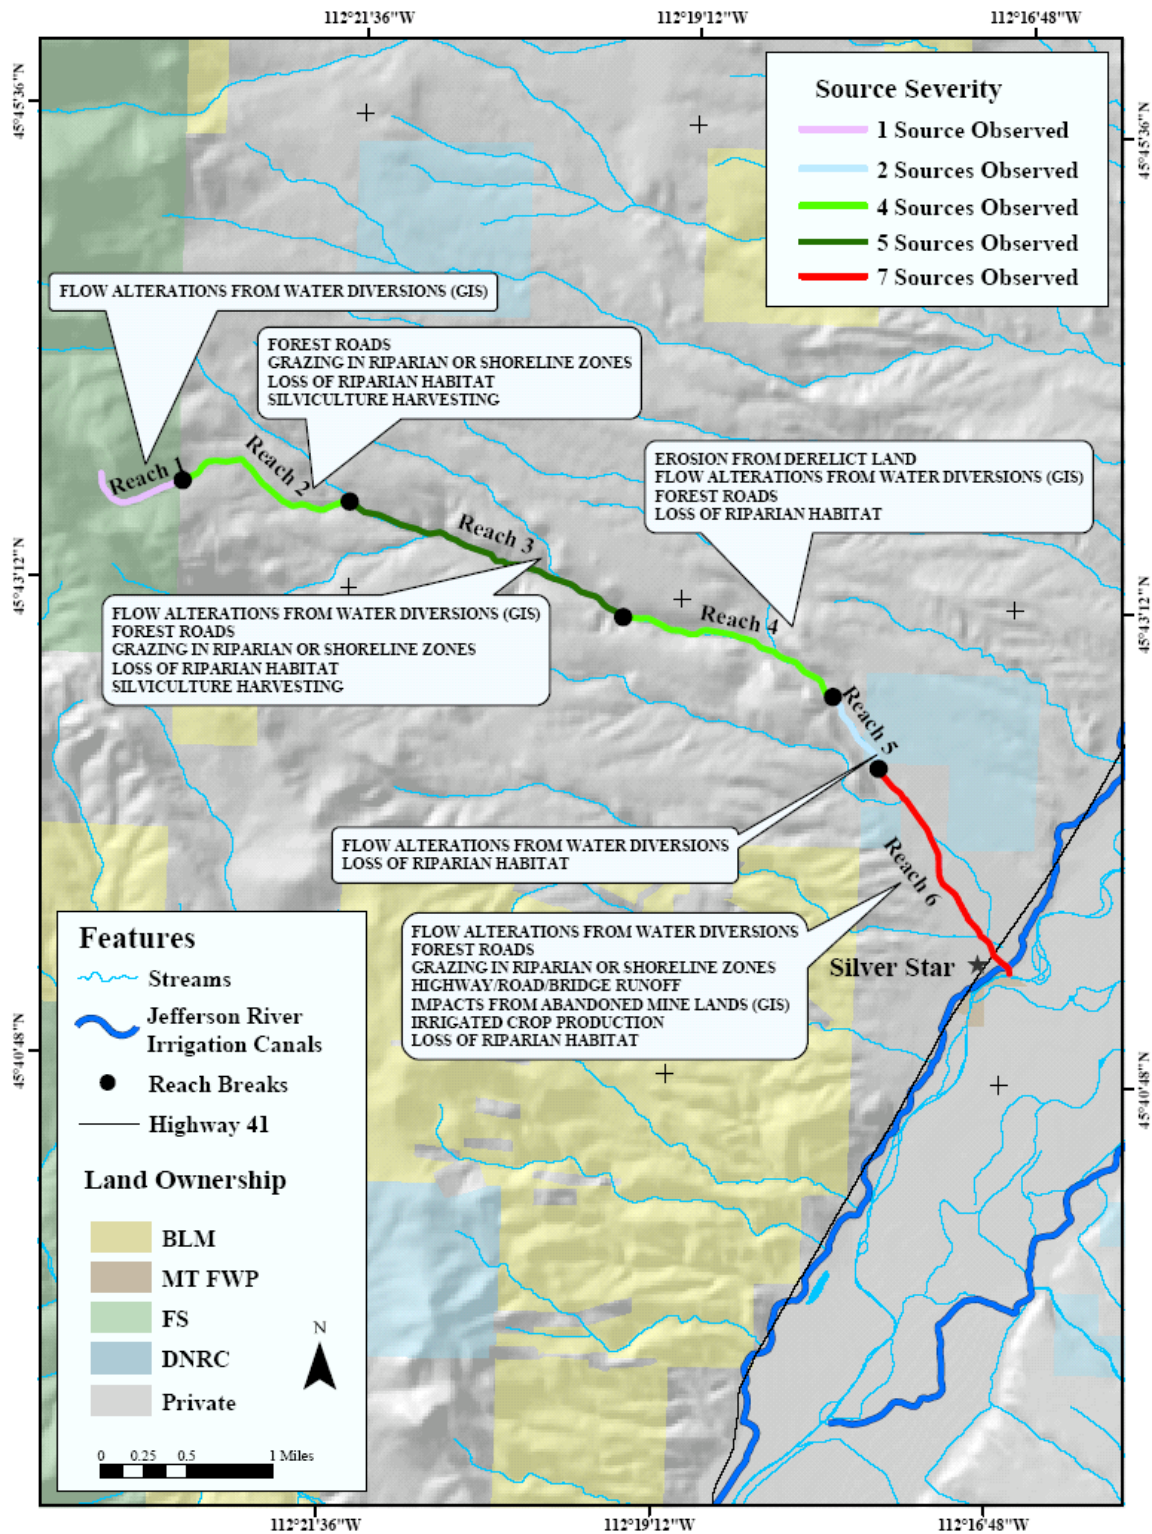
Figure 2-15. Cherry Creek Pollution Sources

Figure 2-15 displays the pollution sources assigned to Cherry Creek. Many pollution sources observed along Cherry Creek were related to riparian grazing and unpaved roads. In the upper reaches of the creek, the source of flow alterations from water diversions was taken from a GIS layer which located water rights claims. In Reach 6 the impacts from abandoned mine lands was also taken from a GIS layer. The GIS identified sources have not been field verified. Silviculture harvest has occurred upslope from Cherry Creek (south side) and any runoff associated with the harvest would enter in Reaches 2 and 3. Again harmful effects from this impact were not field verified. Grazing impacts observed in the field were more detrimental in Reach 2 than in any of the other reaches observed. Sediment input from unpaved roads was fairly minimal. Loss of riparian habitat was associated with development in the floodplain (roads, crops, housing). There were no significant changes in pollution sources between 1983 and 2001.

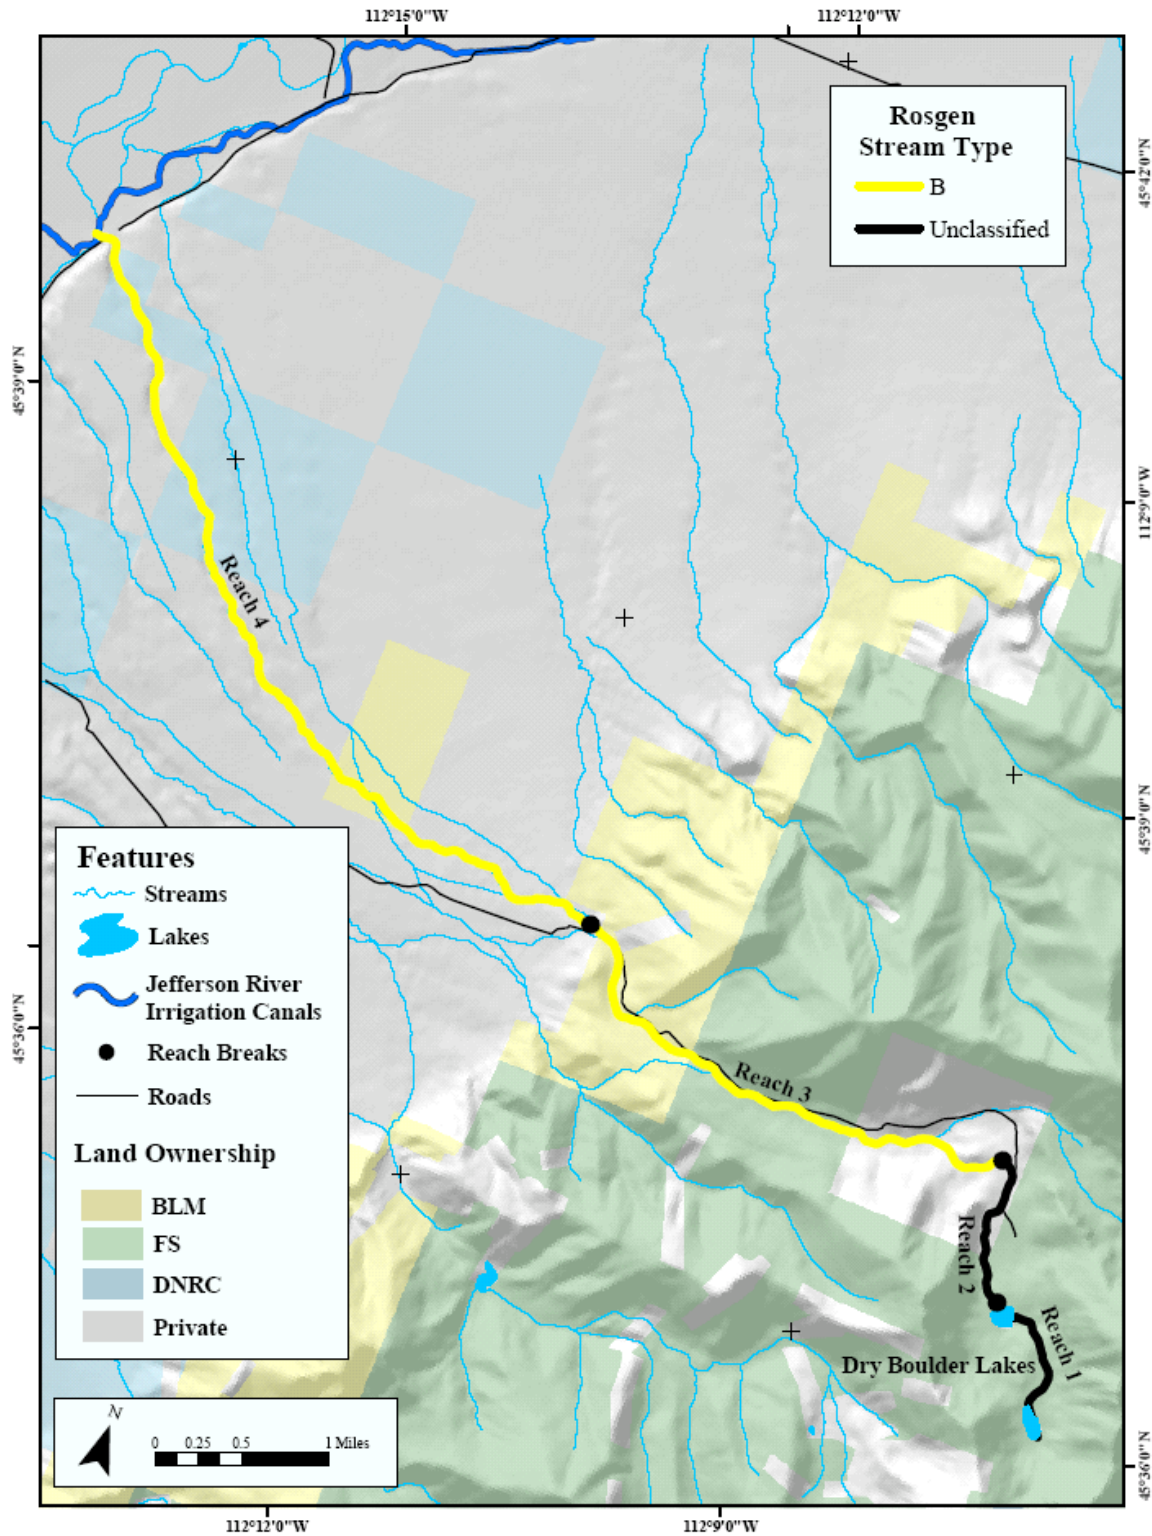
Figure 2-16. Dry Boulder Creek Rosgen Stream Types

Figure 2-16 displays the Rosgen channel types assigned to Dry Boulder Creek. The structural controls on the channel forms of Dry Boulder Creek have led to diverse channel types in the headwaters. For this reason, the channel classifications for Reaches 1 and 2 were 'unclassified' after the field review. Channel forms in Reaches 1 and 2 are influenced by past glaciation. In Reach 1, many Rosgen channel types exist. Most likely the channel starts at the mouth of Upper Boulder Lake as an E or C type stream (not observed in field), but then changes type where the stream hits a nickpoint (A-type, observed). At the base of the falls (A), the channel quickly changes to a Ba type, then to an E type, but with multiple channels and areas of braiding where the stream flows into Lower Boulder Lake. Reach 2 is also difficult to type in areas because of the steep gradient, high entrenchment ratio, and braiding. Ea, A, Ba, and E (meadow area) channel types were observed in this reach. The portions of Reaches 3 and 4 observed in the field exhibited B and Ba type channels. After the field review, it was noted that Reach 4 should have probably be broken into at least two reaches on the alluvial fan, possibly around the 5400' contour interval where contour spacing starts to spread further apart (slope and substrate size probably change here). There were no significant changes in channel form between 1983 and 2001.
