APPENDIX C
2004 AERIAL PHOTO REVIEW AND FIELD SOURCE ASSESSMENT,
UPPER JEFFERSON RIVER WATERSHED

1.1 Upper Jefferson Watershed 2004 Aerial Photo Review and Field Source Assessment

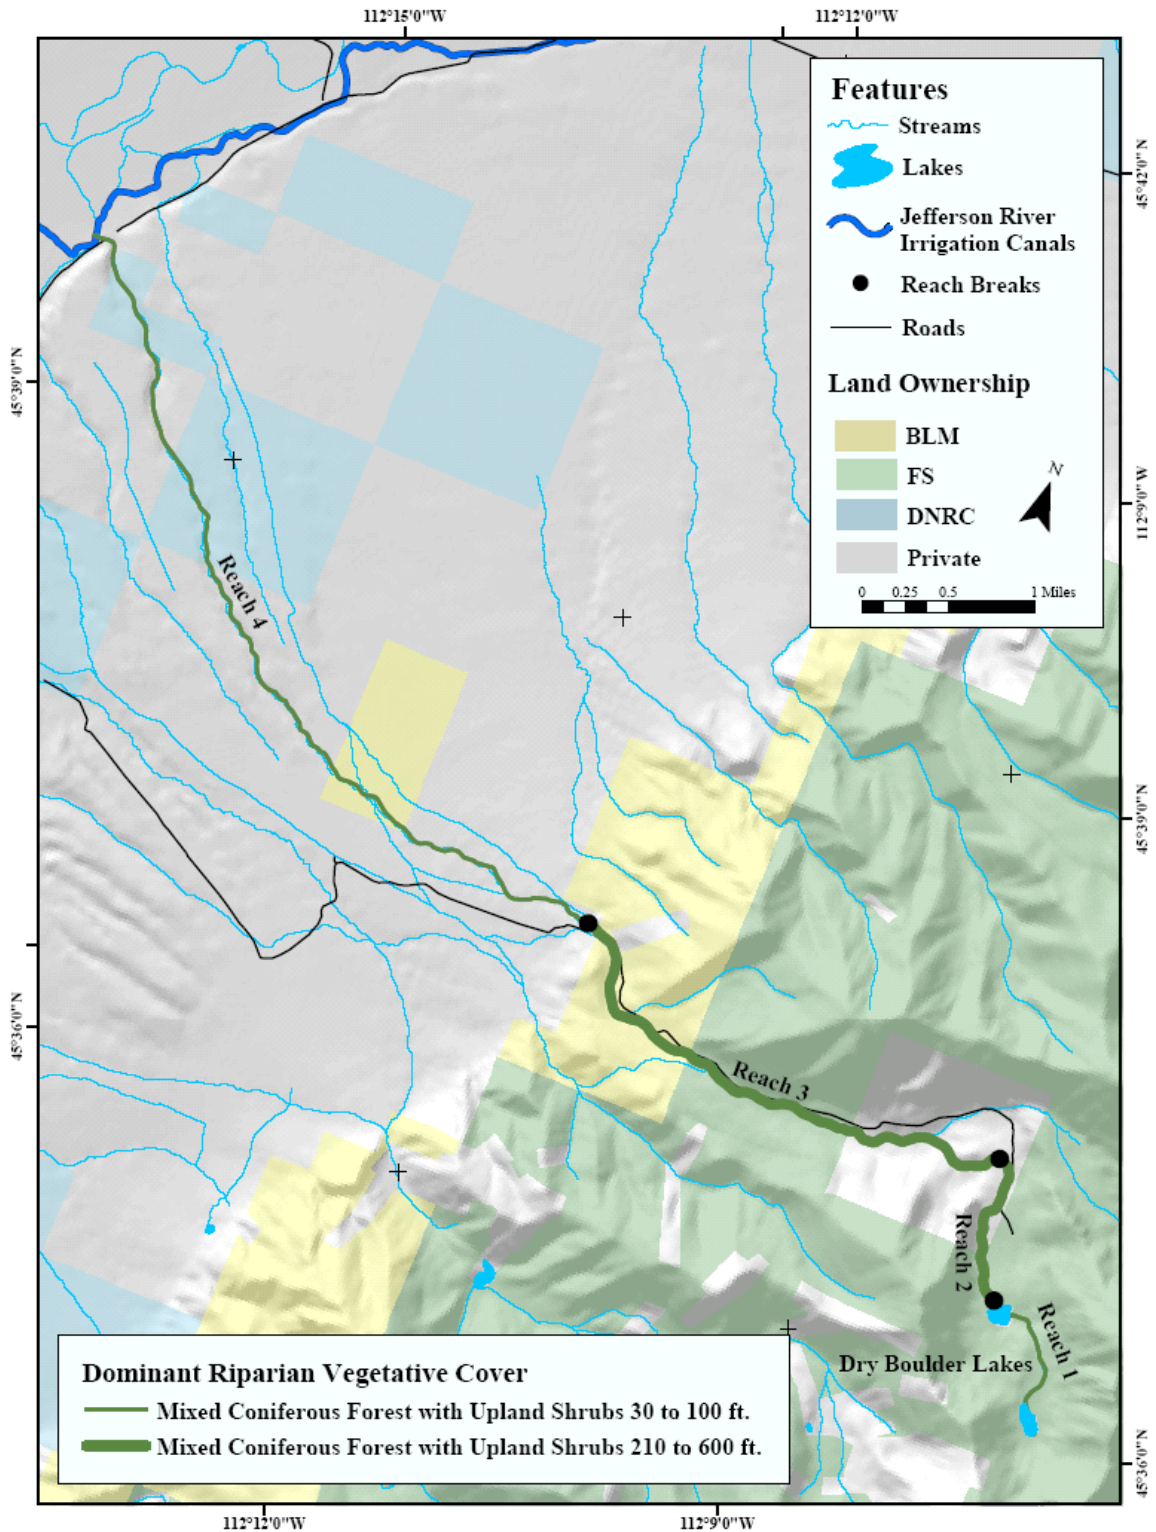
Figure 2-17. Dry Boulder Creek Riparian Vegetation

The dominant riparian cover along Dry Boulder Creek was mixed coniferous forest with upland shrubs (**Figure 2-17**). In the headwaters reaches (1 and 2), vegetative width was generally limited by natural factors and could probably be classified as alpine wetland. During the field review, sedges, alpine flowers, and conifers were observed in Reaches 1 and 2. In Reach 3, buffer widths were generally greater than 100 feet wide along both sides of the stream. In Reaches 3 and 4, the riparian vegetation was mostly conifers with some deciduous vegetation growth (cottonwood, chokecherry, maple). Near the mouth, more deciduous vegetation was observed. Along the areas observed in Reach 4, riparian vegetative width was limited by moisture. The relative health category assigned to all of the reaches was: 'Fair. Vegetation appears healthy, but some disturbance is present.' There were no significant changes in riparian vegetation between 1983 and 2001.

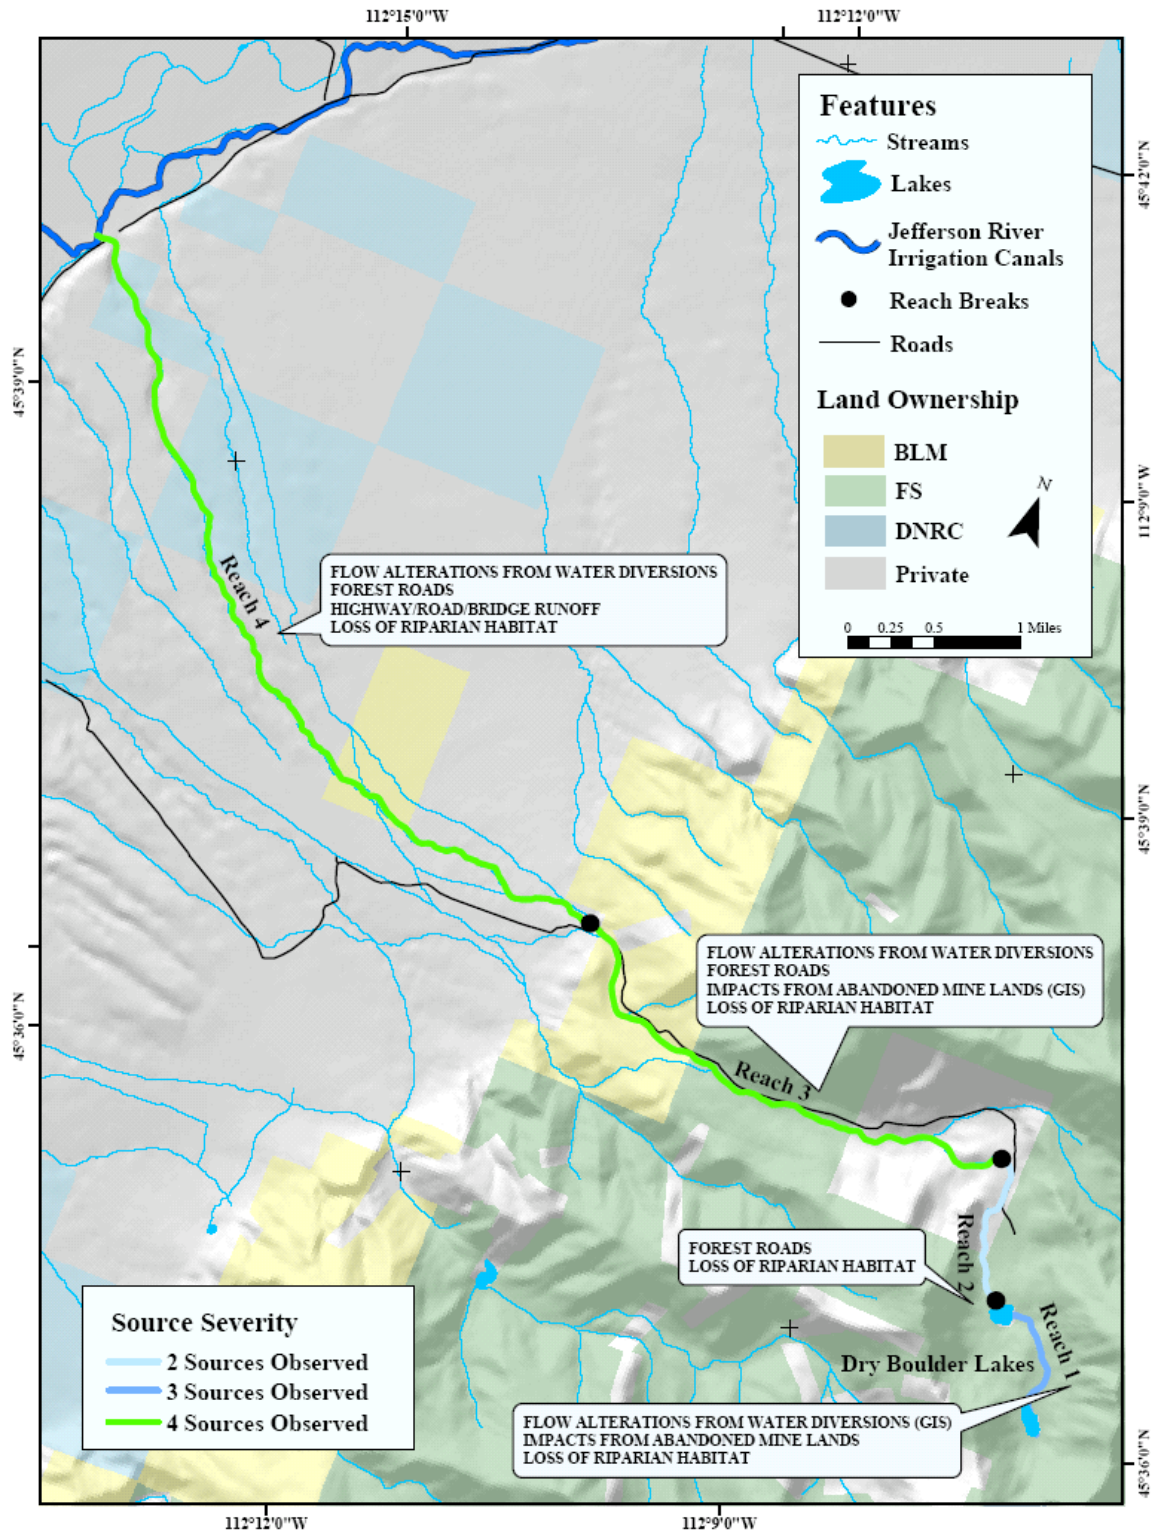
Figure 2-18. Dry Boulder Creek Pollution Sources

Figure 2-18 displays the pollution sources assigned to Dry Boulder Creek. Few pollution sources were observed in the field. The most detrimental source observed was a road sediment delivery site near the end of Reach 3. In some instances, the sources of flow alterations from water diversions and impacts from abandoned mine lands were taken from GIS layers which located water rights claims and abandoned mines. The GIS identified sources have generally not been field verified. Some habitat disturbance in the vicinity of an old mine site in Reach 1 was visible on the aerial photos, but this section of the stream was difficult to access and not field observed. Unfortunately, the canal diversion to Coal Creek (Reach 3) was not noted before the field assessment, and thus it could not be determined if this canal takes all of the stream's flow. It is suspected that the change in lithology from crystalline rocks to porous carbonate rocks in Reach 3 may contribute to natural stream dewatering. On the alluvial fan (Reach 4) the stream goes distributary and probably does not carry flow, except during spring runoff and intense rainfall events (fairly characteristic of streams on alluvial fans in arid environments). There were no significant changes in pollution sources between 1983 and 2001.

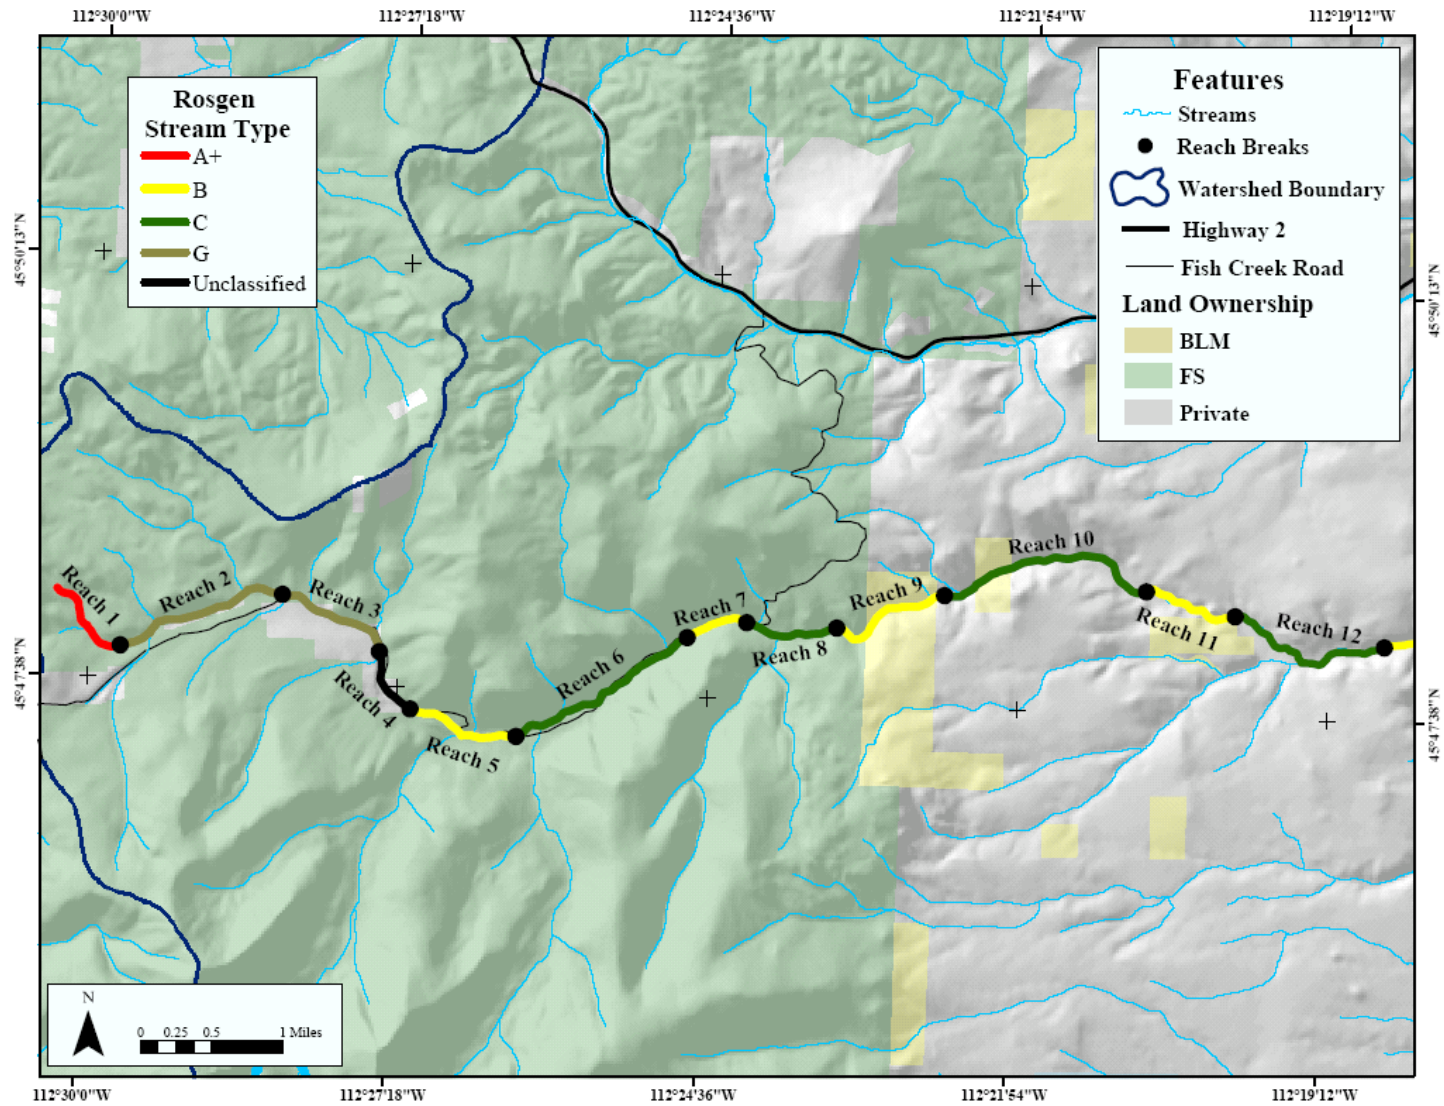
Figure 2-19. Upper Fish Creek Rosgen Stream Types

The channel forms of Fish Creek within the Highland Mountains are predominantly controlled by landform structure, as well as historical land uses (**Figure 2-19**). The upper reaches have been affected by faulting and glaciation, and more recently by placer mining and logging related activities. The entire length of Reach 3 was surveyed and channel form was found to be variable. The reach begins with transition from a B-type to C-type stream, close to the middle of the reach the stream is channelized and exhibits a G-type channel. There were areas of Reach 3 and Reach 4 that were not classifiable, mostly due to the effects of placer mining. Reach 5 was noted as a good potential for a reference B-type channel. Reach 6 appeared to have been altered by the removal of beaver dams (straightened, incised) and had characteristics of C and Bc type channels. From Reach 7 to 13 (**Figure 2-20**), the Boulder Batholith geology has weathered into

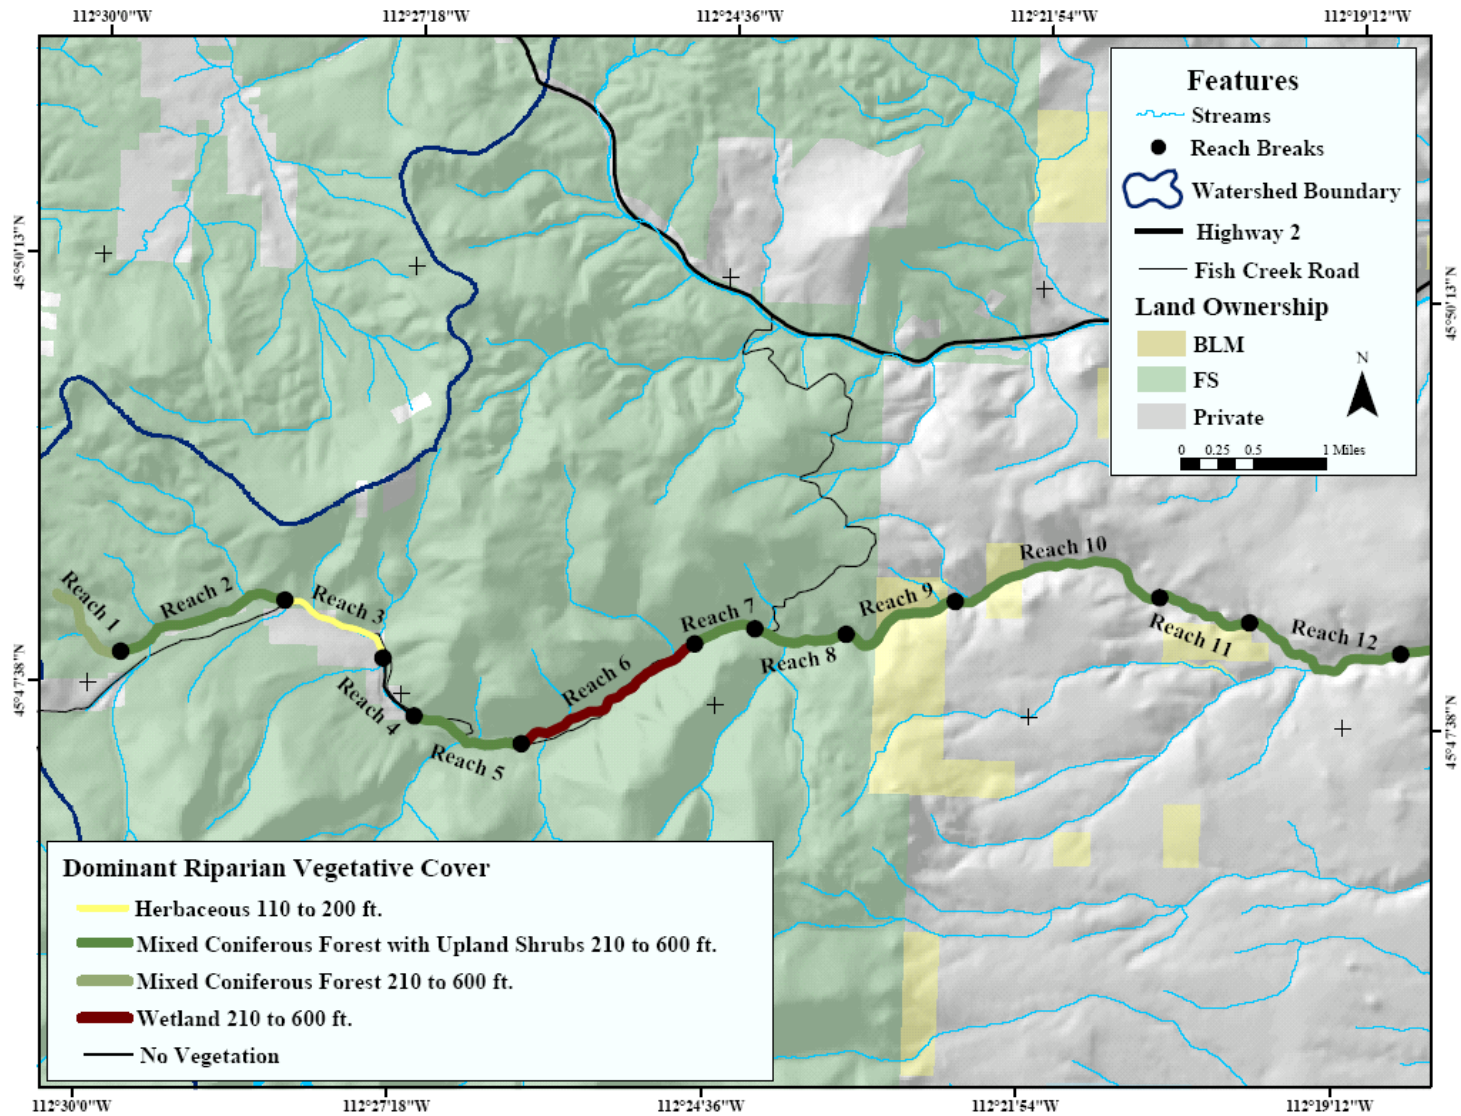
Figure 2-21. Upper Fish Creek Riparian Vegetation

The dominant riparian cover along Fish Creek within the Highland Mountains was mixed coniferous forest with upland shrubs (**Figure 2-21**). Reach 13 is also within the Highland Mountains (**Figure 2-22**). Buffer widths were generally greater than 100 feet wide along both sides of the stream. The buffer widths represented the distance of vegetation surrounding the stream before any disturbance was observed, as opposed to the actual width of 'wet' vegetation (alders, willows, etc.). Healthy riparian vegetation was virtually absent in Reaches 3 and 4, and could probably be attributed to many sources (grazing, logging, placer mining, and roads). The relative health categories in the upper reaches varied from 'Excellent' to 'Poor' depending on the amount of disturbance visible. In Reach 6, the willows were decadent and dying and a thistle infestation was present. Between 1983 and 2001, the riparian buffer widths in Reach 2 appeared to decrease by an average of 20 percent, but in Reach 10 appeared to increase by an average of 90 percent.

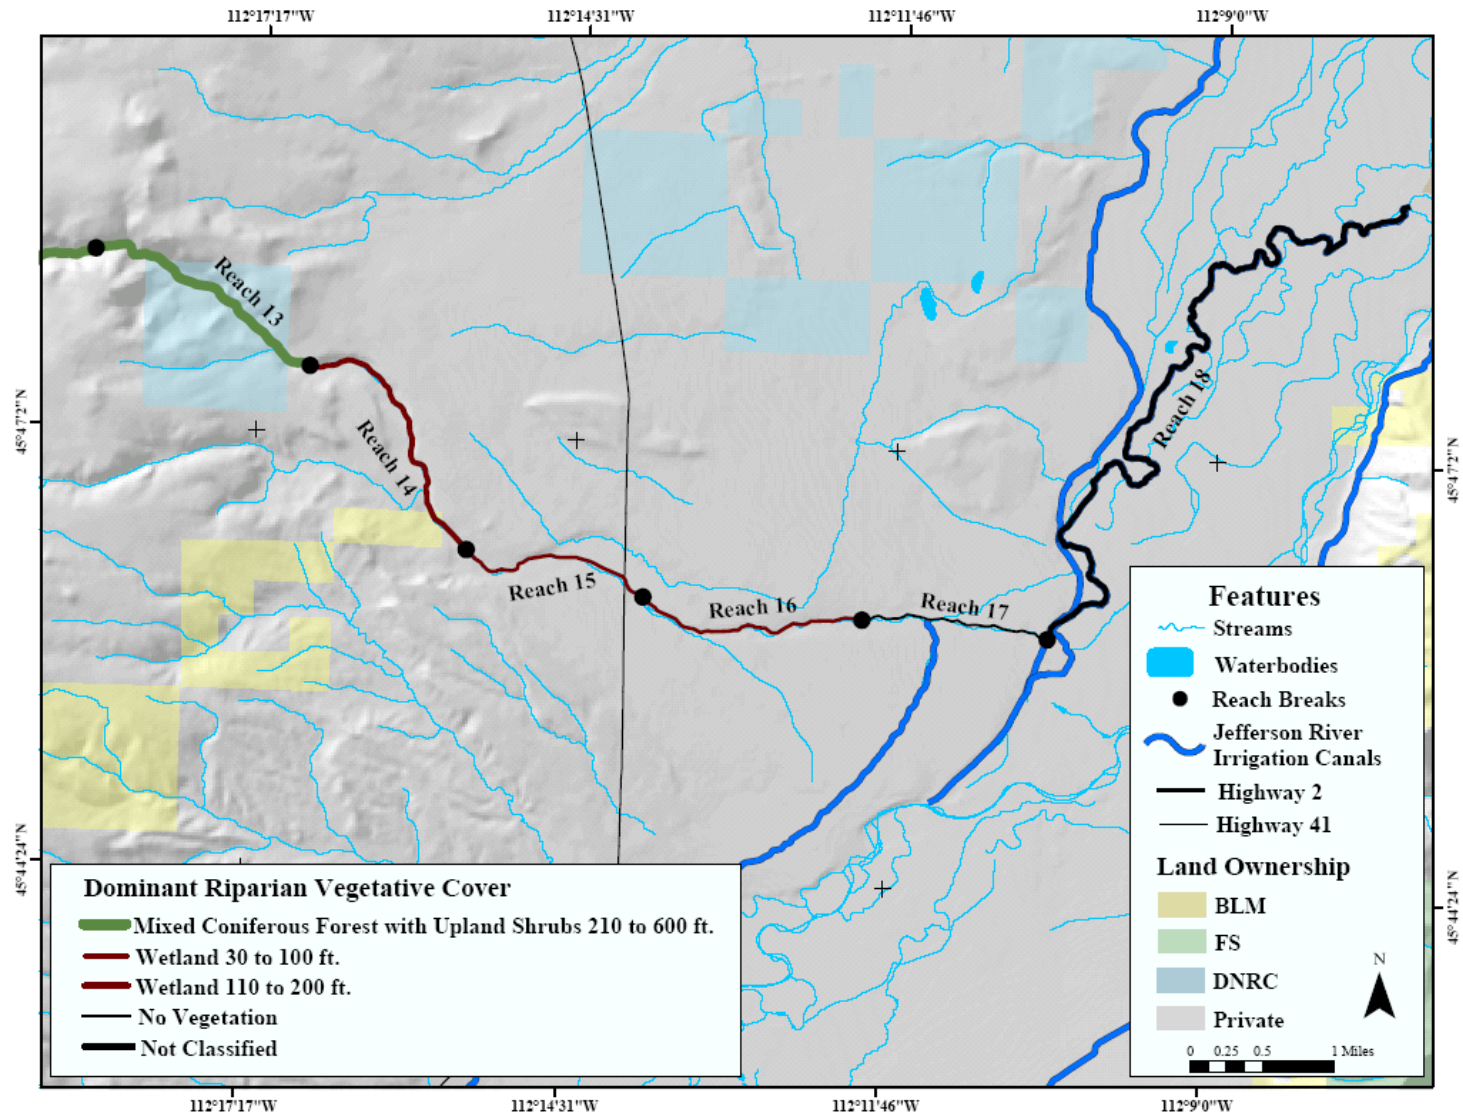
Figure 2-22. Lower Fish Creek Riparian Vegetation

The dominant riparian plants along Fish Creek in the Jefferson Valley were wetland species (**Figure 2-22**). The exception to this was Reach 17, where vegetation was basically absent. The buffer widths of these lower reaches represented the actual width of 'wet' vegetation (alders, willows, etc.). Buffer widths were generally less than 100 feet wide along both sides of the stream. The relative health category assigned to most of the valley reaches was: 'Fair'. During the field review in Reach 14, service berry, alder, rose, red osier, and willows were noted as extending generally to a maximum of 50 feet from the channel. Some areas of knapweed and leafy spurge were observed in Reaches 14 and 15. For the valley portion of Fish Creek, only one time period was analyzed so significant changes in riparian vegetation since 1983 could not be determined.

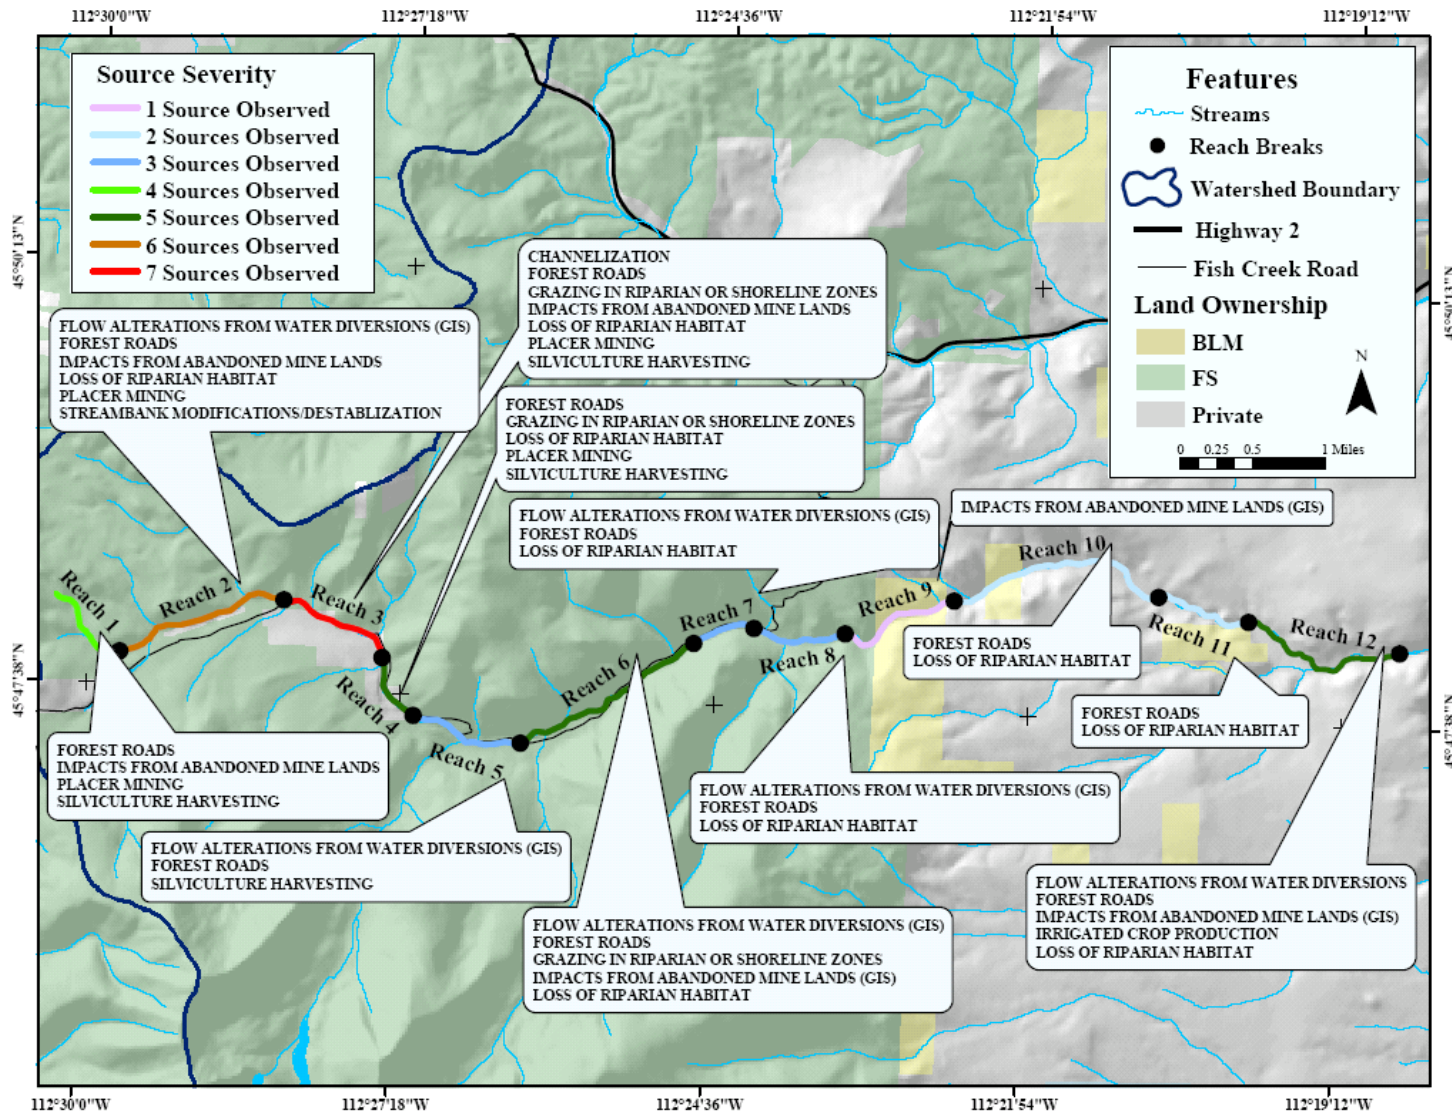
Figure 2-23. Upper Fish Creek Pollution Sources

Figure 2-23 displays the pollution sources assigned to the upper reaches of Fish Creek. Many pollution sources observed along upper Fish Creek were related to placer mining, riparian grazing, and unpaved roads. In many instances, the sources of flow alterations from water diversions and impacts from abandoned mine lands were taken from GIS layers which located water rights claims and abandoned mines. The GIS identified sources have generally not been field verified. Silviculture harvests before 1983 have occurred upslope from and adjacent to Fish Creek. Any runoff associated with the harvests would enter in Reaches 1 through 5. Harmful effects from this impact were not observed in the field. An interesting observation was made during the field survey that the extreme channel modifications in Reach 4, which have lowered the base level for this reach, actually benefit the creek because a lot of the sediment generated in Reach 3 is not able to flow into Reach 4. There were no significant changes in pollution sources between 1983 and 2001.

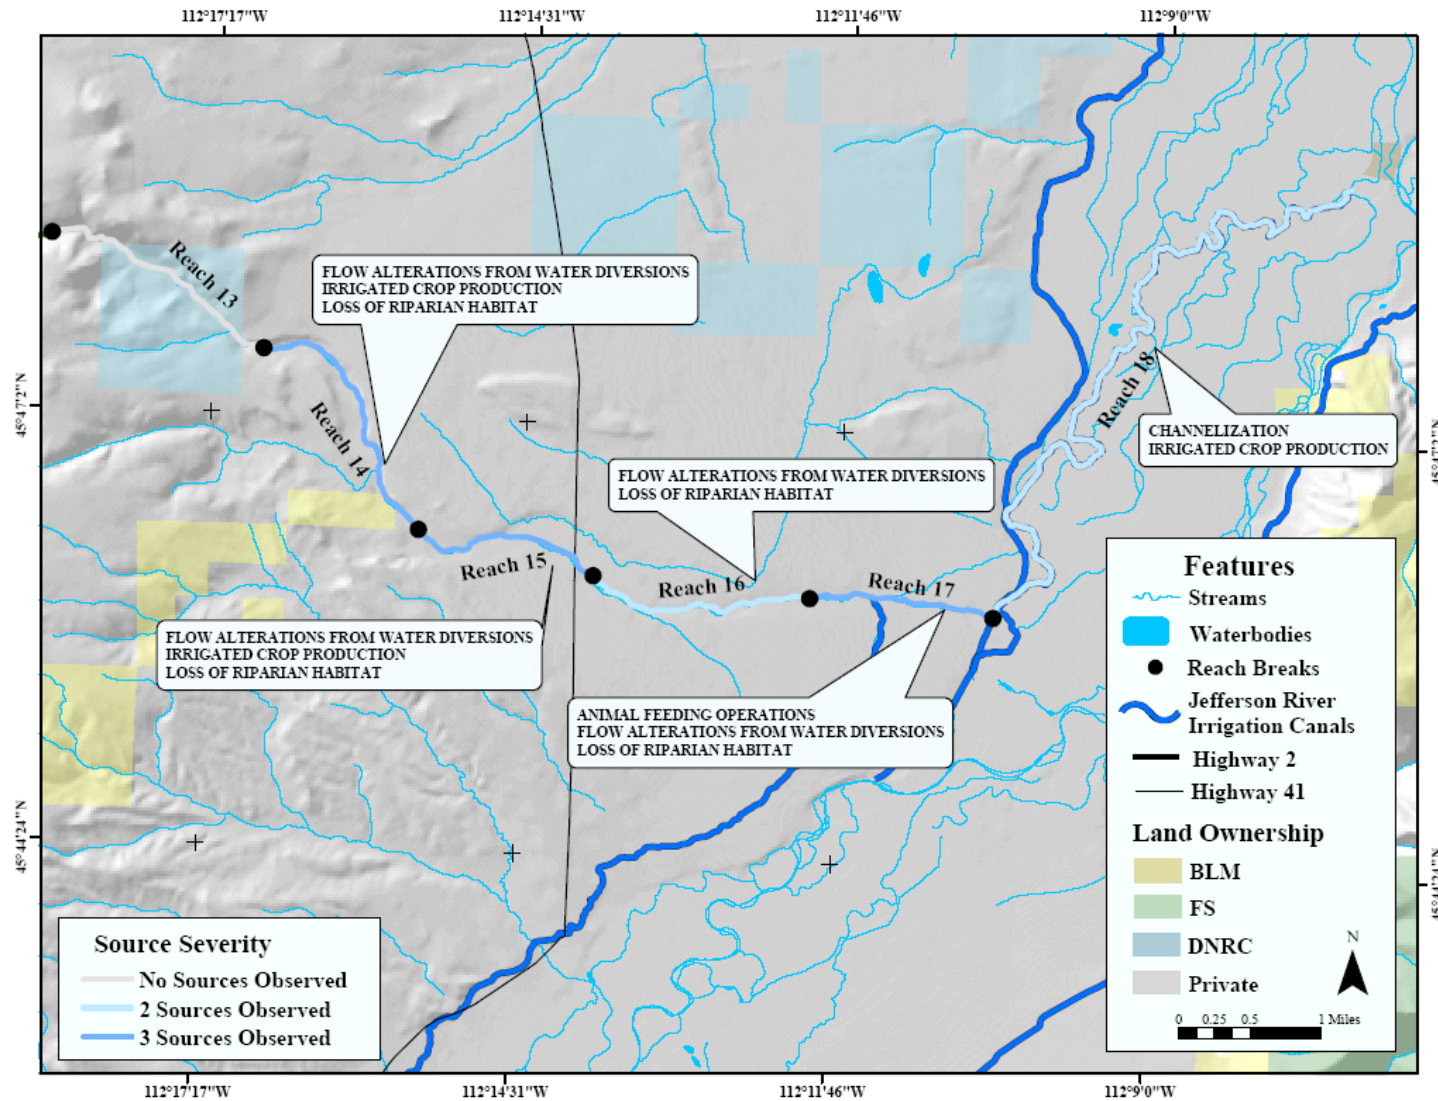
Figure 2-24. Lower Fish Creek Pollution Sources

Figure 2-24 displays the pollution sources assigned to the lower reaches of Fish Creek. Many pollution sources observed on the aerial photographs for lower Fish Creek were related to agricultural operations (irrigation diversions, cropping, and loss of riparian area). During the field source assessment, active beaver dams were observed in Reach 14. The landowner did not eradicate beavers on the property in order to help to maintain flow levels and soil moisture. Discussions with the landowner revealed that dewatering of the creek results in isolation of a genetically pure westslope cutthroat trout population, which apparently thrives in the reaches above the alluvial fan. For the valley portion of Fish Creek, only one time period was analyzed so significant changes in pollution sources since 1983 were not determined.

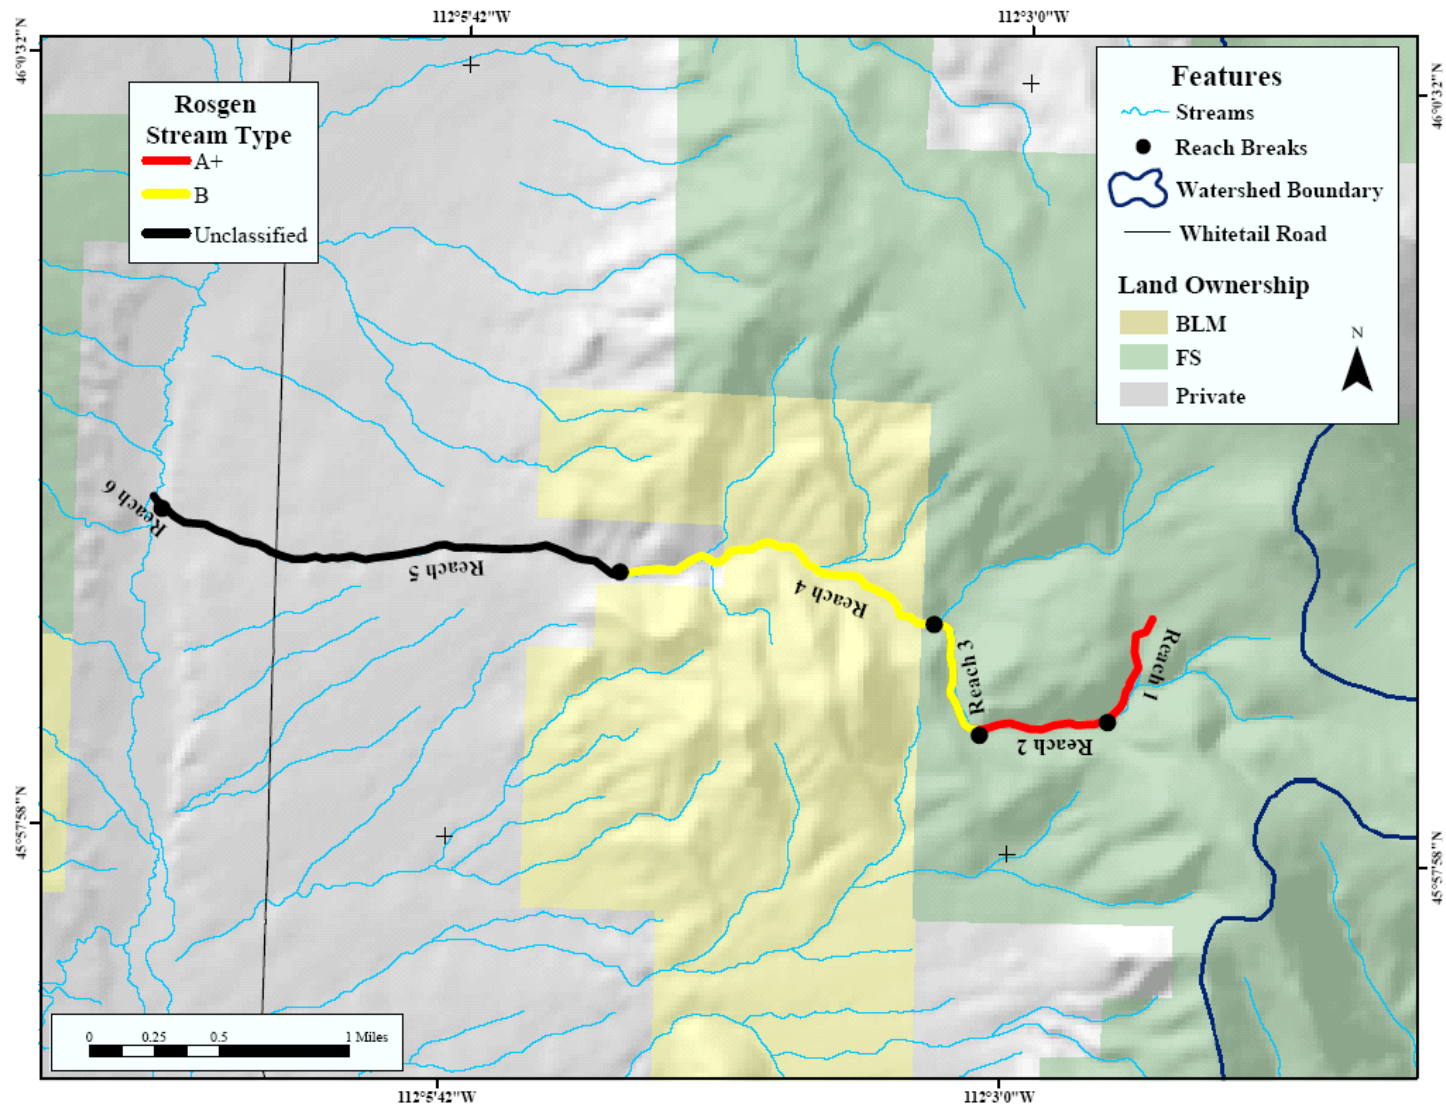
Figure 2-25. Fitz Creek Rosgen Stream Types

The channel forms of Fitz Creek are primarily controlled by landform structure (**Figure 2-25**). The stream headwaters on relatively steep slopes (A-type) and then progresses downstream to more moderate slopes. The valley bottom is fairly confined (B-type reaches) along the canyon and alluvial fan sections, until entering the floodplain of Little Whitetail Creek. The small section of Reach 4 observed in the field appeared to transition from an Eb to B-type channel near the head of the alluvial fan. On the alluvial fan, the stream goes distributary and definition of the main channel was tenuous at best. For this reason, the channel classification for Reach 5 was changed to 'unclassified' after the field review. During the field review, the largest channel walked in, Reach 5 exhibited characteristics of B and mostly G-type channels. Reach 6 was not classified either due to the difficulty of locating the channel on recent photos for this small section of the stream. In 1983, Reaches 3 and 6 were observed as having stream flow. This led to a significant decrease in active channel width between 1983 and 1995.

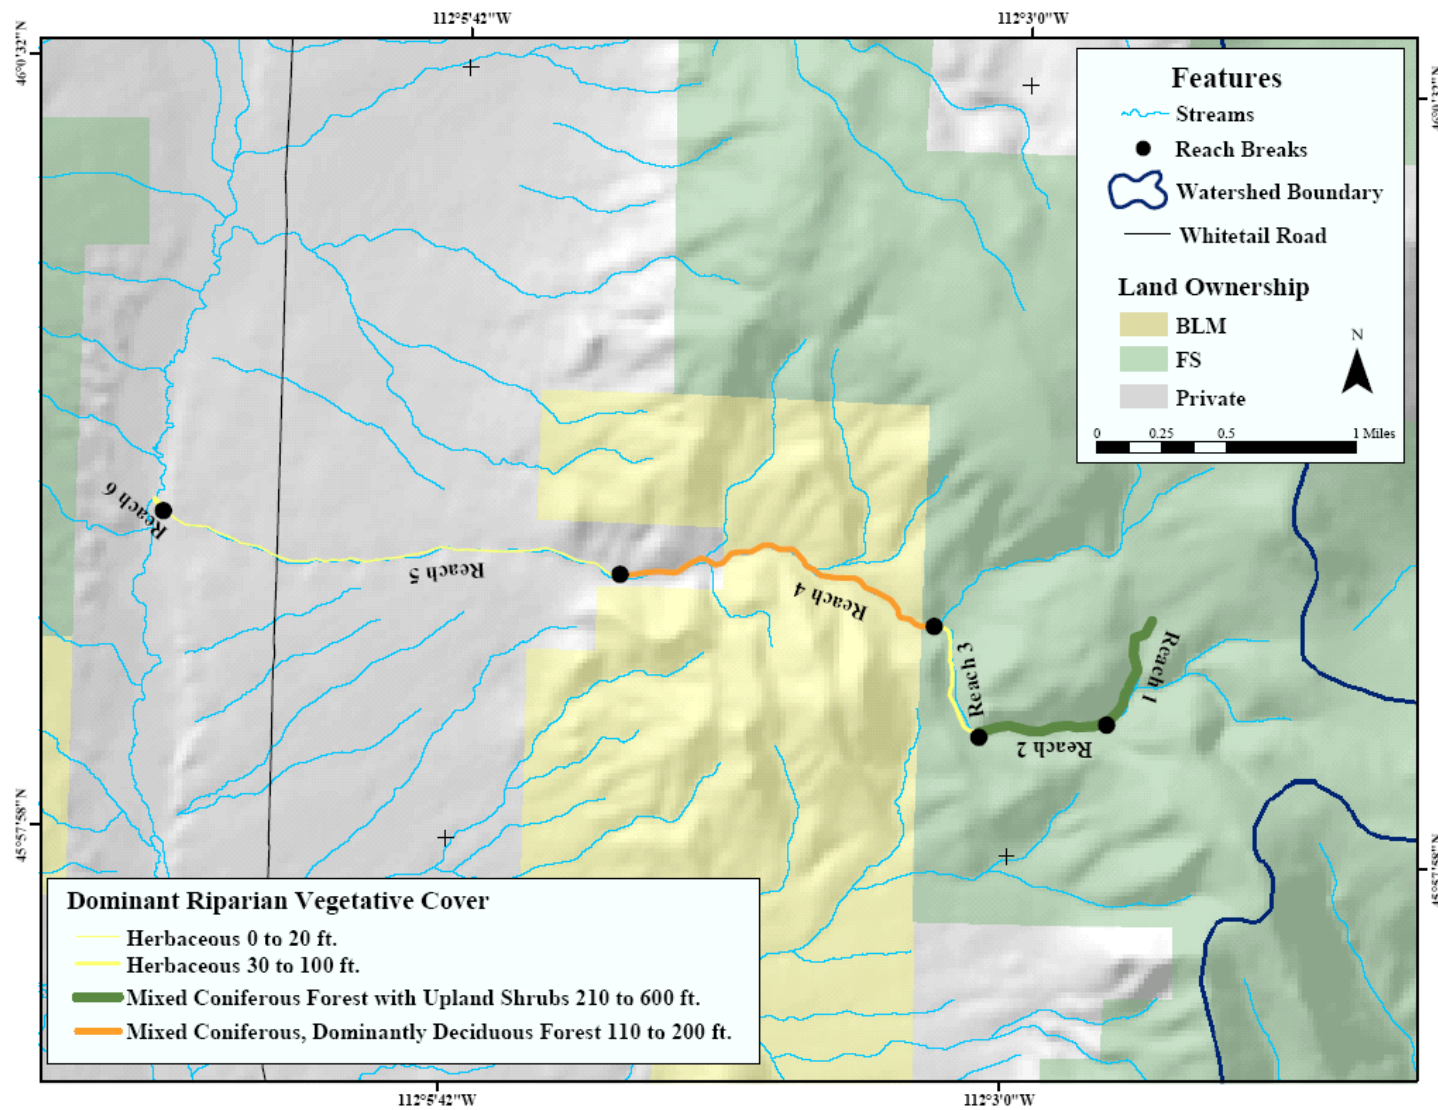
Figure 2-26. Fitz Creek Riparian Vegetation

The dominant riparian cover in the headwaters of Fitz Creek was mixed coniferous forest with upland shrubs (**Figure 2-26**). Buffer widths were generally greater than 300 feet wide along both sides of the stream. The buffer widths represented the distance of vegetation surrounding the stream before any disturbance was observed, as opposed to the actual width of 'wet' vegetation (alders, willows, etc.). The relative health category assigned to Reaches 1 and 2 was: 'Fair', due to the presence of an unpaved road.

The dominant riparian cover along Reach 4 was mixed coniferous, dominantly deciduous forest. Buffer width was generally greater than 50 feet wide along both sides of the stream. The buffer widths represented the distance of vegetation surrounding the stream before any disturbance was observed, or vegetation type changed. Buffer widths were generally limited by valley bottom width. During the field review, aspen, rose, sedges, and grasses were observed in the field. The relative health category assigned to Reach 4 was: 'Fair', due to the presence of an unpaved road. Between 1983 and 2001, the riparian buffer width in Reach 4 appeared to increase by an average of 20 percent.

The dominant riparian cover along the Reaches 3, 5, and 6, was herbaceous, whereby, the grasses or forbs were being grown into the riparian and almost no woody vegetation was present (**Figure 2-26**). The buffer widths of these lower reaches represent the actual width of 'wet' vegetation. Buffer widths were generally less than 10 feet wide along both sides of the stream. The relative health category assigned to all of the reaches was 'Fair'. The riparian area in Reach 5 appeared to be limited by moisture. In 1983, Reaches 3 and 6 were observed as having stream flow. This led to a significant decrease in riparian buffer width between 1983 and 1995.

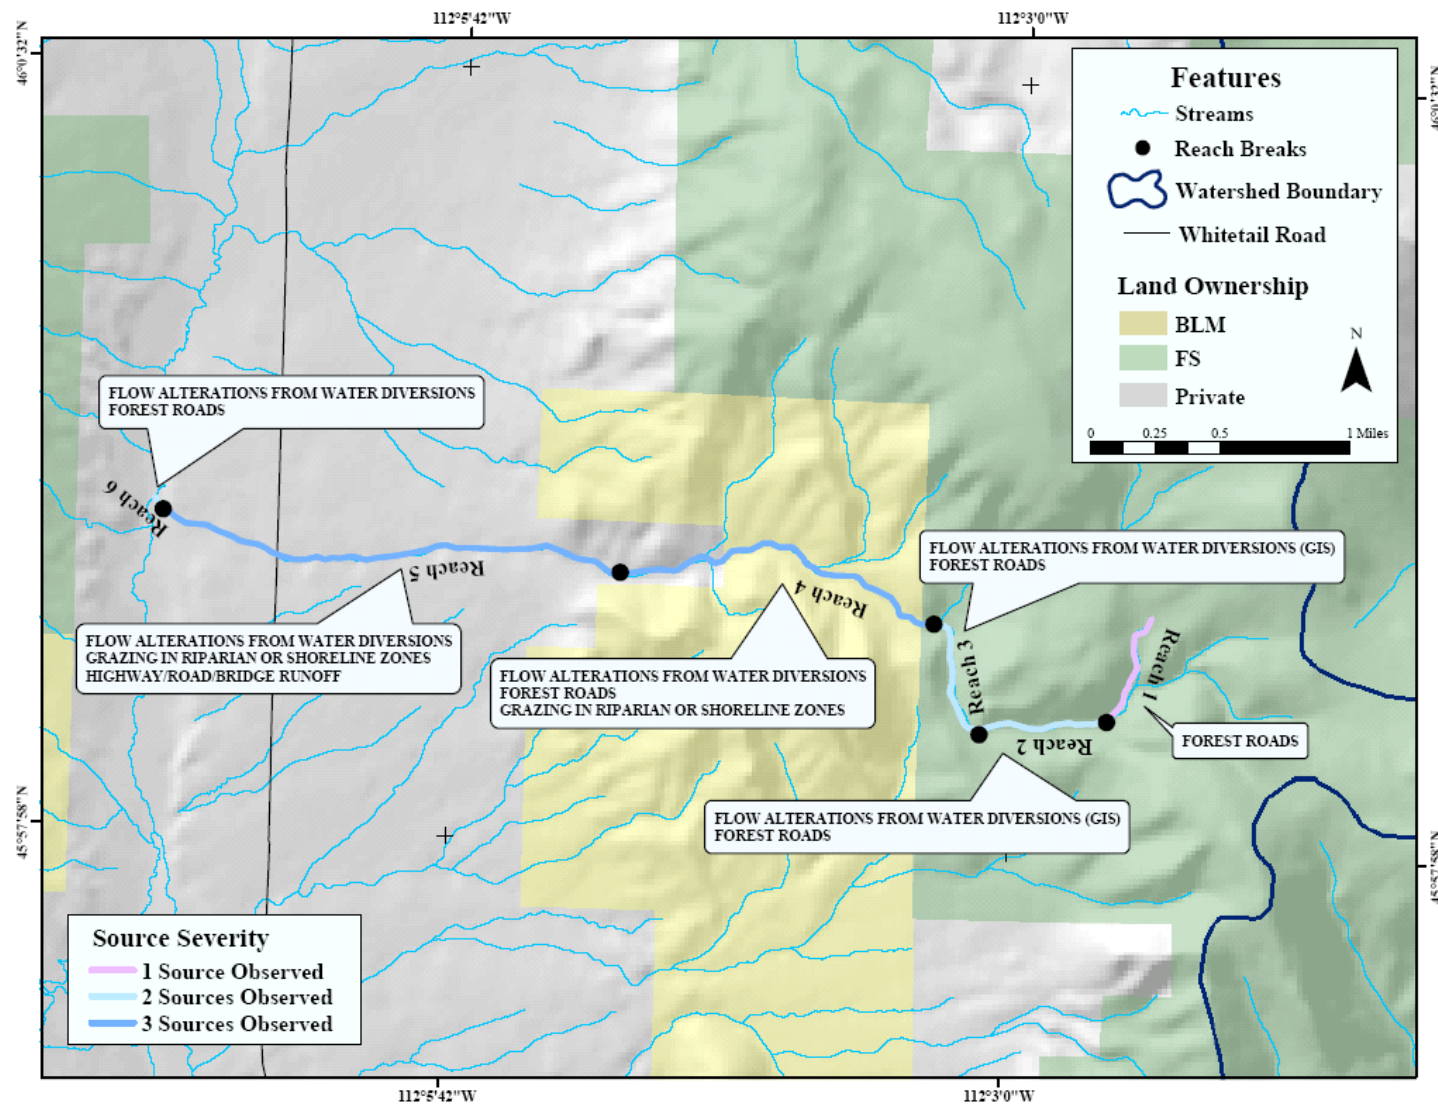
Figure 2-27. Fitz Creek Pollution Sources

Figure 2-27 displays the pollution sources assigned to Fitz Creek. Most of the pollution sources observed on the aerial photos were related to flow alterations and unpaved roads. In many instances, the source of flow alterations from water diversions was taken from a GIS layer, and was not field verified. Grazing was observed along much of Reach 5, but the impacts were fairly minimal due to the lack of water. During the field source assessment the stream was observed as naturally going dry at the head of the alluvial fan. On the alluvial fan (Reach 5) the stream goes distributary and probably does not carry flow, except during spring runoff and intense rainfall events (fairly characteristic of streams on alluvial fans in arid environments). There were no significant changes in pollution sources between 1983 and 2001.

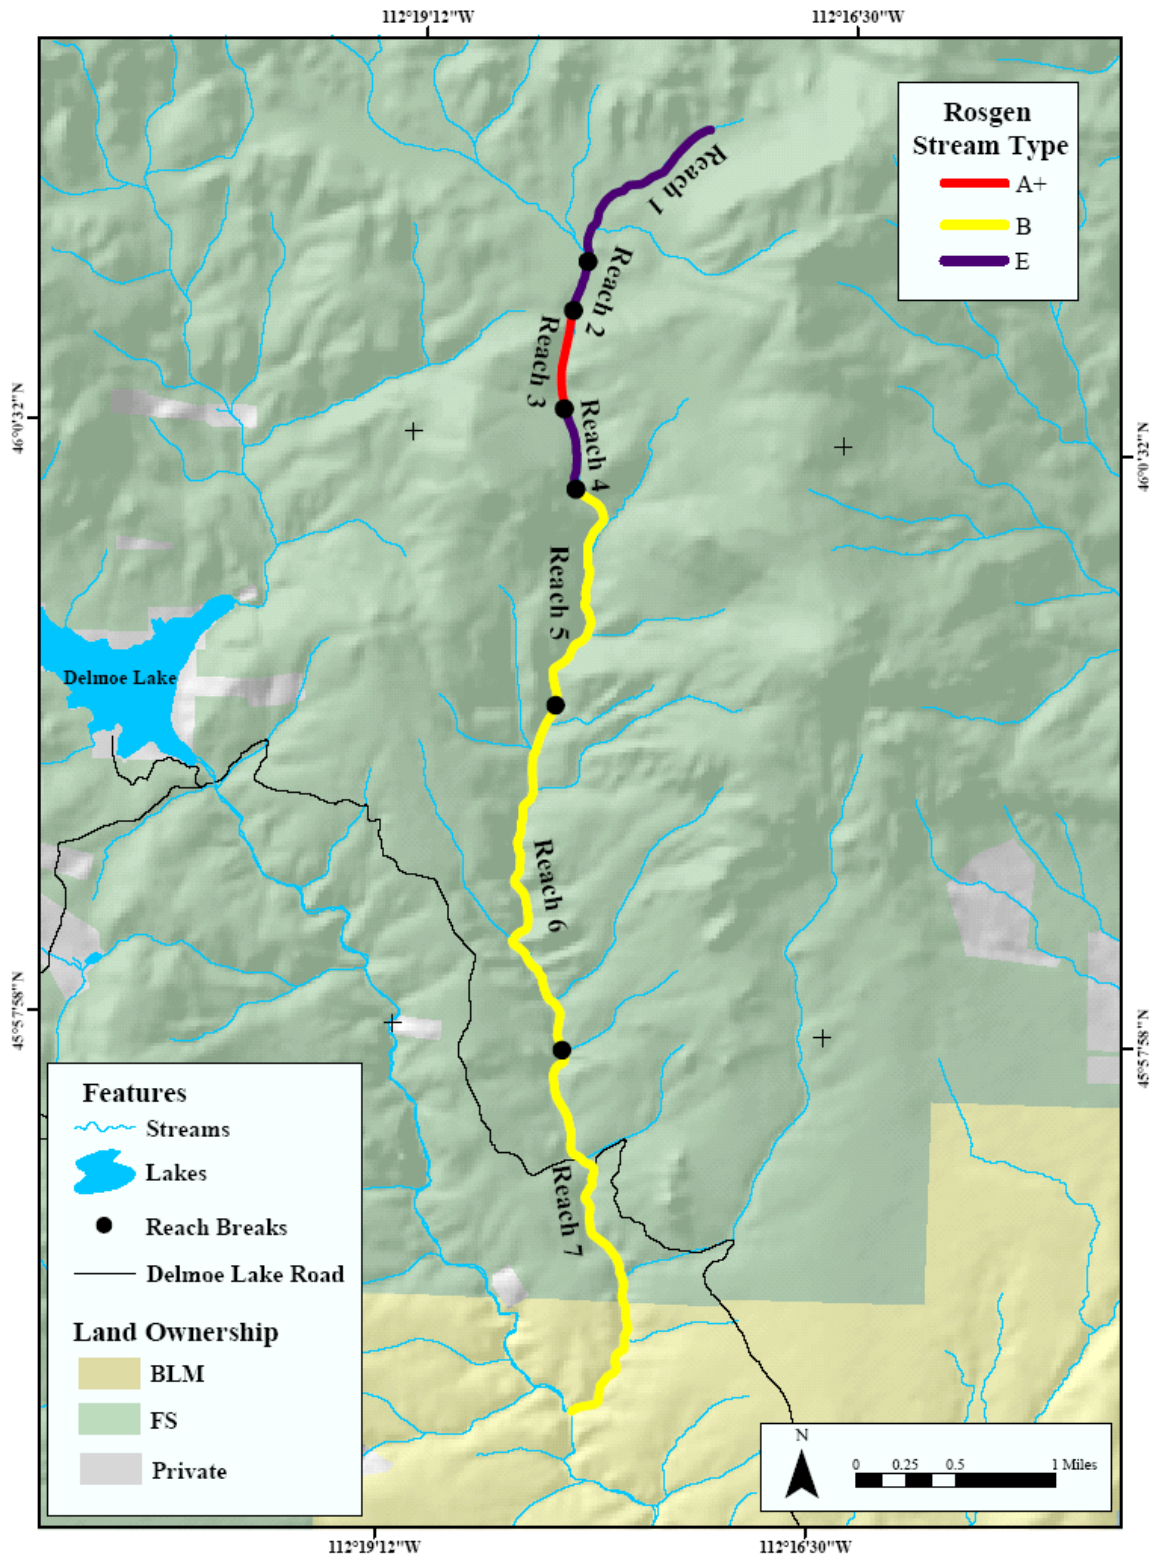
Figure 2-28. Halfway Creek Rosgen Stream Types

The channel forms of Halfway Creek are predominantly controlled by landform structure (**Figure 2-28**). Halfway Park, the headwater area, is a broad wetland meadow with fairly gentle slopes. Channel form here is thought to be an E-type channel. Reach 2 was broken into a separate reach due to an unknown disturbance, which has resulted in a widening of the channel and ponding at the end of the reach. Once the stream leaves Halfway Park, gradient steepens (A-type) and flow is confined to the canyon. From Reaches 4 to 7 the Boulder Batholith geology has weathered into less confined valley bottom sections (Ea and Eb-type reaches), as well as narrow valley bottom areas (B-type reaches). A portion of Reach 6 viewed during the field survey exhibited a B-type channel, with some sections trending toward Eb form. The portion of Reach 7 viewed in the field exhibited a slightly incised, B-type channel. There were no significant changes in channel form between 1983 and 2001.
