APPENDIX C
2004 AERIAL PHOTO REVIEW AND FIELD SOURCE ASSESSMENT,
UPPER JEFFERSON RIVER WATERSHED

1.1 Upper Jefferson Watershed 2004 Aerial Photo Review and Field Source Assessment

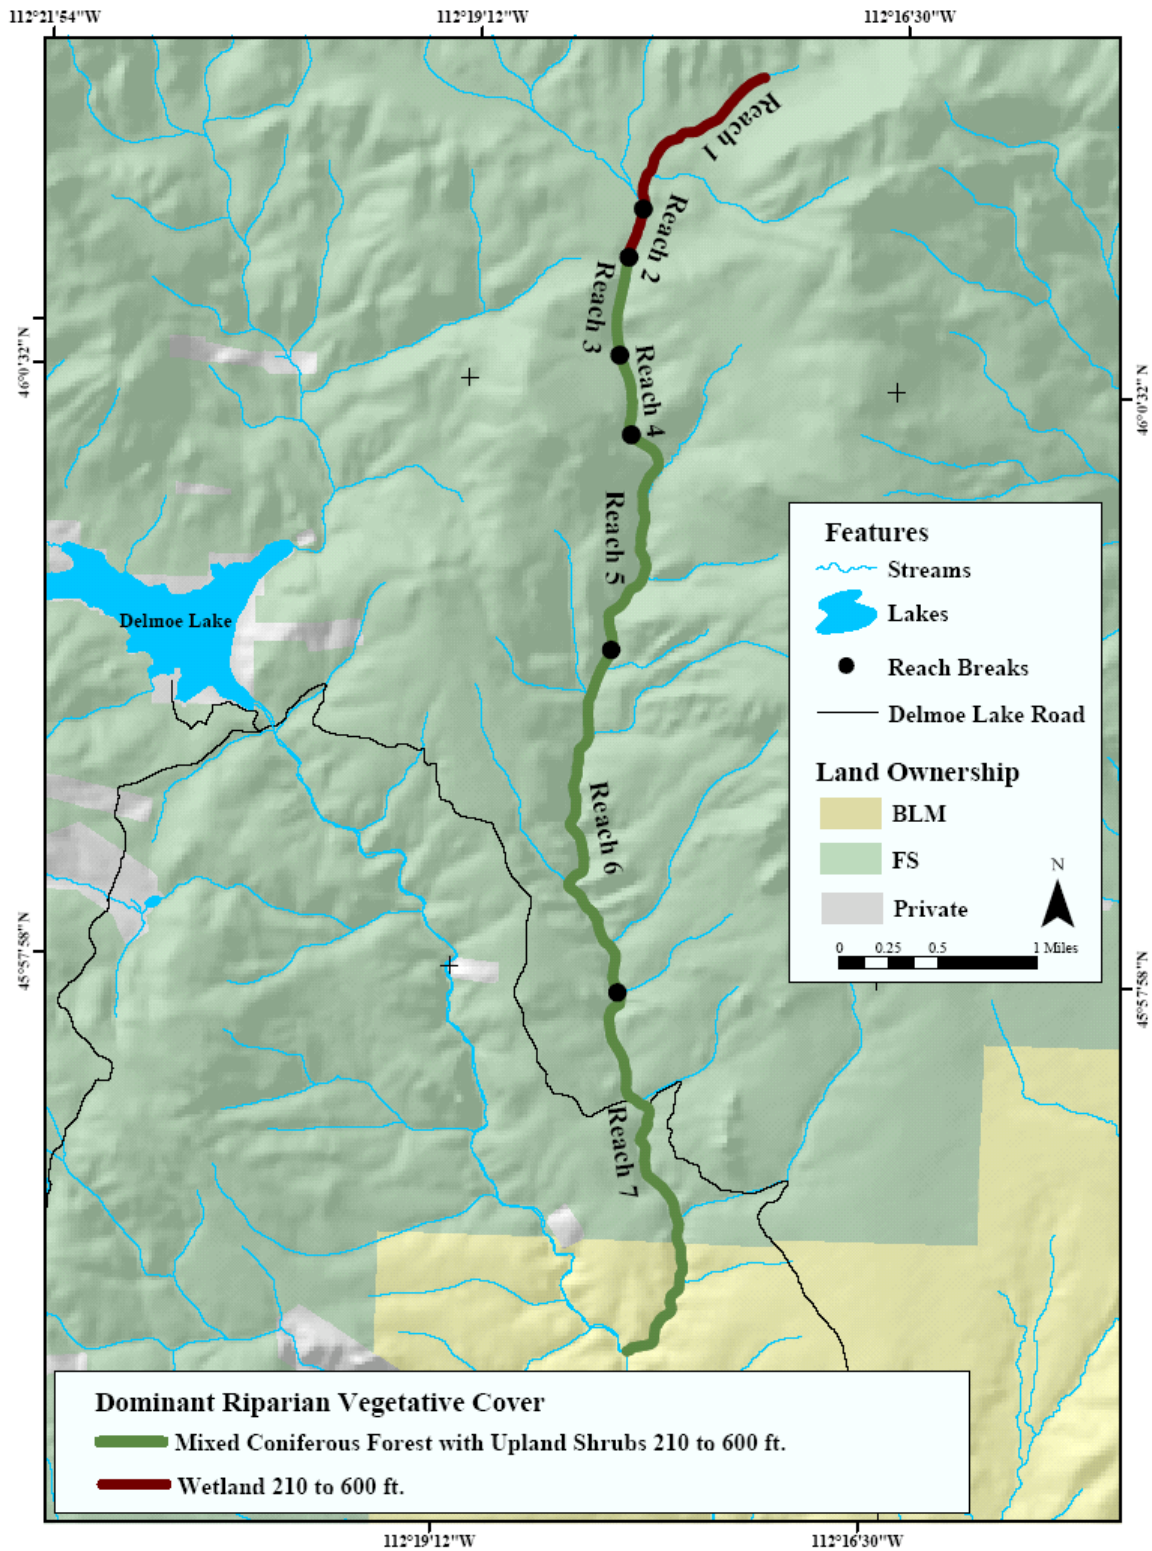
Figure 2-29. Halfway Creek Riparian Vegetation

The dominant riparian cover along Halfway Creek in the headwaters was wetland, while the canyon sections were predominantly mixed coniferous forest with upland shrubs (**Figure 2-29**). The headwater wetland buffer widths were generally greater than 100 feet wide along both sides of the stream. The wetland buffer widths represented the distance of vegetation surrounding the stream before any disturbance was observed, and included some area of mixed coniferous forest with upland shrubs. The relative health category assigned to the wetland dominated reaches was 'Fair', due to disturbance from unpaved roads. Mixed coniferous forest buffer widths were generally greater than 200 feet wide along both sides of the stream. GIS layers indicated that no roads exist from Reaches 3 to 5. During the field observation of Reaches 6 and 7, unpaved ATV/motorcycle trails were observed less than 100 feet from the stream, but often were not visible on the aerial photos. During the field review, alder, willows, red osier, rose, current, sedges, and grasses were noted as extending to a maximum of 40 feet from the channel within the conifer forest. The relative health category assigned to the mixed coniferous forest dominated reaches was 'Excellent' in Reaches 3 to 6, but 'Fair' in Reach 7 due to disturbance from unpaved roads. Some areas of thistle and mullein infestation were present. Between 1983 and 2001, the riparian buffer widths in Reaches 6 and 7 appeared to increase by an average of 30 percent and 15 percent respectively.

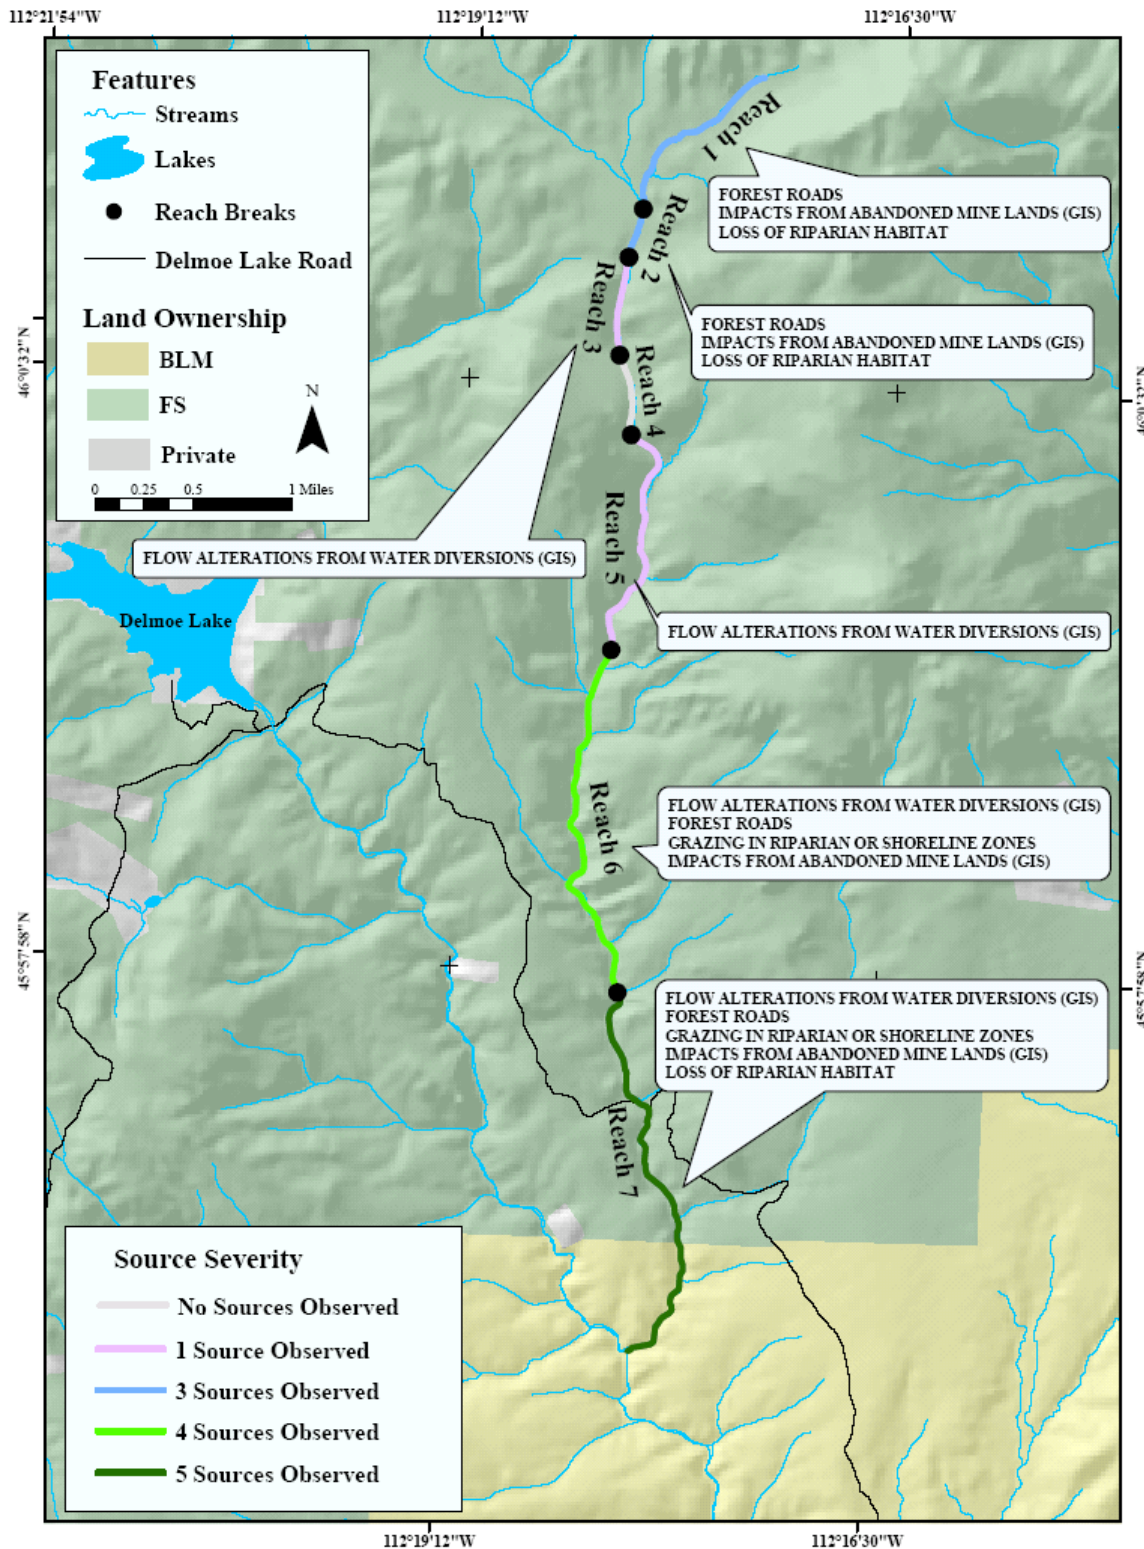
Figure 2-30. Halfway Creek Pollution Sources

Figure 2-30 displays the pollution sources assigned to Halfway Creek. The sources of flow alterations from water diversions and impacts from abandoned mine lands were taken from GIS layers which located water rights claims and abandoned mines. The GIS identified sources have not been field verified. Loss of riparian habitat was associated with road development and grazing. Many pollution sources observed along Halfway Creek were related to riparian grazing and unpaved roads and trails (overwidened channel, bank erosion, loss of vegetation). During the field source assessment, channel condition appeared to degrade in a downstream manner. There were no significant changes in pollution sources between 1983 and 2001.

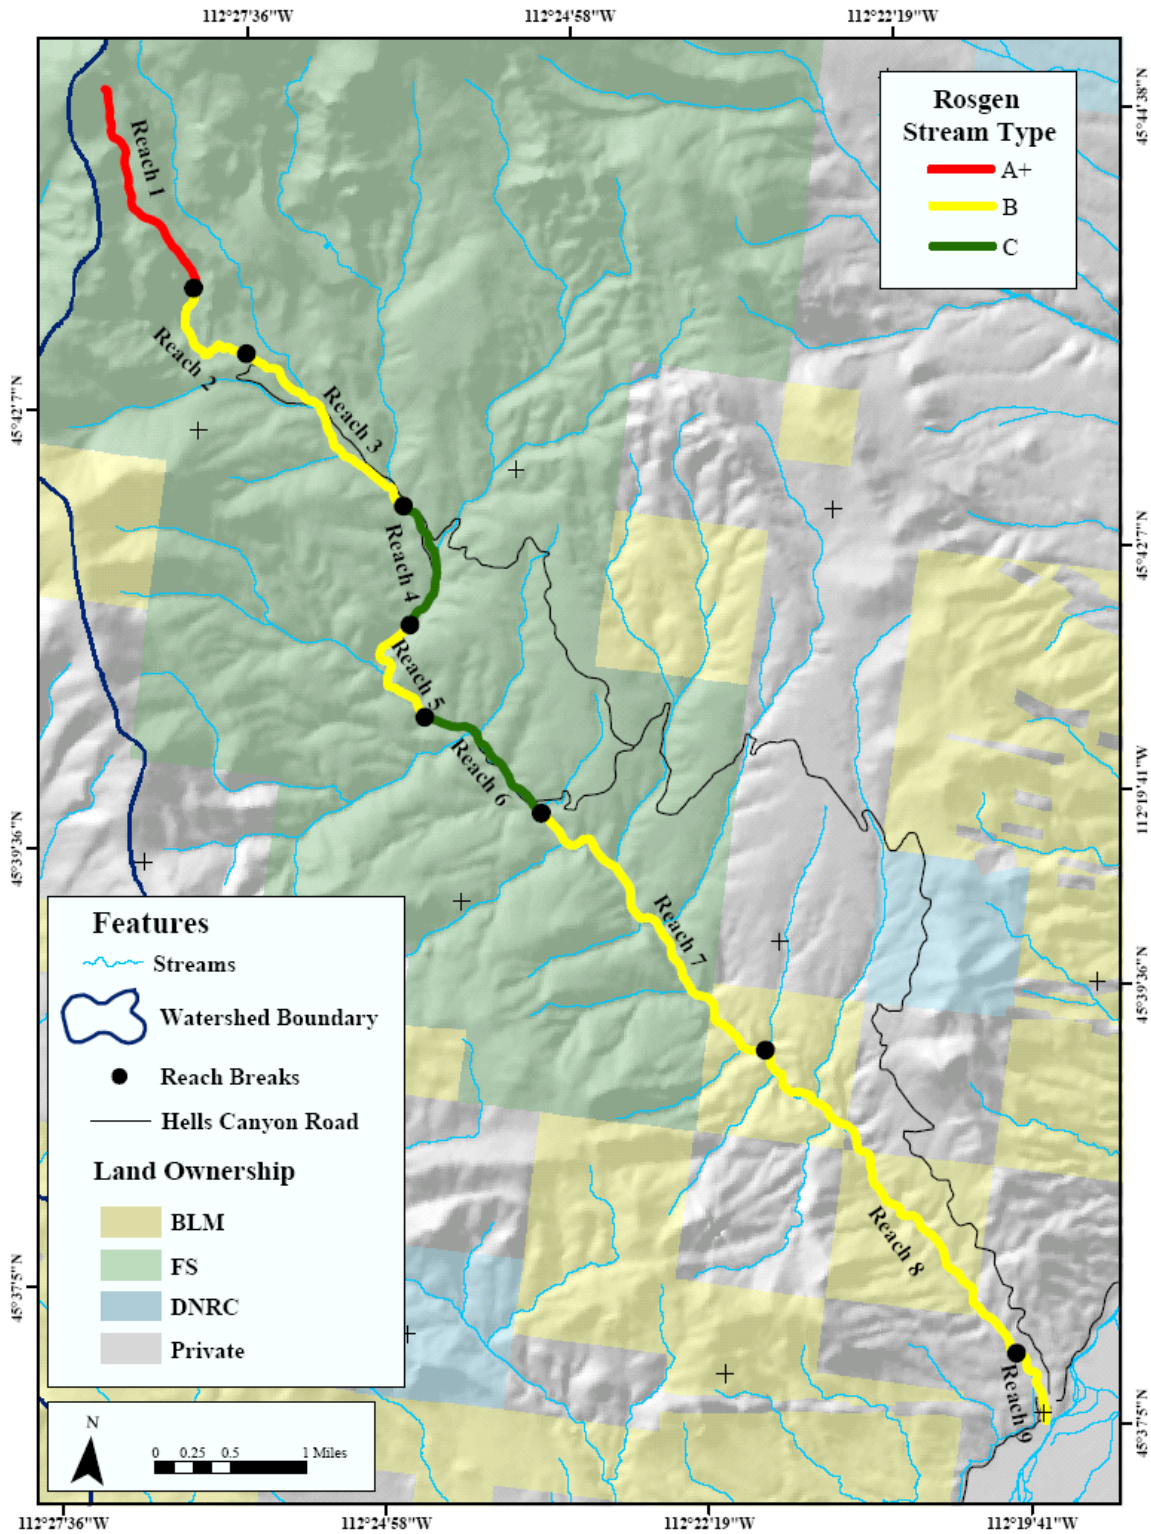
Figure 2-31. Hells Canyon Creek Rosgen Stream Types

The channel forms of Hells Canyon Creek are predominantly controlled by landform structure, as well as historic and current land uses (**Figure 2-31**). The prominent landform geology, the Boulder Batholith, has resulted in valley bottom formation along weathered joints. The stream headwaters on steep slopes (A-type) and then progresses downstream to more moderate slopes. The canyon valley bottom alternates between confined (B-type) and unconfined sections (C-type). In Reach 9, the stream is also fairly confined within the alluvial fan until reaching the floodplain of the Jefferson River. The portion of Reach 4 viewed during the field survey exhibited C and Bc channel types. Reach 5 exhibited a B-type channel. The portion of Reach 6 viewed in the field exhibited C, Bc, and B-type channel sections. Remnants of beaver dams were observed in Reach 4 and Reach 6. It is suspected that the removal of beaver dams has altered channel form (straightened, incised), and that channel type would probably have naturally trended towards an E-type stream in these reaches. The section of Reach 9 surveyed exhibited a somewhat incised B-type channel on the alluvial fan but was unconfined at the mouth. There was one significant difference in channel measurements between 1983 and 2001. For the 1983 analysis a series of ponds were visible in Reach 2, but in 2001 no ponds were visible.

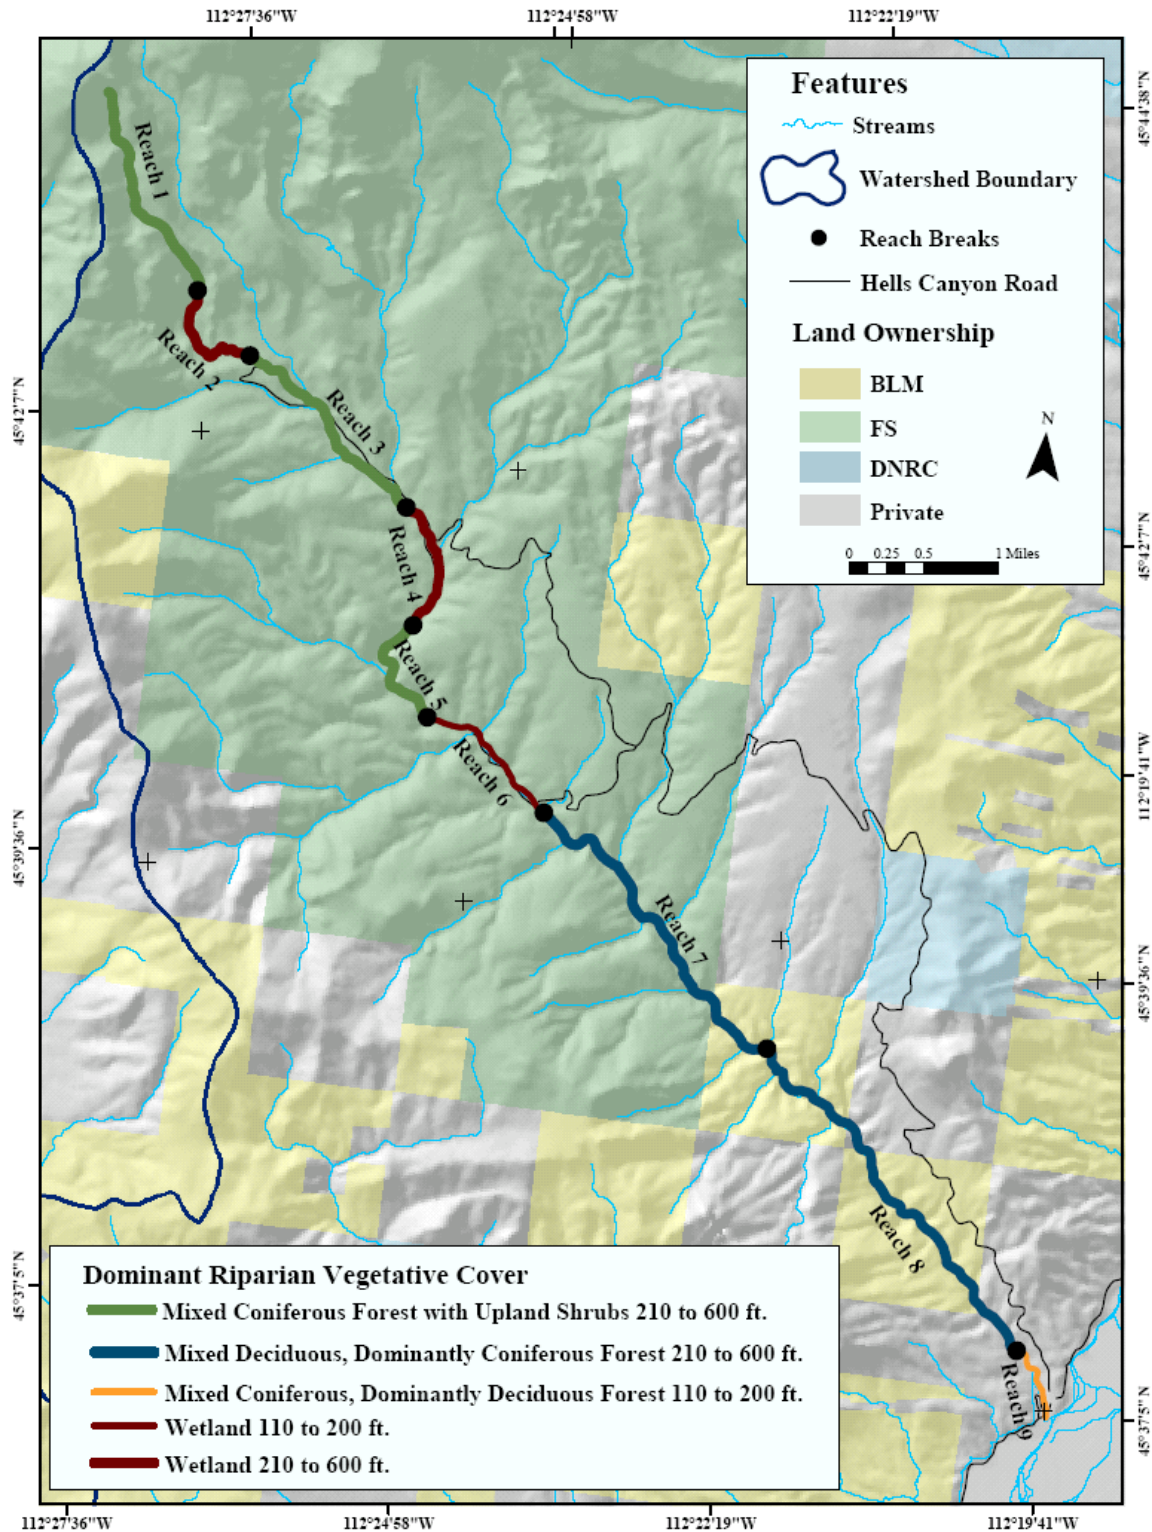
Figure 2-32. Hells Canyon Creek Riparian Vegetation

The dominant riparian cover along the alluvial fan (Reach 9) portion of Hells Canyon Creek was mixed coniferous, dominantly deciduous forest (**Figure 2-32**). Buffer width was generally less than 50 feet wide along both sides of the stream. The relative health category assigned to Reach 9 was 'Fair' due to development near the floodplain. During the field review, cottonwood (with some runners), willows, alder, rose, and grasses were noted as extending generally to a maximum of 40 feet from the channel. Thistles were also present. Between 1983 and 2001, the riparian buffer width in Reach 9 appeared to increase by an average of 15 percent.

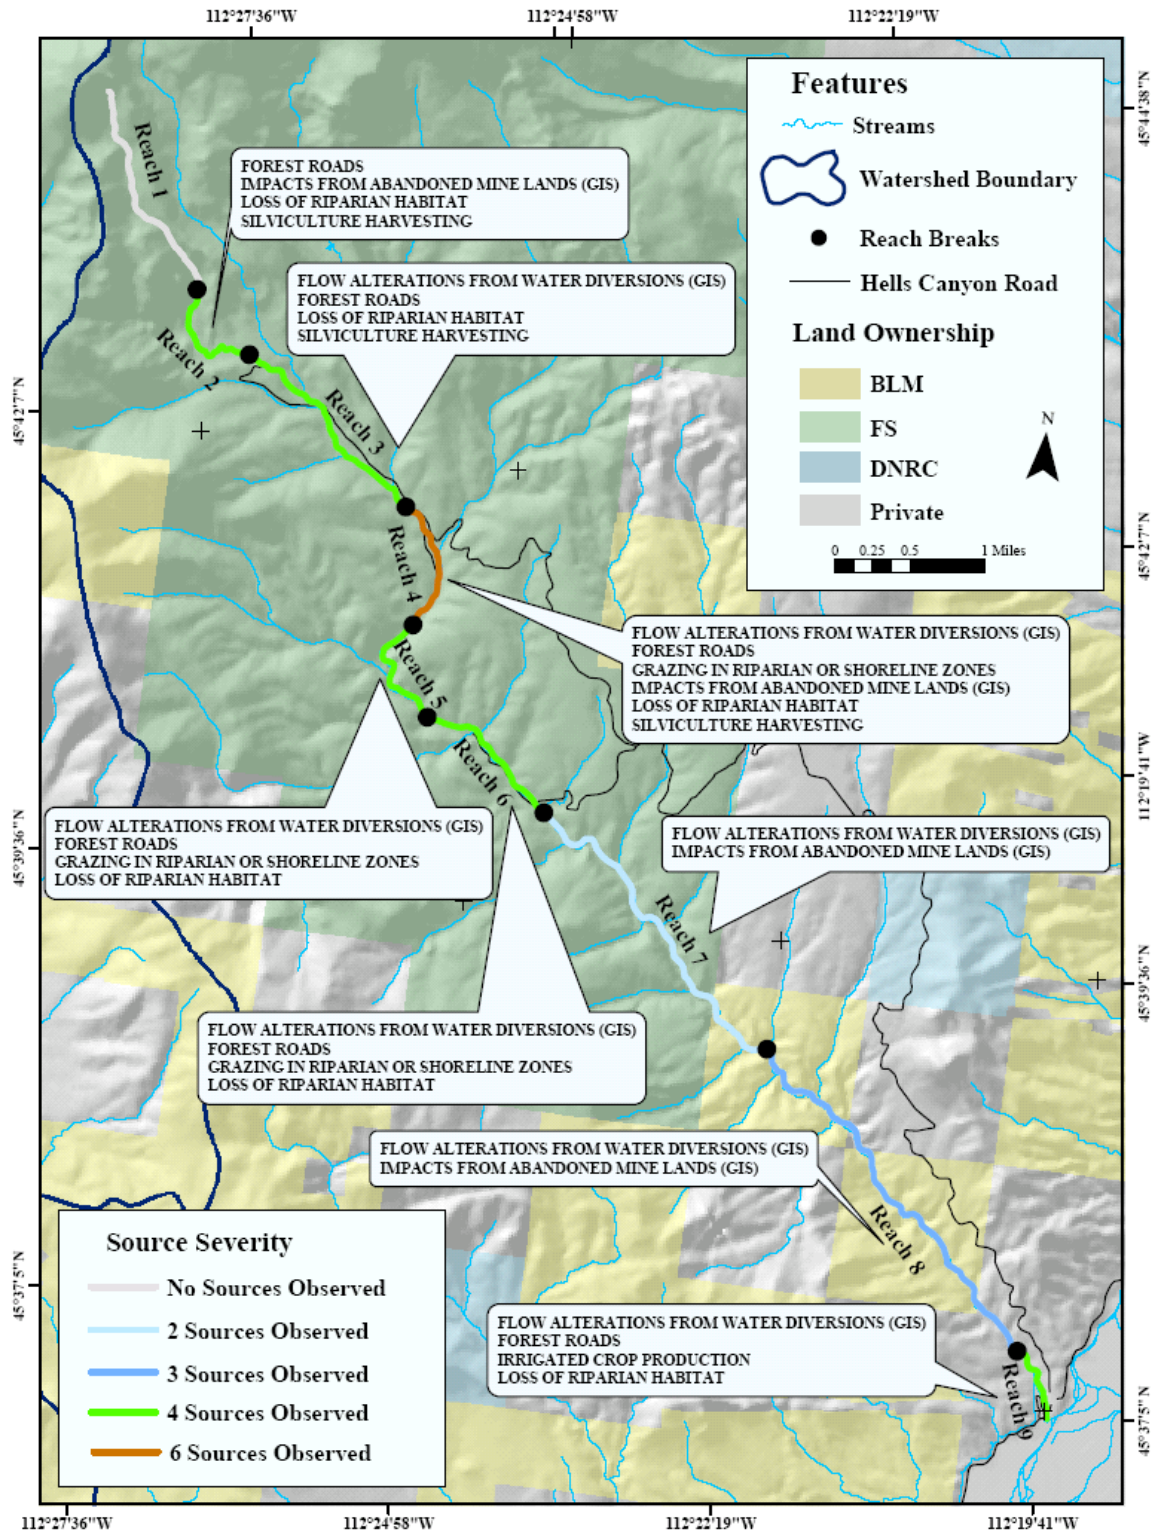
Figure 2-33. Hells Canyon Creek Pollution Sources

Figure 2-33 displays the pollution sources assigned to Hells Canyon Creek. Most pollution sources observed along upper Hells Canyon Creek were related to riparian grazing and unpaved roads. The sources of flow alterations from water diversions and impacts from abandoned mine lands were taken from GIS layers which located water rights claims and abandoned mines. The GIS identified sources were not field verified. Silviculture harvests occurred before 1983, upslope from and adjacent to Hells Canyon Creek. Any runoff associated with the harvests would enter in Reaches 2 through 4. Harmful effects from this impact were not observed in the field. Loss of riparian habitat was generally associated with road development and grazing. There were no significant changes in pollution sources between 1983 and 2001.

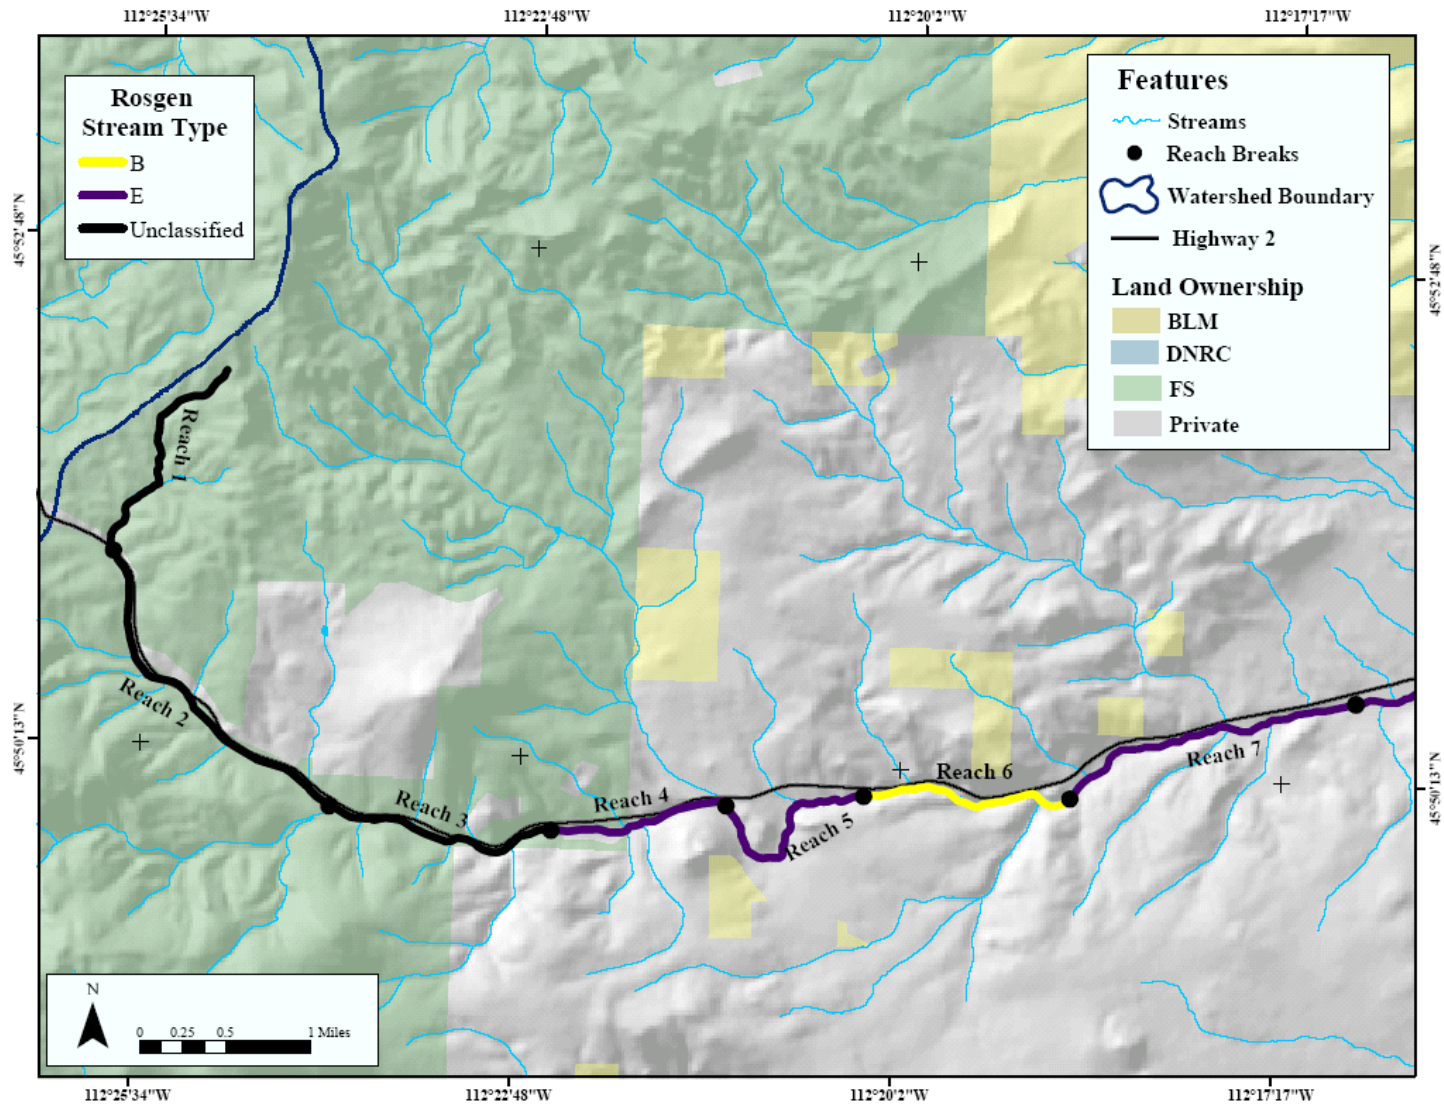
Figure 2-34. Upper Little Pipestone Creek Rosgen Stream Types

The channel forms of Upper Little Pipestone Creek are predominantly controlled by landform structure, as well as historical and current landuse activities (**Figure 2-34**). The channel forms of Little Pipestone Creek in Reaches 1 to 3 were difficult to type in areas because of channelization and grazing impacts. As well during the aerial review, the channel was not visible until Reach 4. For these reasons, the channel classifications for Reaches 1, 2, and 3 were changed to 'unclassified' after the field review. The area surveyed in Reach 1 was more of a flooded wet meadow than an actual stream. There were ponded areas from earthen dams, and some areas of multiple threads with E-type channel characteristics. Reach 2 was affected by channelization between Highway 2 and the railway. Channel forms observed in Reach 2 were characteristic of E and mostly G-type streams. The portion of Reach 3 observed in the field trended from an Eb to a B-type channel. The channel was less confined in Reaches 4, 5, and 7, and was thought to have characteristics on an E-type channel. Structural controls in Reach 6 led to the classification of a B-type reach. The Boulder Batholith is the prominent geology of the upper reaches. There were no significant changes in channel form between 1983 and 2001.

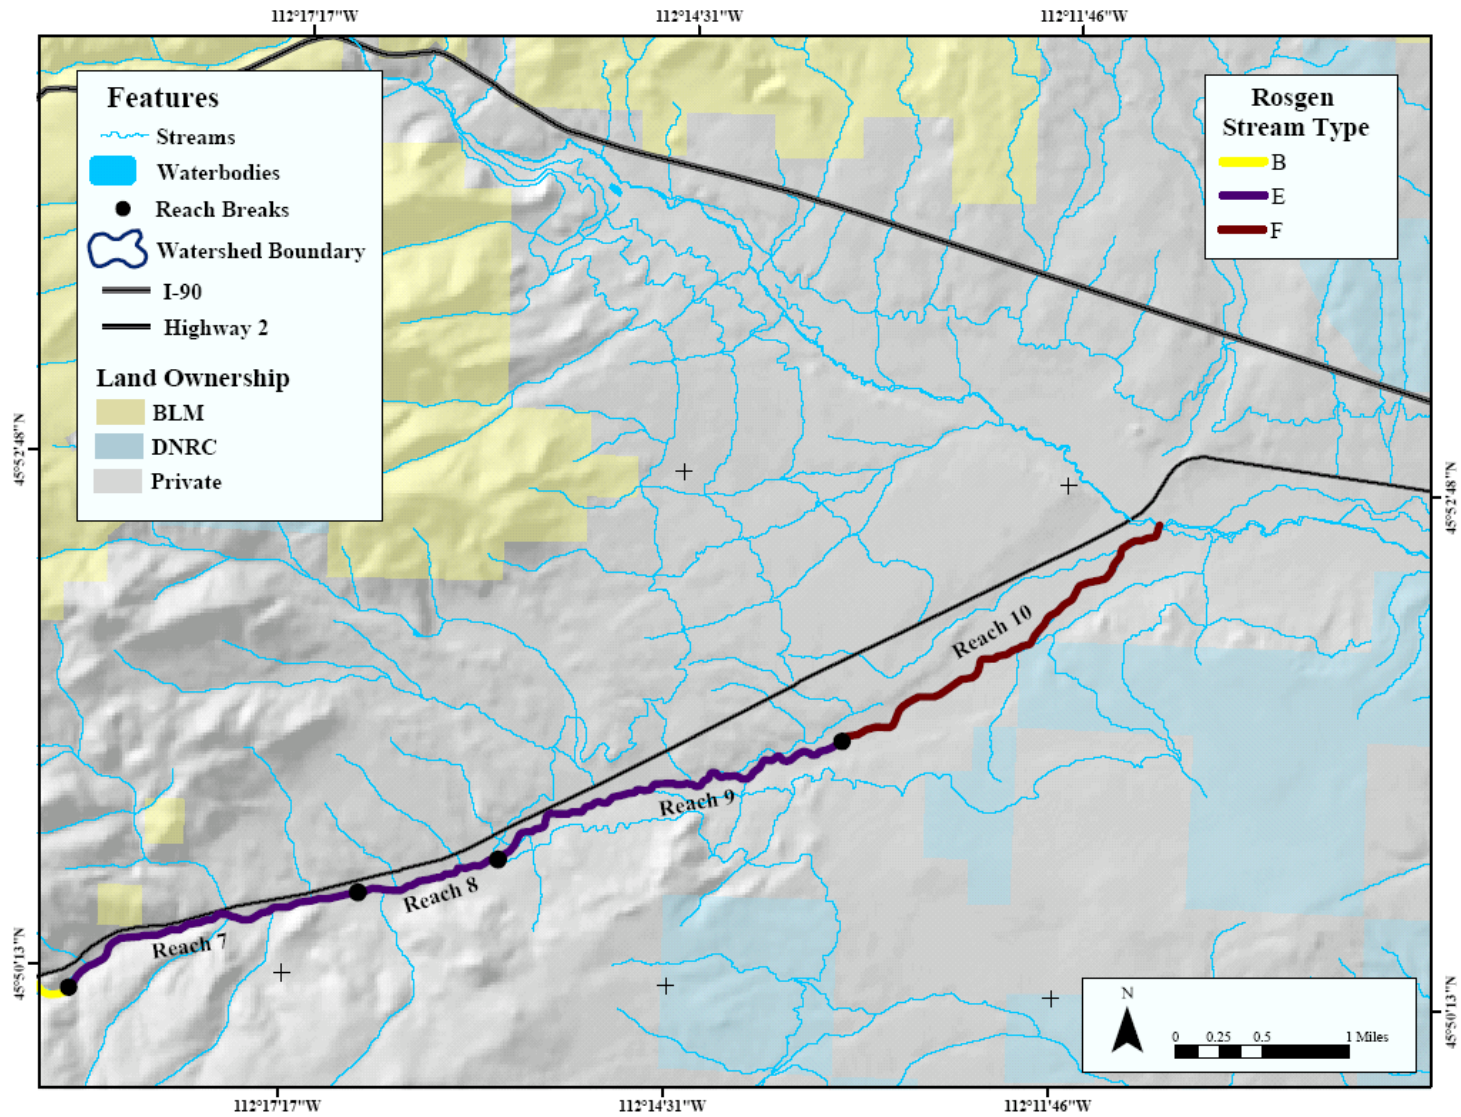
Figure 2-35. Lower Little Pipestone Creek Rosgen Stream Types

The channel forms of Lower Little Pipestone Creek are also predominantly controlled by landform structure, and historical and current landuse activities (**Figure 2-35**). The predominant valley type (VIII) would typically result in an unconfined stream type (C or E), yet channel alterations have resulted in stream types out of balance with the valley type (directly observed in Reach 10). The small section of Reach 8 viewed in the field exhibited E-type channel characteristics. Active beaver dams were observed on the creek above Highway 41 in this reach. It is suspected that channel form in Reach 9 could possibly be an F-type due to the Delmoe Ditch irrigation diversion and disruption of riparian habitat in this reach. Observed channel forms in Reach 10 were variable, but an overall classification of F-type was given to this reach. Areas of braiding were observed, along with overwidened sections, as well as a large downcut section. For the lower portion of Little Pipestone Creek, only one time period was analyzed so significant changes in channel form since 1983 could not be determined.

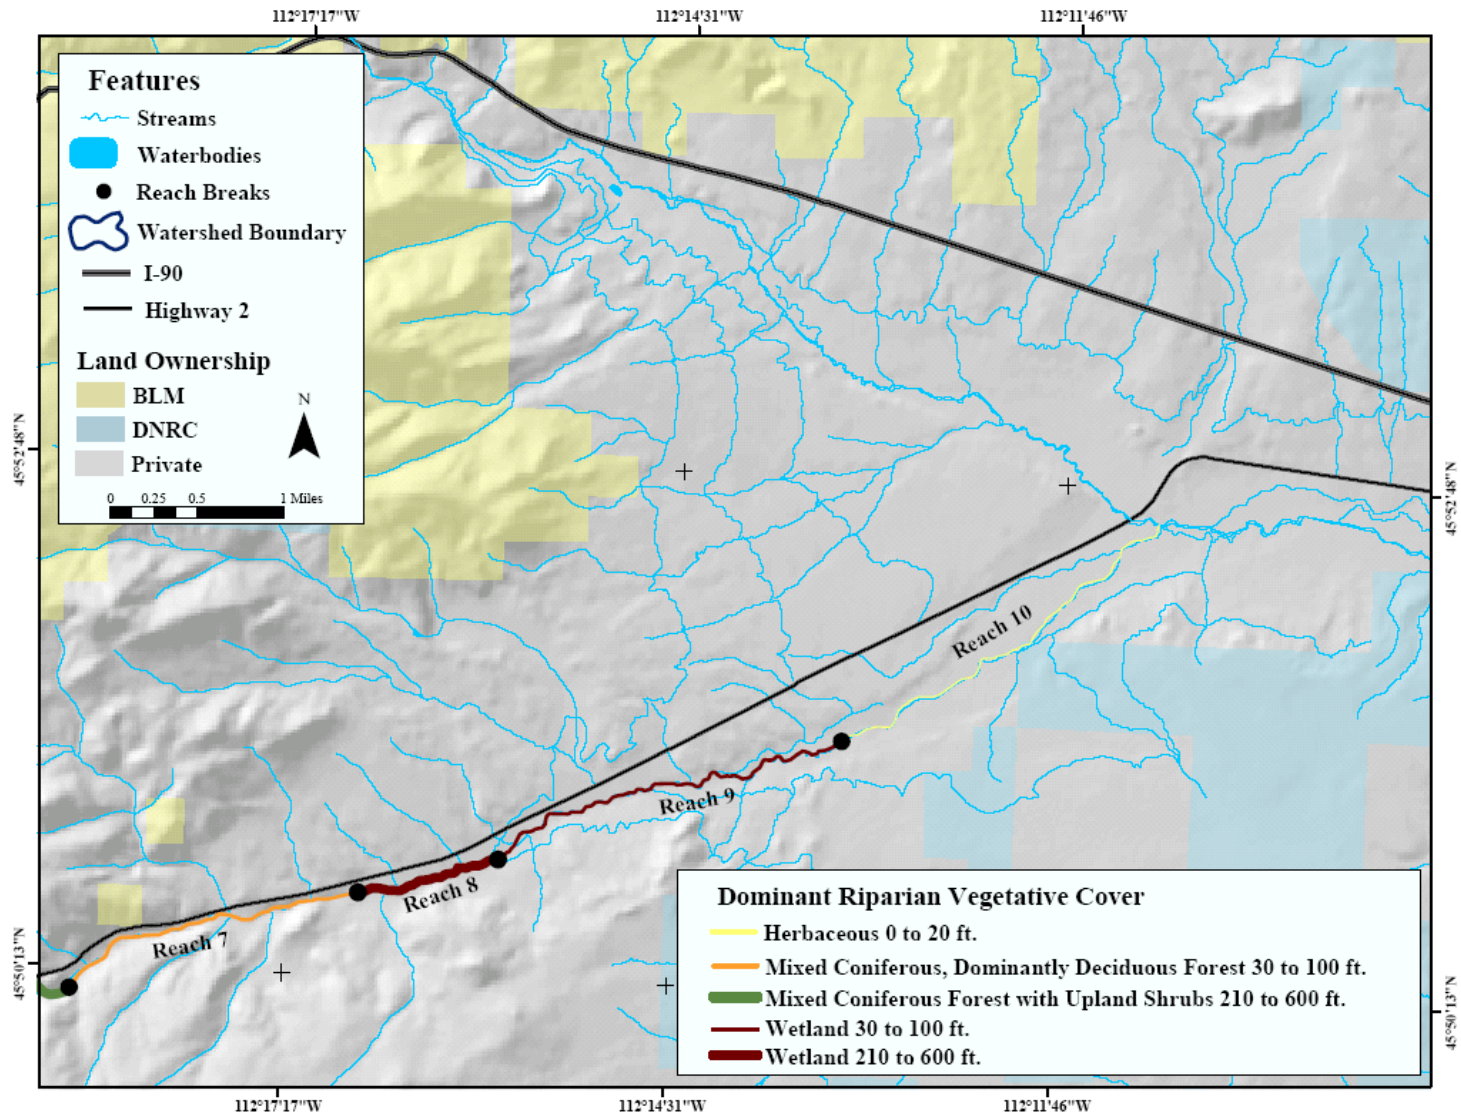
Figure 2-37. Lower Little Pipestone Creek Riparian Vegetation

Riparian vegetative cover along Lower Little Pipestone Creek progressed from predominantly deciduous, to wetland, to herbaceous (**Figure 2-37**). Buffer widths were generally less than 50 feet wide along both sides of the stream, except for in Reach 8. The relative health category assigned to the lower reaches progressed from 'Fair' to 'Poor' in a downstream manner. During the field review, decadent hedged willows and sedges were noted as extending to a maximum of 20 feet from the channel in Reach 10. For the lower portion of Little Pipestone Creek, only one time period was analyzed so significant changes in riparian vegetation since 1983 could not be determine

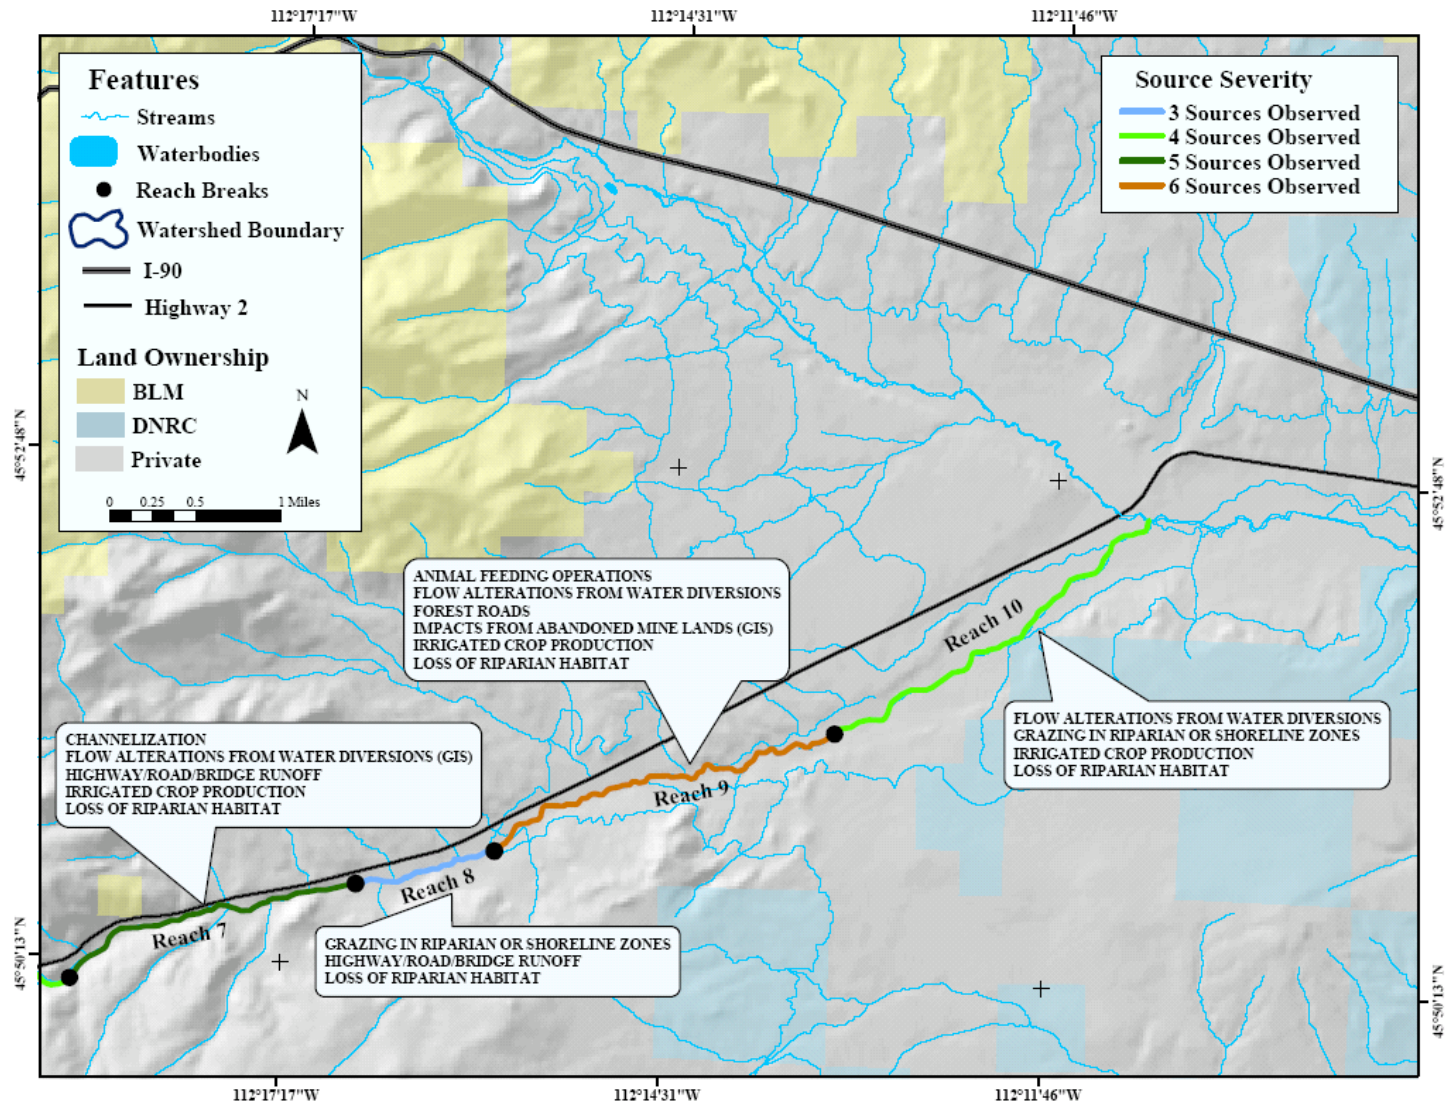
Figure 2-39. Lower Little Pipestone Creek Pollution Sources

Figure 2-39 displays the pollution sources assigned to the lower reaches of Little Pipestone Creek. Many pollution sources observed along Lower Little Pipestone Creek were related to agricultural operations and rural housing development. Alterations for irrigation diversions were observed in reaches 9 and 10. During the field source assessment, grazing impacts and flow alterations were observed in Reach 10. In general, stream condition deteriorates in a downstream manner from Reach 8 to Reach 10. For the lower portion of Little Pipestone Creek, only one time period was analyzed so significant changes in pollution sources since 1983 were not determined.

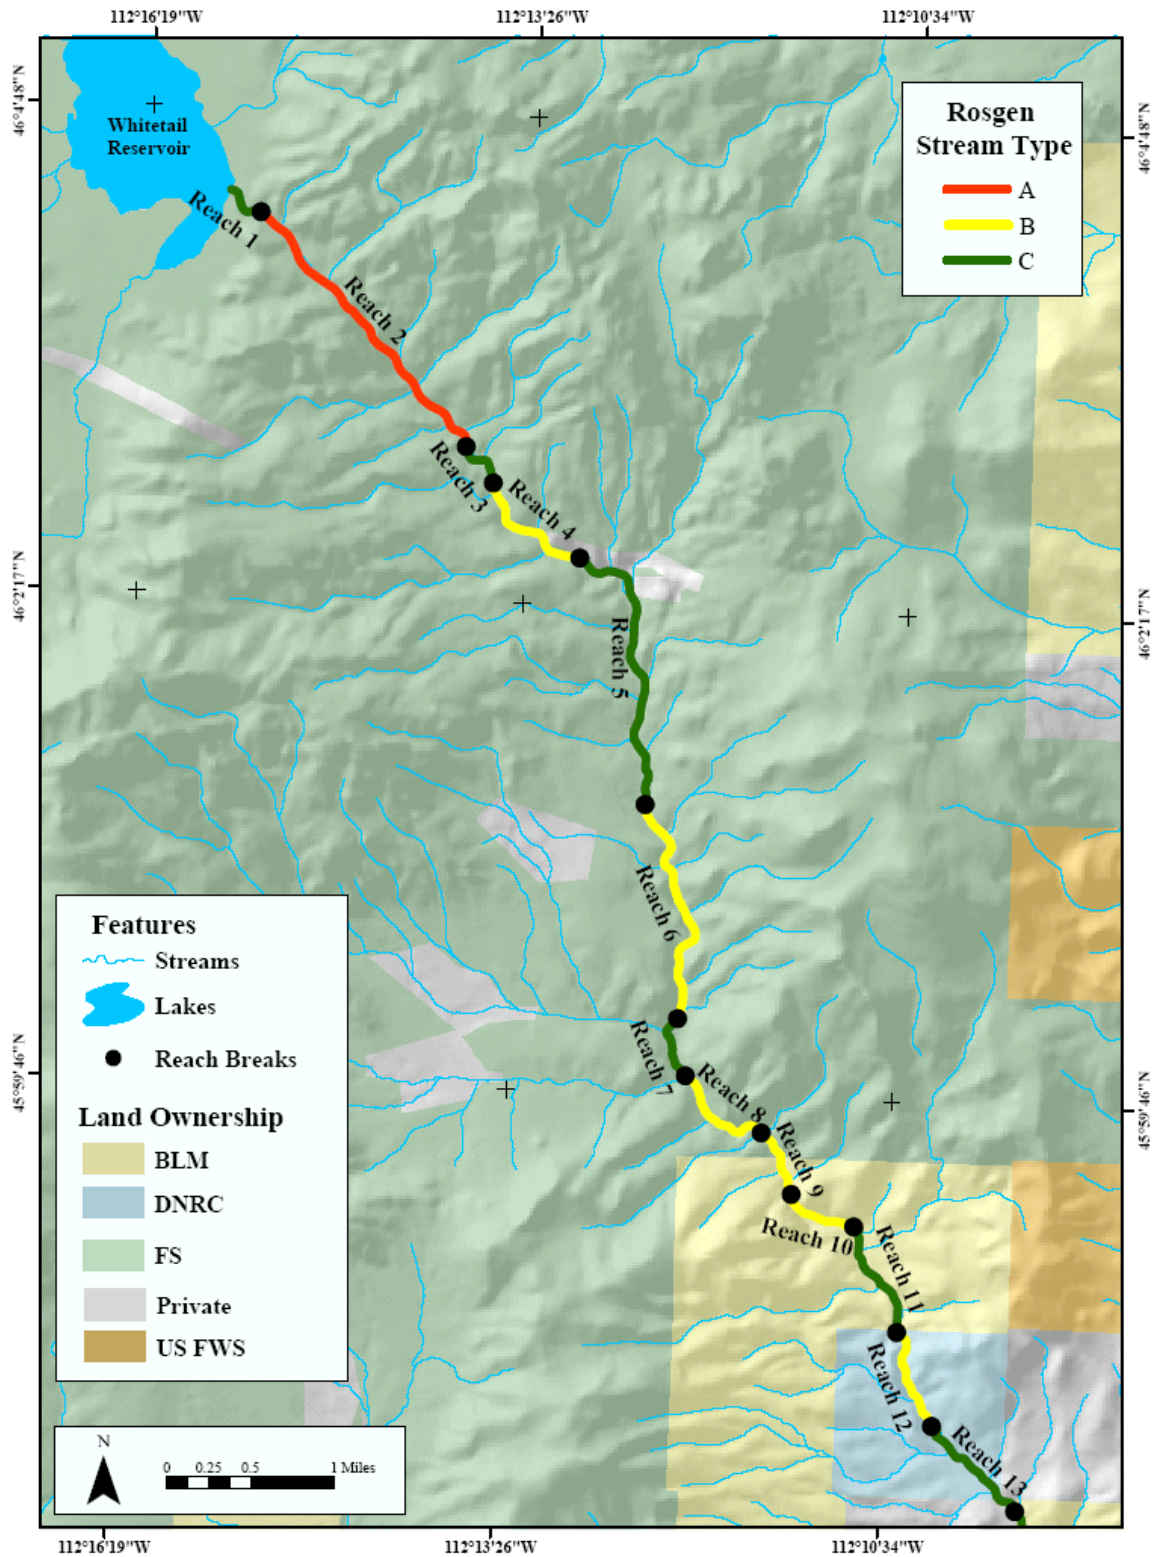
Figure 2-40. Upper Whitetail Creek Rosgen Stream Types

The channel forms of Upper Whitetail Creek are predominantly controlled by landform structure, and flow releases from Whitetail Reservoir (**Figure 2-40**). The landform geology of Reaches 1 to 6 is the Boulder Batholith, while intrusive volcanic rocks are prominent in reaches 7 to 12. The stream headwaters in Whitetail Park at the outlet of Whitetail Reservoir (C-type) and then flows through a steep, narrow canyon (A-type). The canyon gradient lessens and valley bottom openings alternate between relatively confined (B-type reaches), and unconfined areas (C-type reaches). The area of Reach 5 viewed during the field survey exhibited a C-type channel with transformation to a B-type channel at the end of the reach. The beginning of Reach 6 was noted as a good potential for a reference B-type channel. Reach 12 was observed as a B-type channel trending to C-type in less confined areas, while Reach 13 had characteristics of a C-type channel. There were no significant changes in channel form between 1983 and 2001.

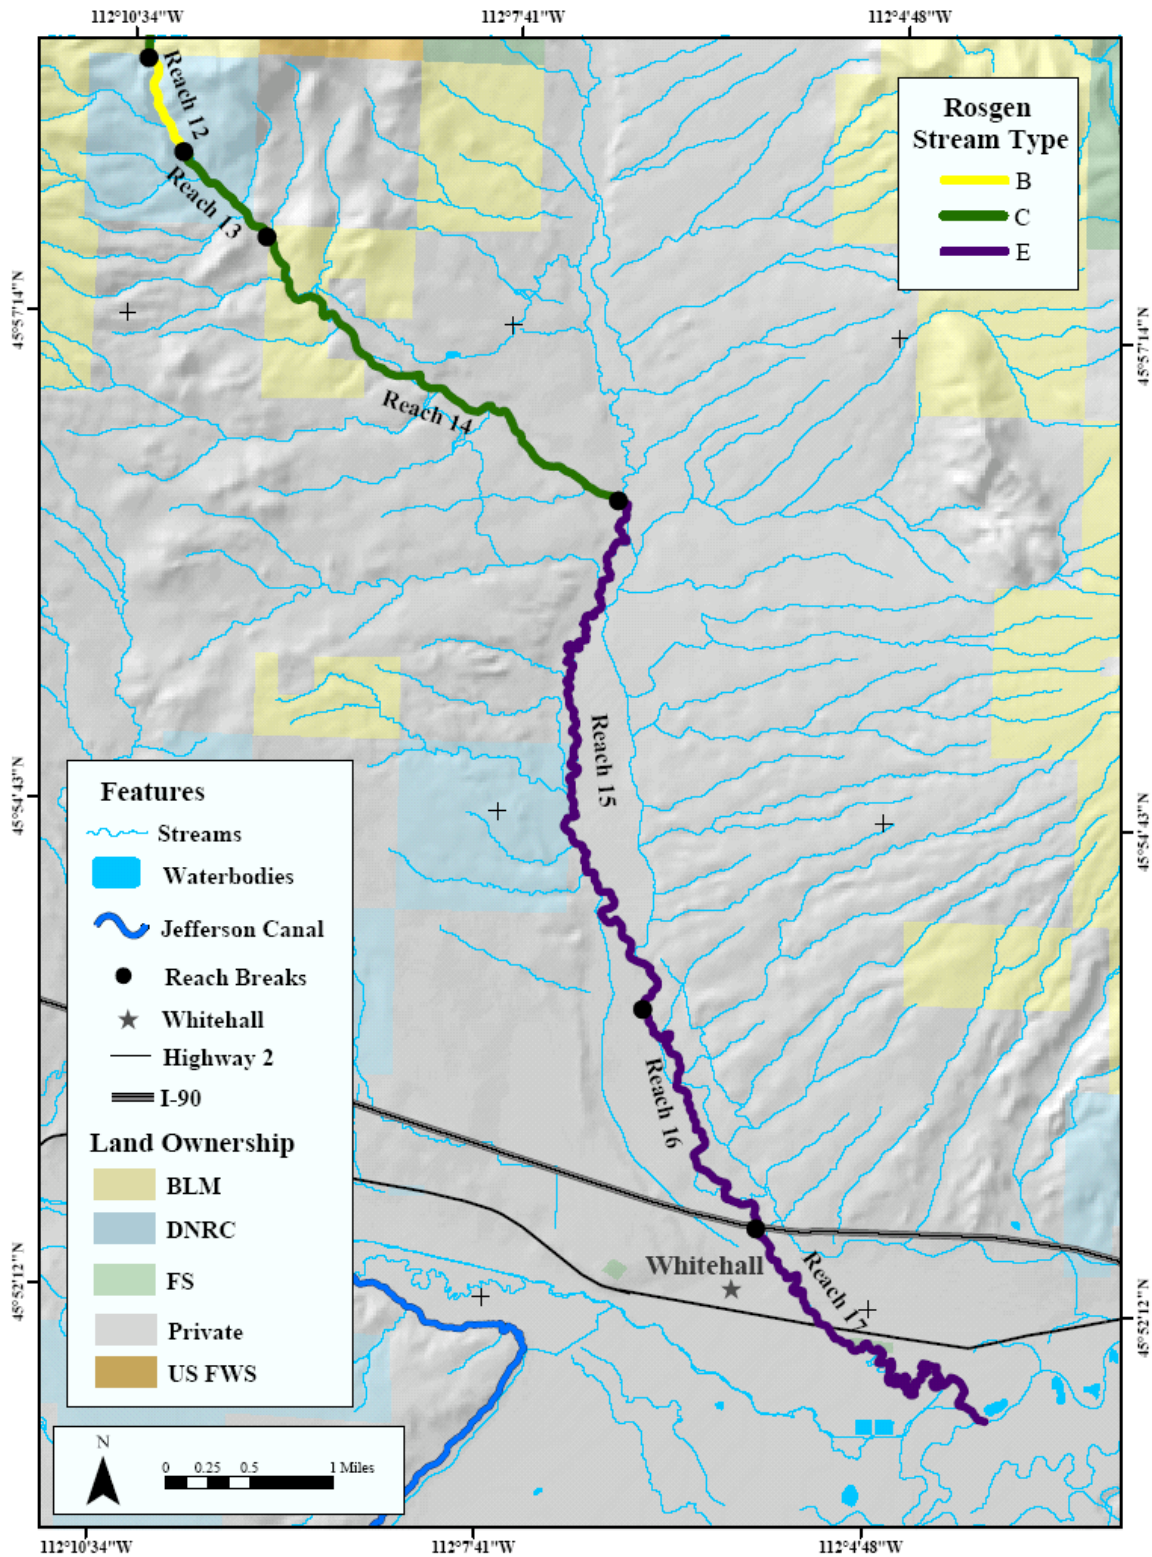
Figure 2-41. Lower Whitetail Creek Rosgen Stream Types

The channel forms of Lower Whitetail Creek are controlled by landform and historical and current landuse activities (Figure 2-41). The predominant valley type (VIII) would typically
