APPENDIX C
2004 AERIAL PHOTO REVIEW AND FIELD SOURCE ASSESSMENT,
UPPER JEFFERSON RIVER WATERSHED

1.1 Upper Jefferson Watershed 2004 Aerial Photo Review and Field Source Assessment

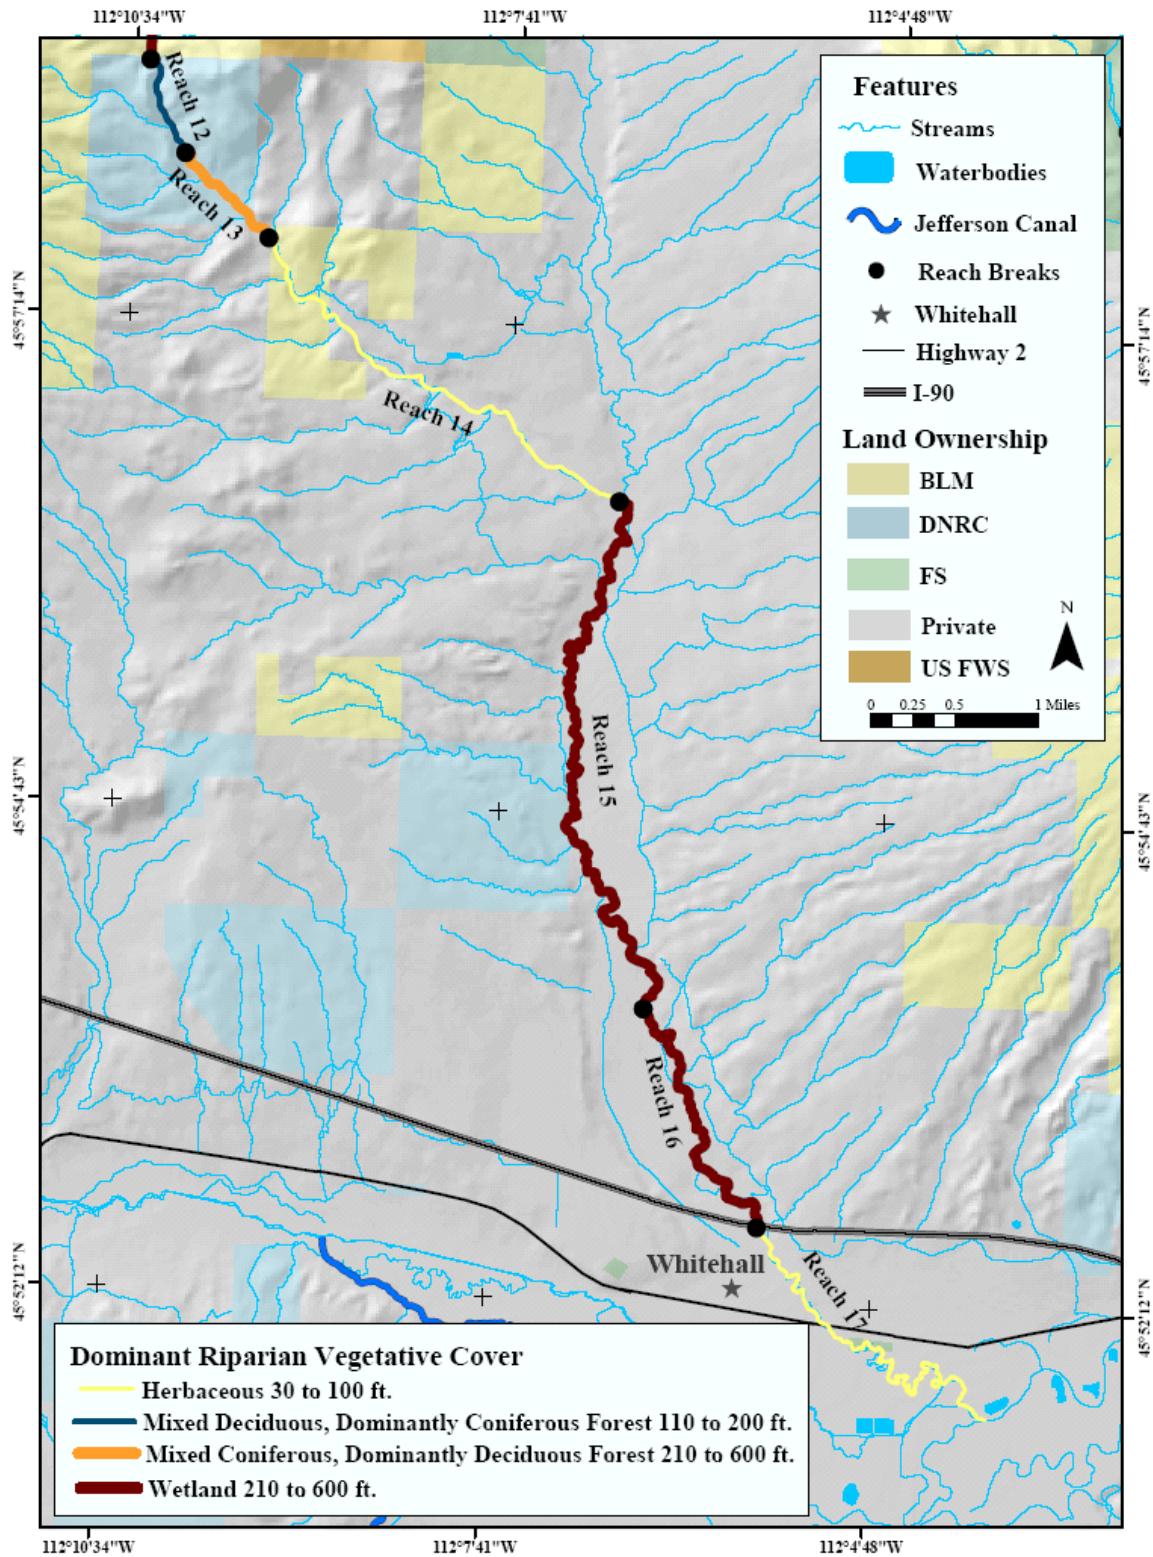
Figure 2-43. Lower Whitetail Creek Riparian Vegetation

Riparian cover along Lower Whitetail Creek transitioned from herbaceous, to wetland, to herbaceous (**Figure 2-43**). This is largely a reflection of landuse. It is suspected that a lowering of the water table in Reach 14 is one factor in the decrease of deciduous vegetation. During the field survey in Reach 14, decadent and dying cottonwood, intermixed with willow, alder, current, and red osier were confined to a narrow corridor along stream. Reaches 15 and 16 were dominated by willows. The riparian area appeared to be more intact in Reach 15 than in Reach 16, and may reflect the fact that land ownership was more subdivided in Reach 16 versus Reach 15. The herbaceous category for Reach 17 was due to development and farming in the riparian zone. The relative health category assigned to most of the lower reaches was: 'Poor'. For the lower portion of Whitetail Creek, only one time period was analyzed so significant changes in riparian vegetation since 1983 could not be determined.

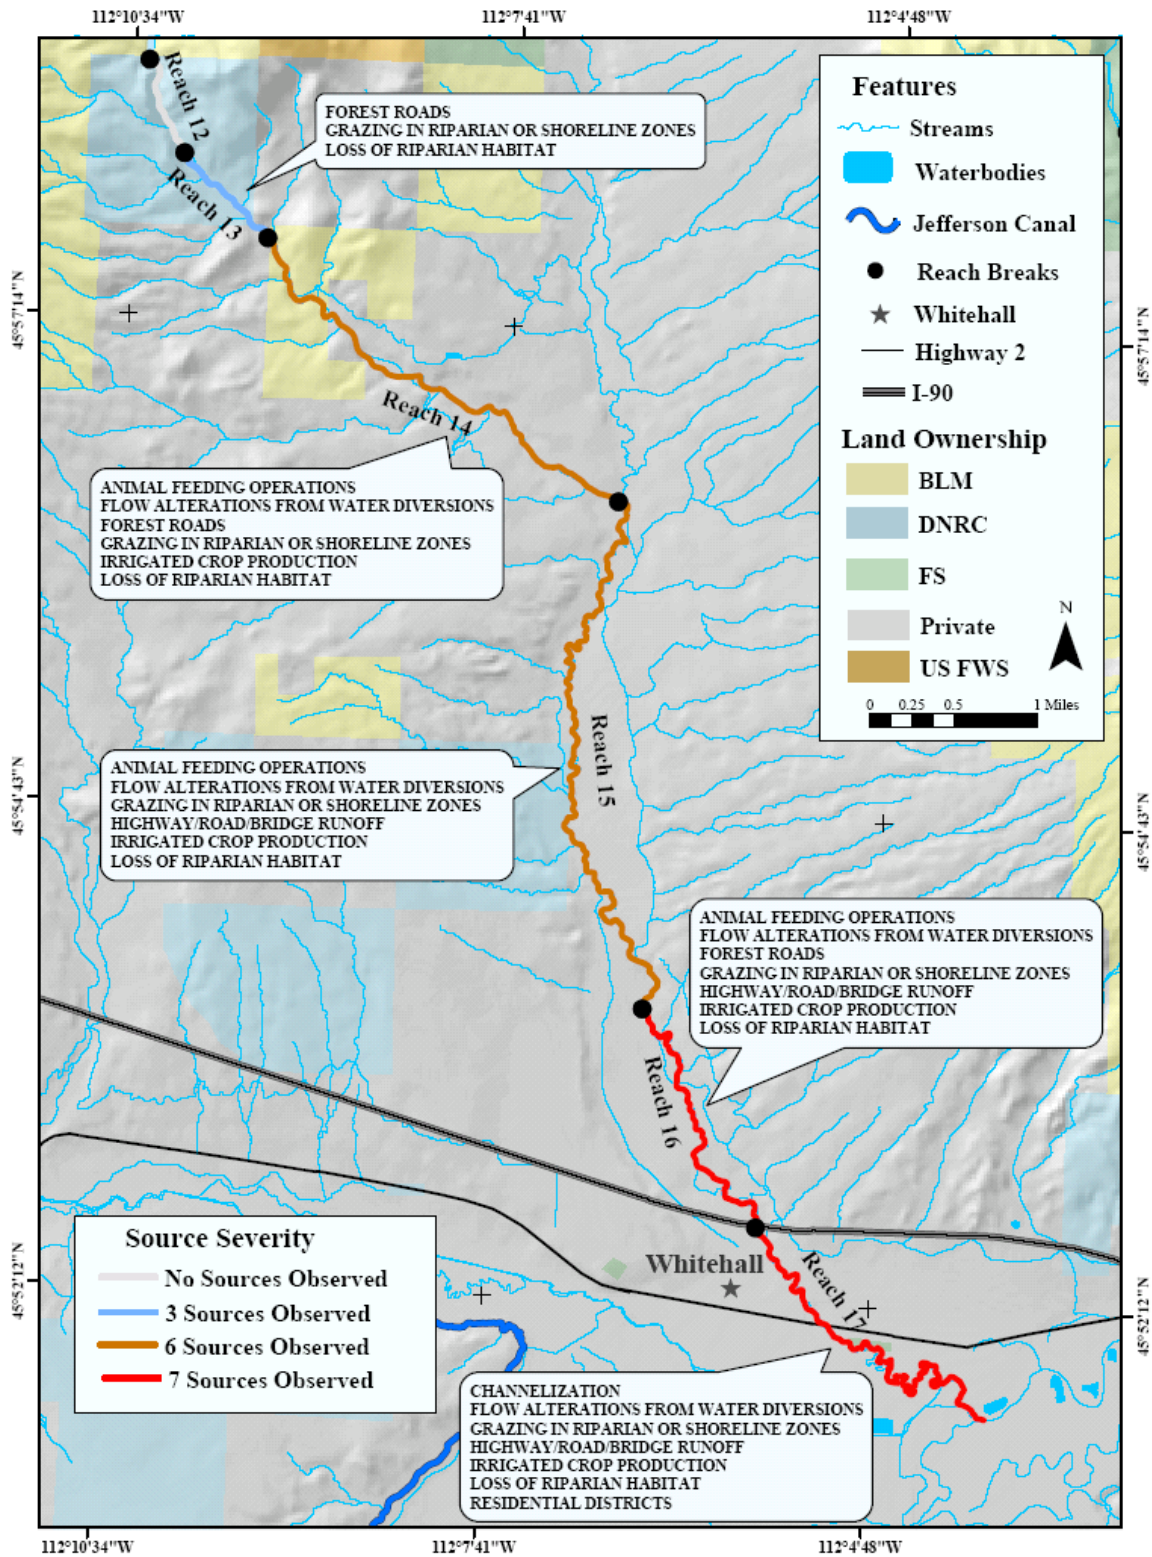
Figure 2-45. Lower Whitetail Creek Pollution Sources

Figure 2-45 displays the pollution sources assigned to the lower reaches of Whitetail Creek. Many pollution sources observed along Lower Whitetail were related to agricultural operations. During the field source assessment, grazing impacts were observed in all of the field surveyed reaches. Alterations for irrigation diversions were observed in reaches 14, 16, and 17. The sources observed were localized by the property owner's land use, such as confined feedlots, removal of riparian vegetation, and small grazing pastures. For the valley portion of Whitetail Creek, only one time period was analyzed so significant changes in pollution sources since 1983 were not be determined.
