APPENDIX C
2004 AERIAL PHOTO REVIEW AND FIELD SOURCE ASSESSMENT,
UPPER JEFFERSON RIVER WATERSHED

1.1 Upper Jefferson Watershed 2004 Aerial Photo Review and Field Source Assessment

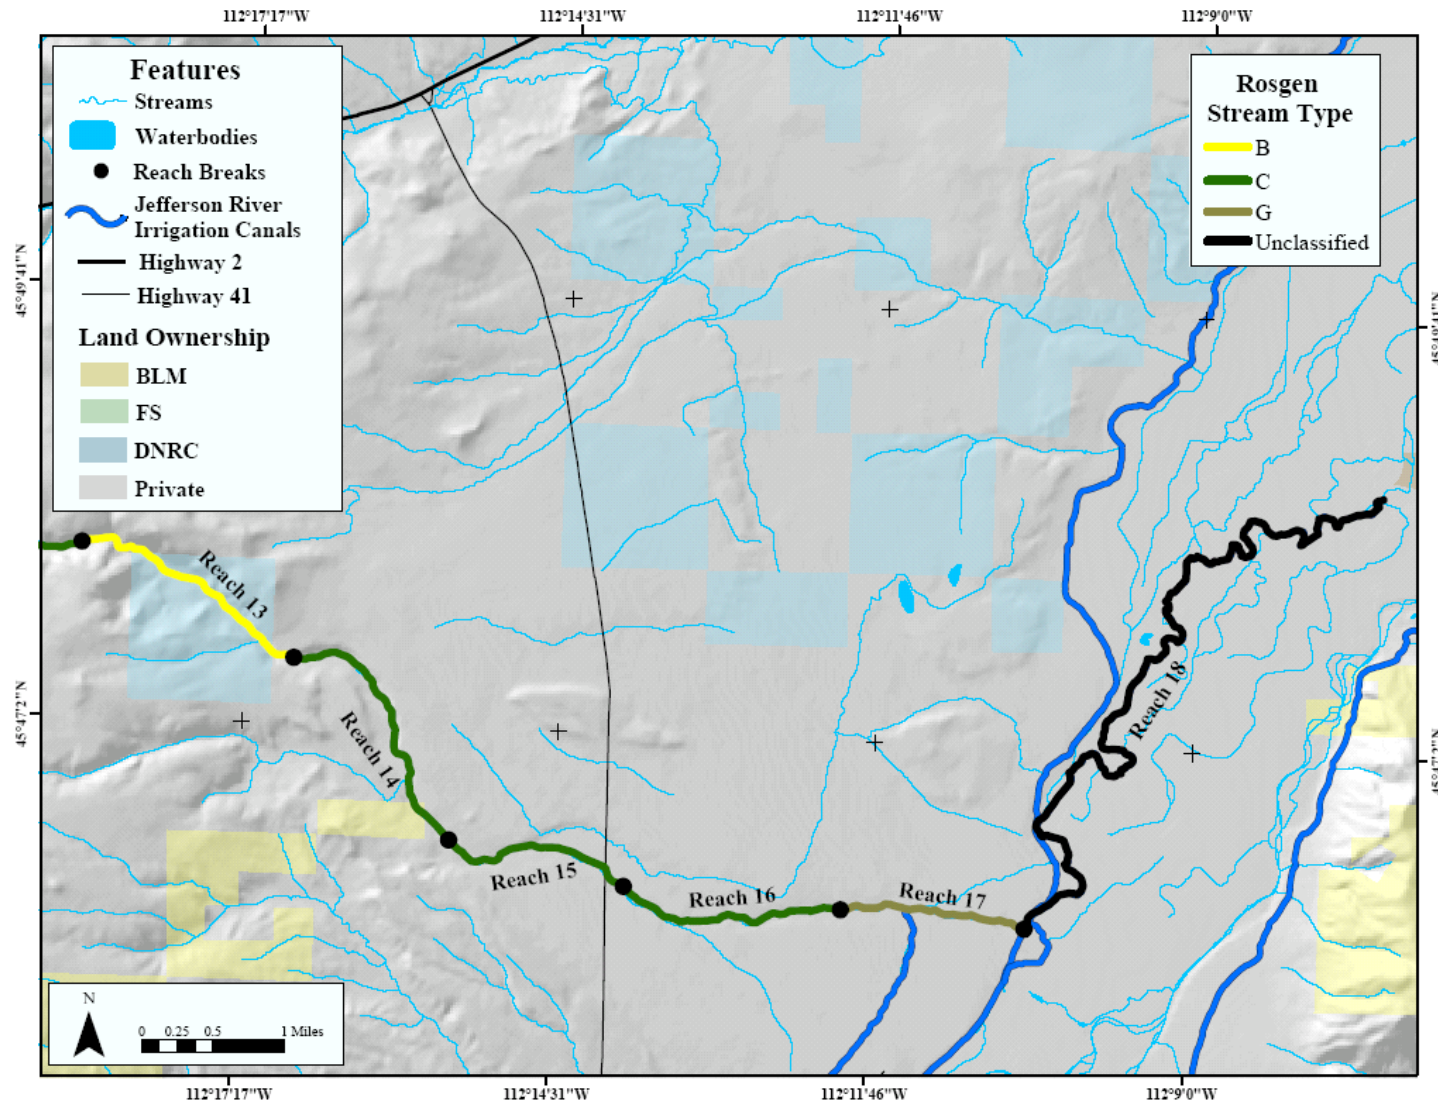
Figure 2-20. Lower Fish Creek Rosgen Stream Types

Many of the channel forms of Fish Creek in the Jefferson Valley are controlled by landform structure, and historical and current landuse activities (**Figure 2-20**). Channel form on the alluvial fan (Reaches 14 to 17) tended to be more unconfined than expected (C-type versus B-type). Portions of Reaches 14 and 15 viewed during the field survey exhibited C-type channels. Reach 17 was typed as a G channel due to the lack of water and vegetation, however this was not field verified. Fish Creek usually goes dry before entering Fish Creek Canal (Reach 18). Reach 18 was not classified due to the fact that it is part of a major irrigation canal system in the Jefferson Valley, and probably carries flow from the Jefferson River versus Fish Creek. For the valley portion of Fish Creek, only one time period was analyzed so significant changes in channel form since 1983 could not be determined.

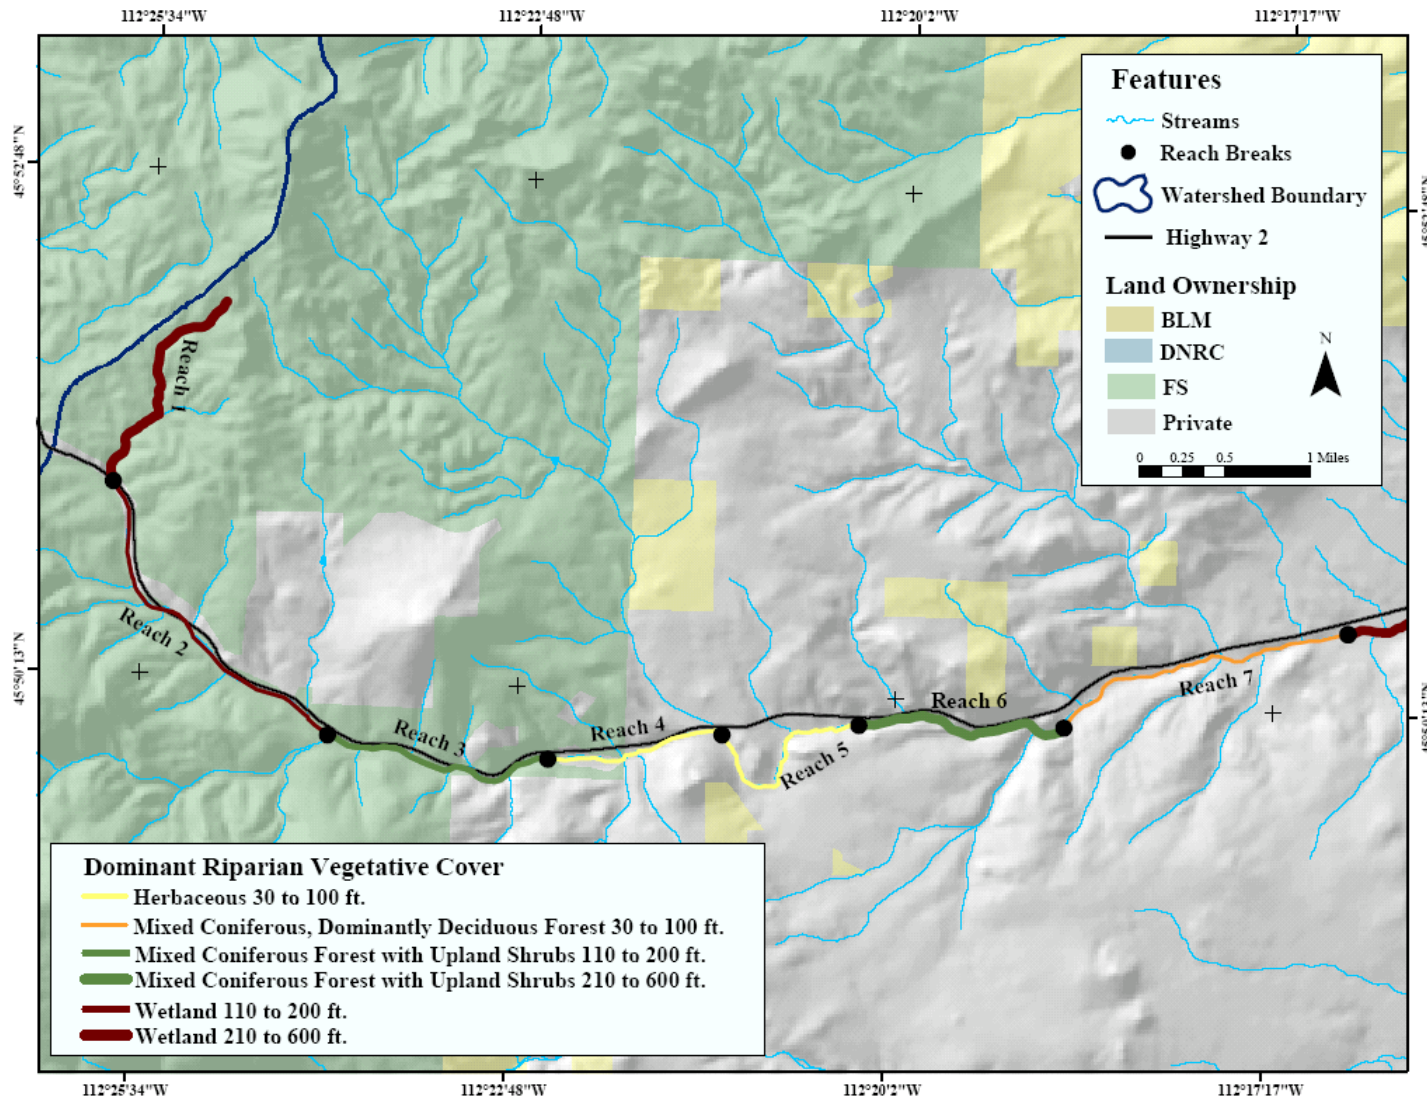
Figure 2-36. Upper Little Pipestone Creek Riparian Vegetation

Riparian cover along Upper Little Pipestone Creek was variable (**Figure 2-36**). The predominant cover in Reaches 1 and 2 was wetland vegetation. Field assessment in Reaches 1 and 2 revealed that the willows were decadent from heavy browsing, and dying in areas due to ponding. Buffer widths were limited in Reaches 2, 3, and 6 by proximity to the highway. Riparian vegetation type in Reaches 3 and 6 was mixed coniferous forest with upland shrubs. Development in Reaches 4 and 5 resulted in a loss of woody vegetation, and the classification was changed to predominantly herbaceous. Woody vegetation generally extended to a maximum of 20 feet on either side on the channel in these reaches. The relative health category assigned to the riparian vegetation progressed from excellent to poor in a downstream manner. There were no significant changes in riparian vegetation between 1983 and 2001.

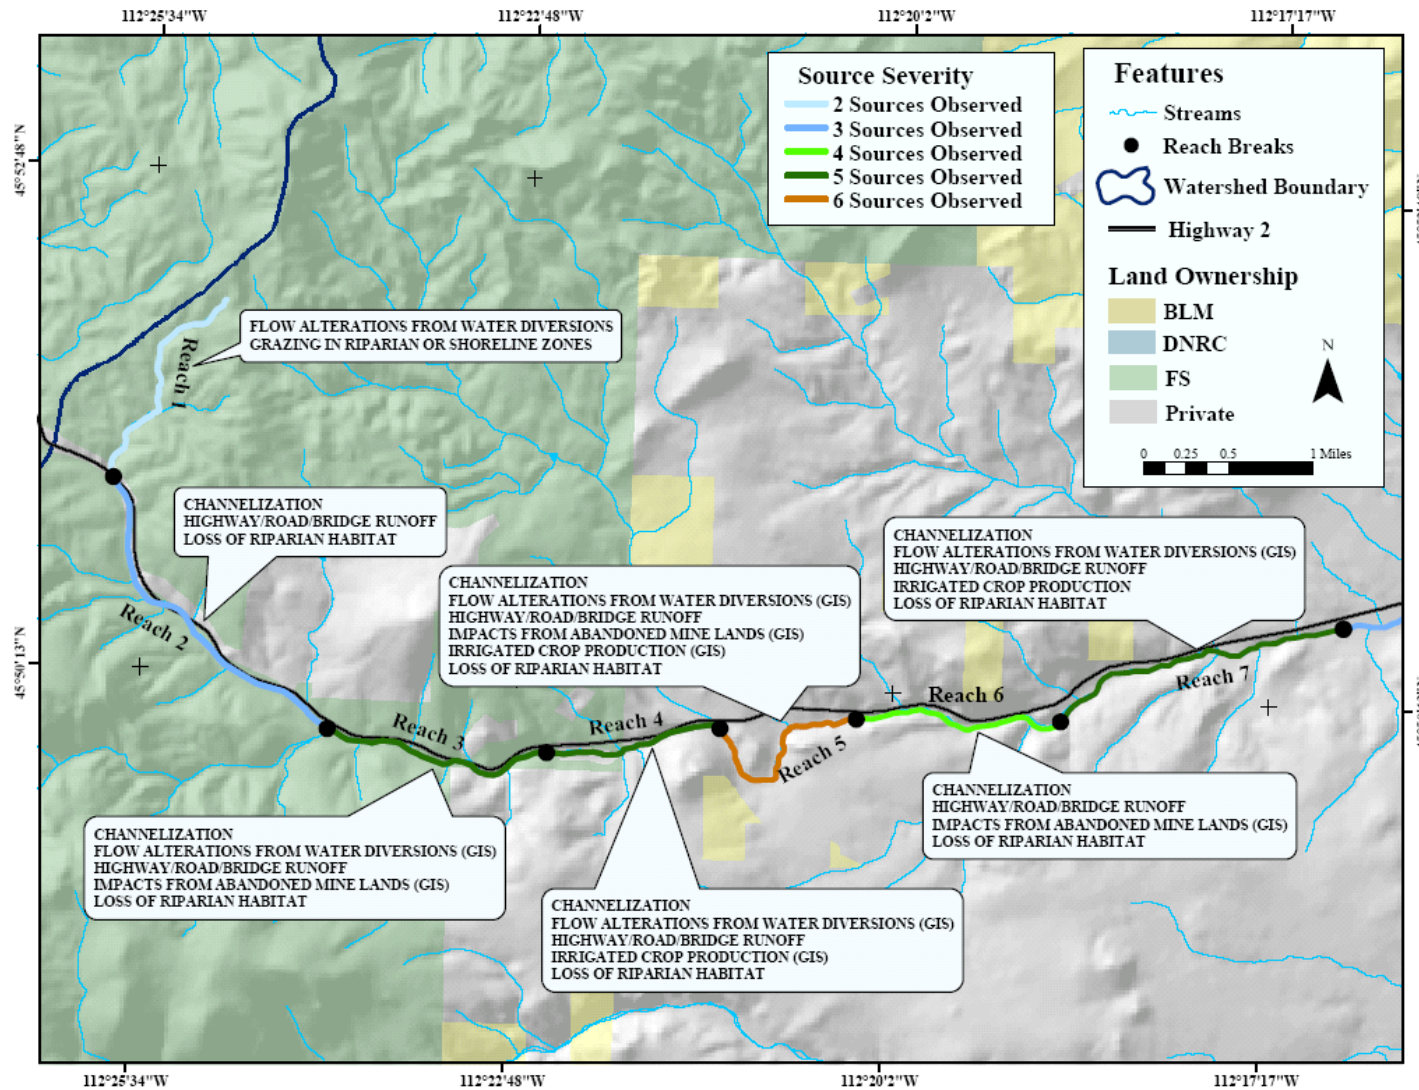
Figure 2-38. Upper Little Pipestone Creek Pollution Sources

Figure 2-38 displays the pollution sources assigned to the upper reaches of Little Pipestone Creek. Many pollution sources observed along Upper Little Pipestone Creek were related to roads and riparian grazing. In many instances, the sources of flow alterations from water diversions and impacts from abandoned mine lands were taken from GIS layers which located water rights claims and abandoned mines. The GIS identified sources were not field verified, except in Reach 1 where 3 earthen dams have obstructed the channel. A large road sediment source was observed entering the creek in Reach 2. Channelization effects were prominent in Reaches 2 and 3. There were no significant changes in pollution sources between 1983 and 2001.

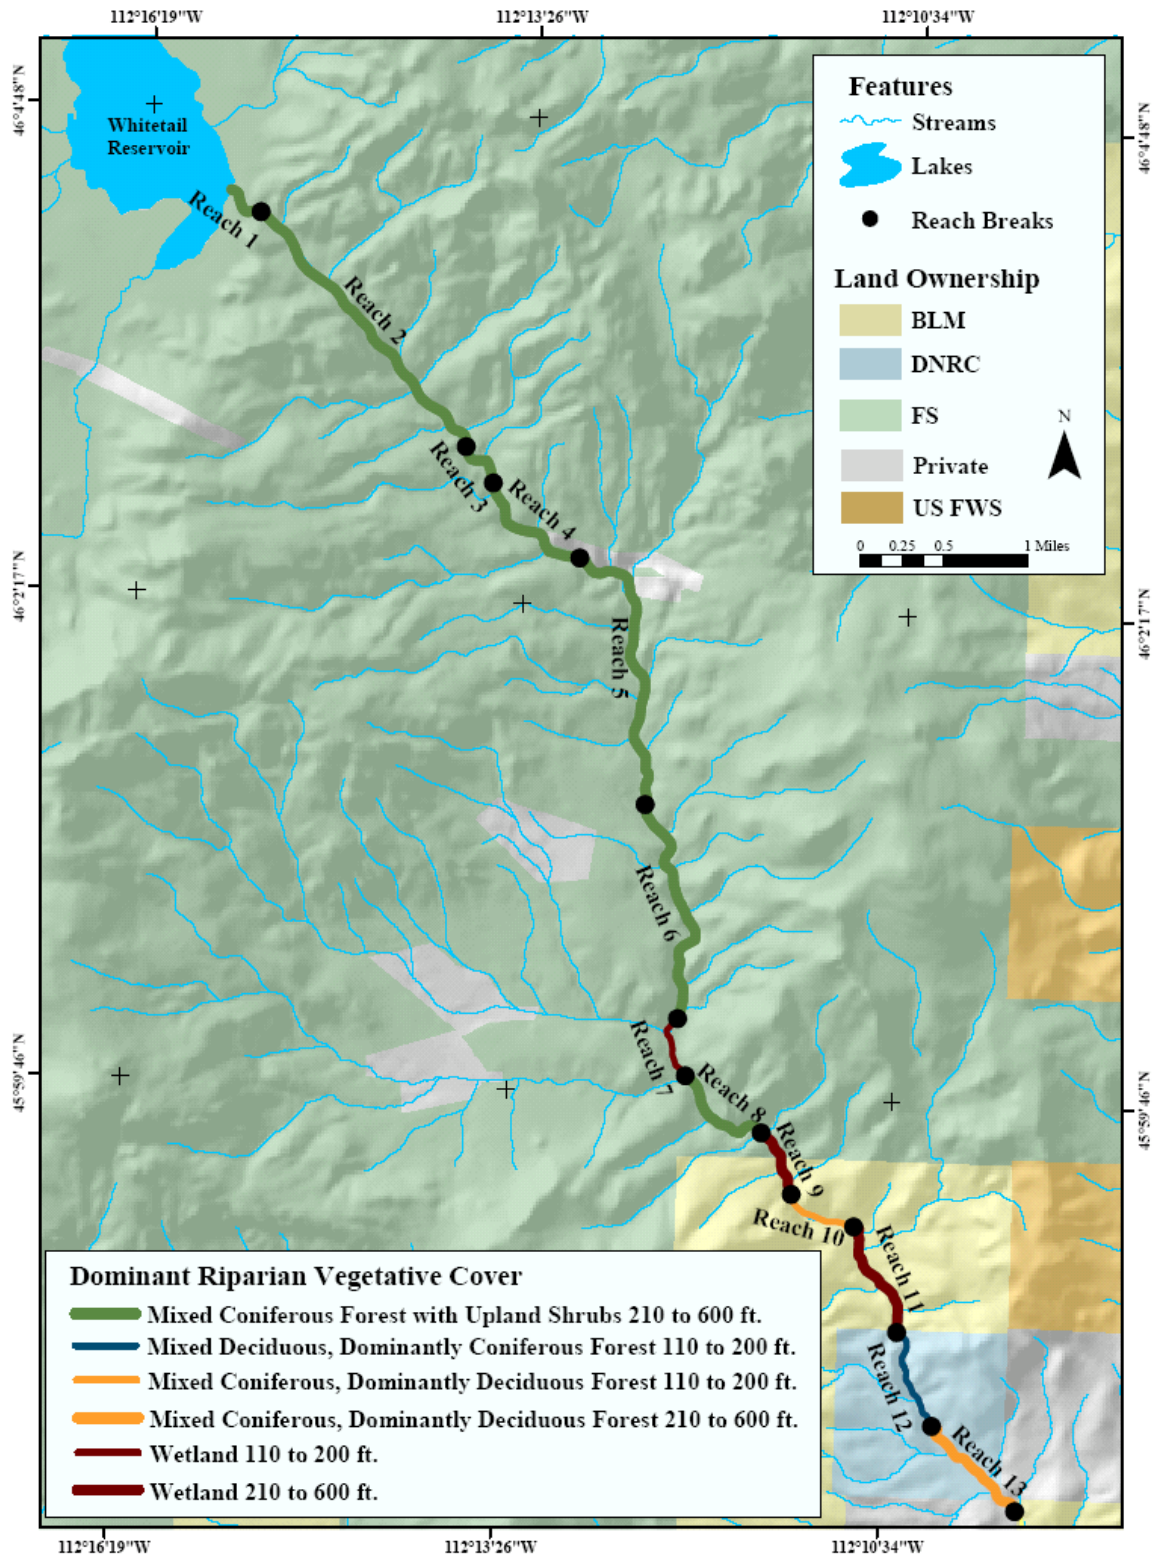
Figure 2-42. Upper Whitetail Creek Riparian Vegetation

The dominant riparian cover along Upper Whitetail Creek in Reaches 1 to 6 was mixed coniferous forest with upland shrubs (**Figure 2-42**). During the field review in Reach 5, sedges, alder, and willows were observed extending about 10 feet from the channel within the conifer forest. Riparian cover from Reaches 7 to 13 alternated between wetland (less confined valley bottom areas), mixed coniferous forest, and deciduous forest. Buffer widths were generally limited by valley bottom width and the availability of moisture. The relative health categories assigned to all of the upper reaches was either 'Excellent' or 'Fair', depending on whether disturbance was visible. Some areas of thistle infestation were observed in Reaches 5 and 13. Buffer widths were generally greater than 100 feet wide along both sides of the stream, and represented the distance of vegetation surrounding the stream before any disturbance was observed. There were no significant changes in riparian vegetation between 1983 and 2001.

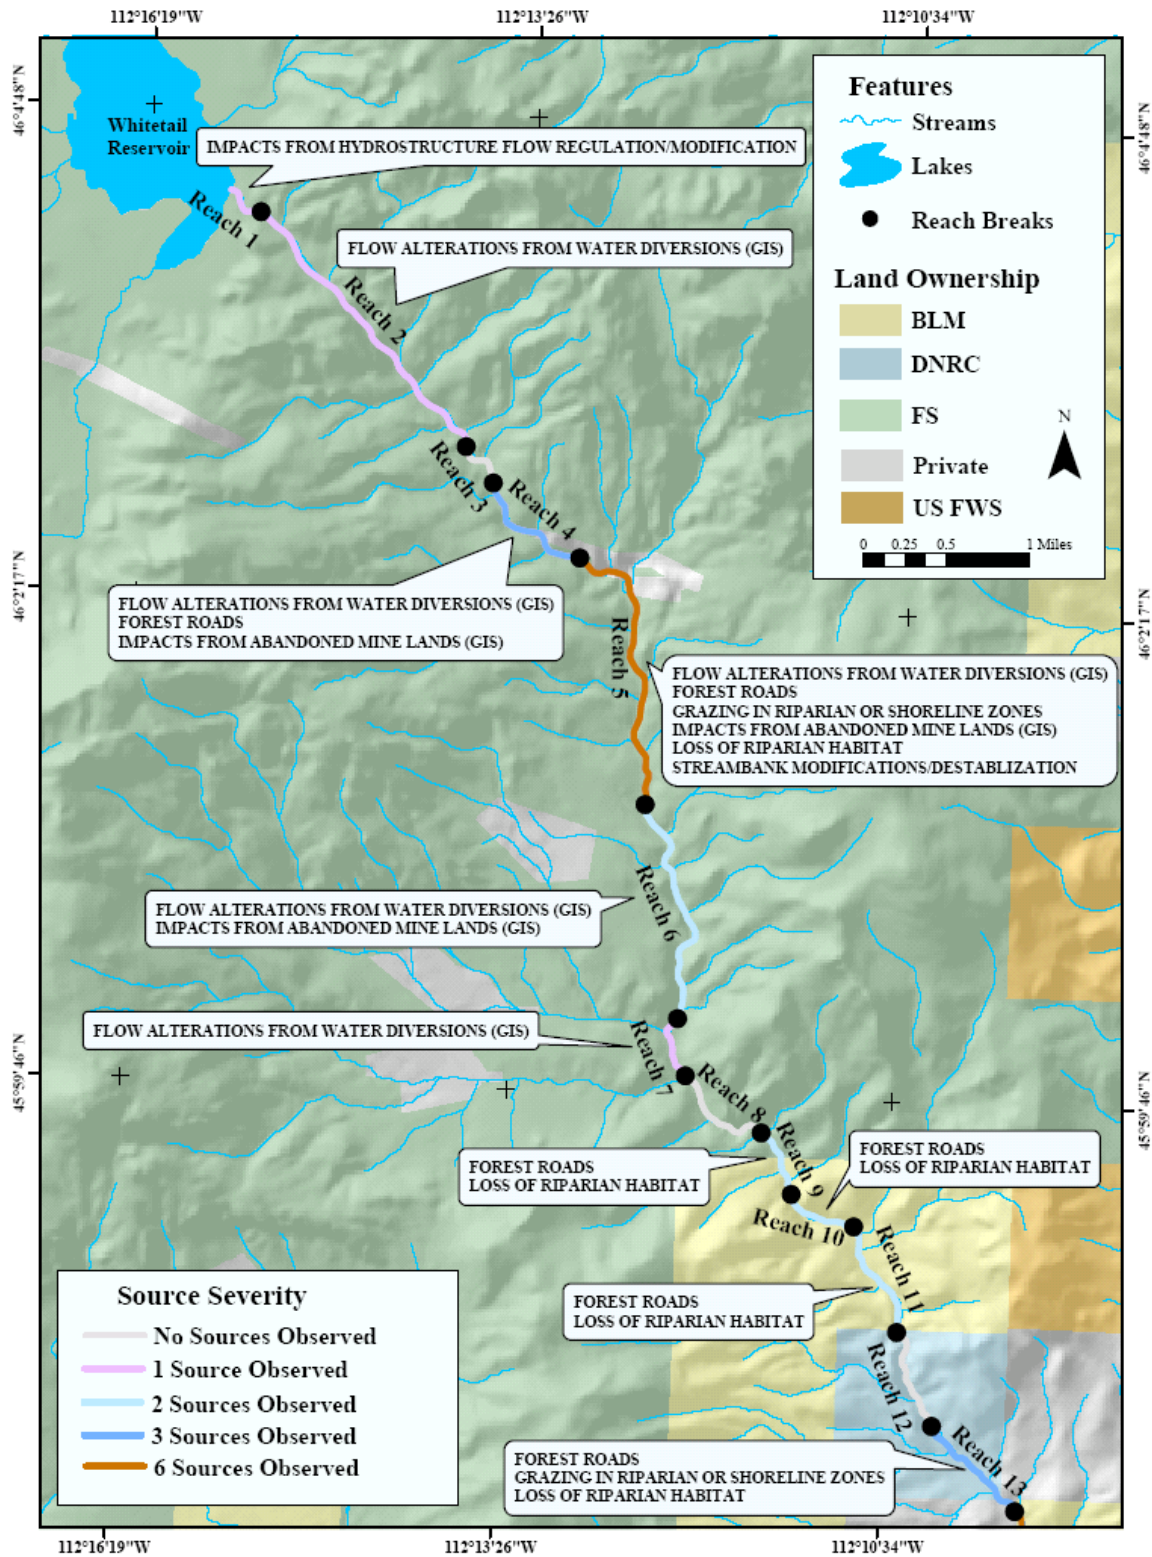
Figure 2-44. Upper Whitetail Creek Pollution Sources

Figure 2-44 displays the pollution sources assigned to the upper reaches of Whitetail Creek. In many instances, the sources of flow alterations from water diversions and impacts from abandoned mine lands were taken from GIS layers, and were not field verified. Most of the pollution sources observed in the field along Upper Whitetail Creek were related to the riparian grazing and unpaved roads (Reaches 5 and 13). Brown trout were observed in the upper reaches of Whitetail Creek during the October field assessment. During the aerial assessment of the 1983 photos, disturbance below a prospect area was visible in Reach 4, but was not visible in 2001. In 1983, beaver ponds were visible on two major tributaries to Whitetail Creek: Grouse Creek and Gillespie Creek (Reach 7), but were gone by 2001.

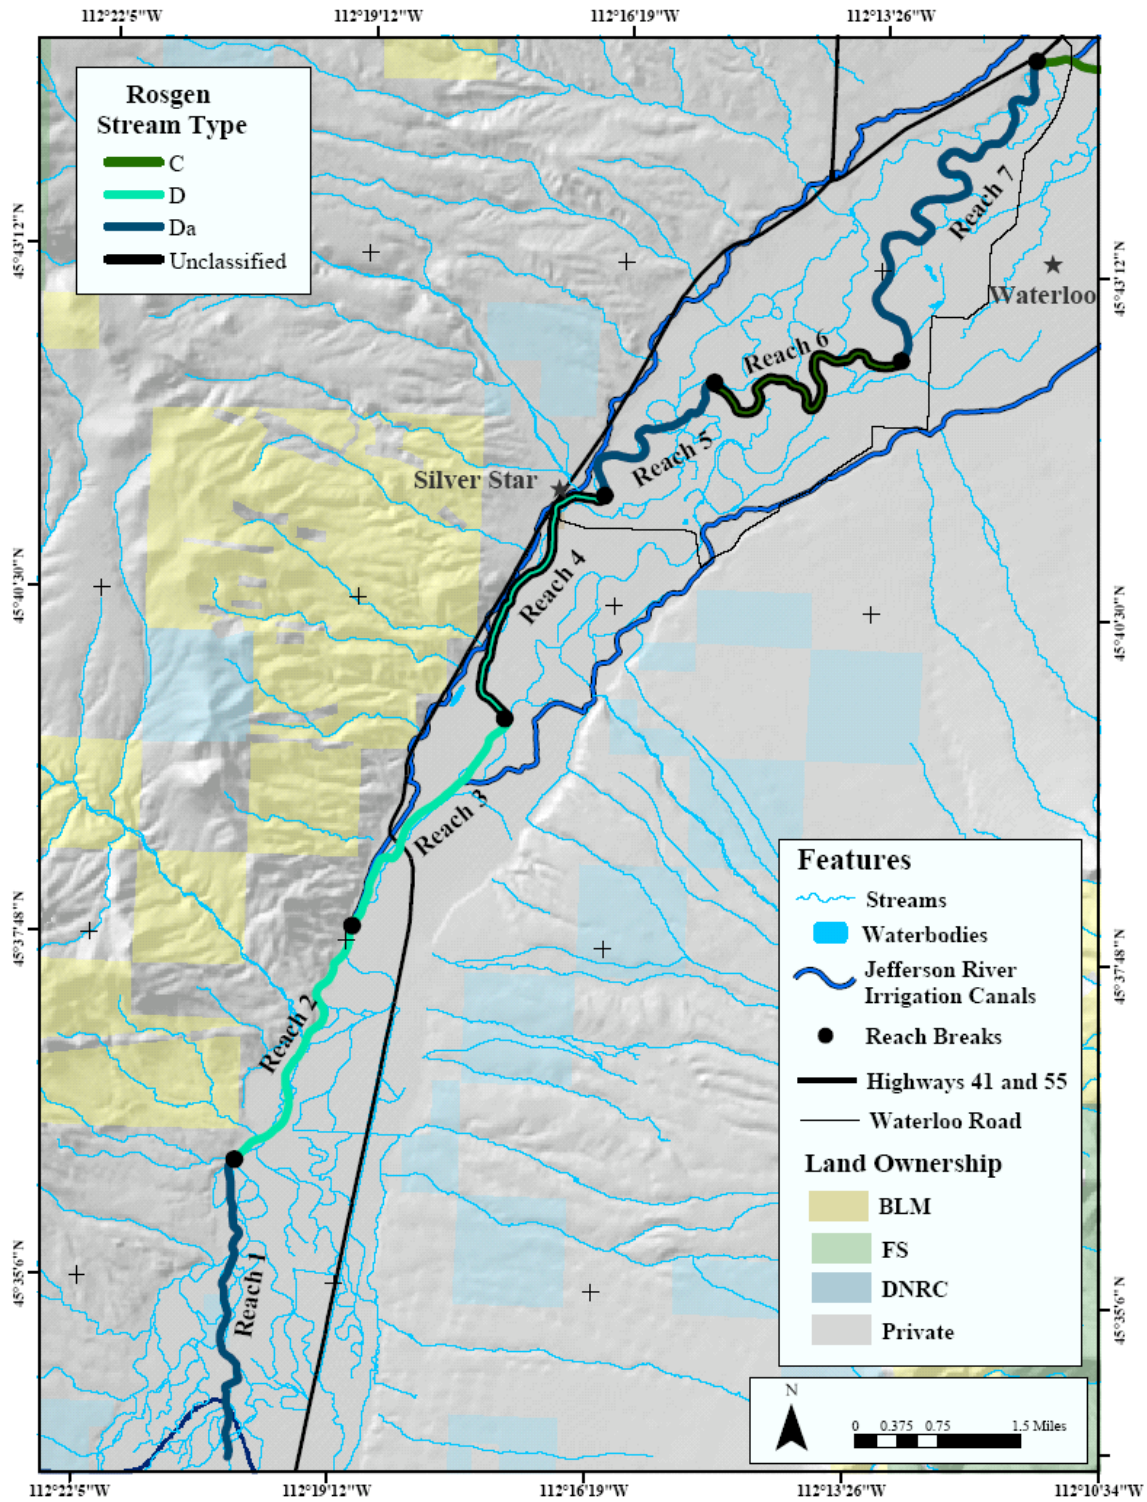
Figure 2-46. Upper Jefferson River Rosgen Stream Type, Reaches 1 to 7

An overall Rosgen stream type was assigned to the 14 designated reaches of the Upper Jefferson River (**Figures 2-46 and 2-47**). See **Table 2-9** for a review of the various channel patterns observed within the reaches. Overall Rosgen channel form changed for Reaches 4, 6, 11, 13, and 14 between 1983 and 1982. The changes were mostly due to the fact that drought impacts have reduced wetted channel width and exposed more gravel bars. Loss of wetted channel width has resulted in fewer channel anabranches in Reaches 6, 11 and 13; while exposure of gravel bars has increased channel braiding in Reaches 4 and 14. Subtle changes have occurred in Reaches 8, 10, and 12, but not enough to cause an overall change in the dominant channel type. It is the

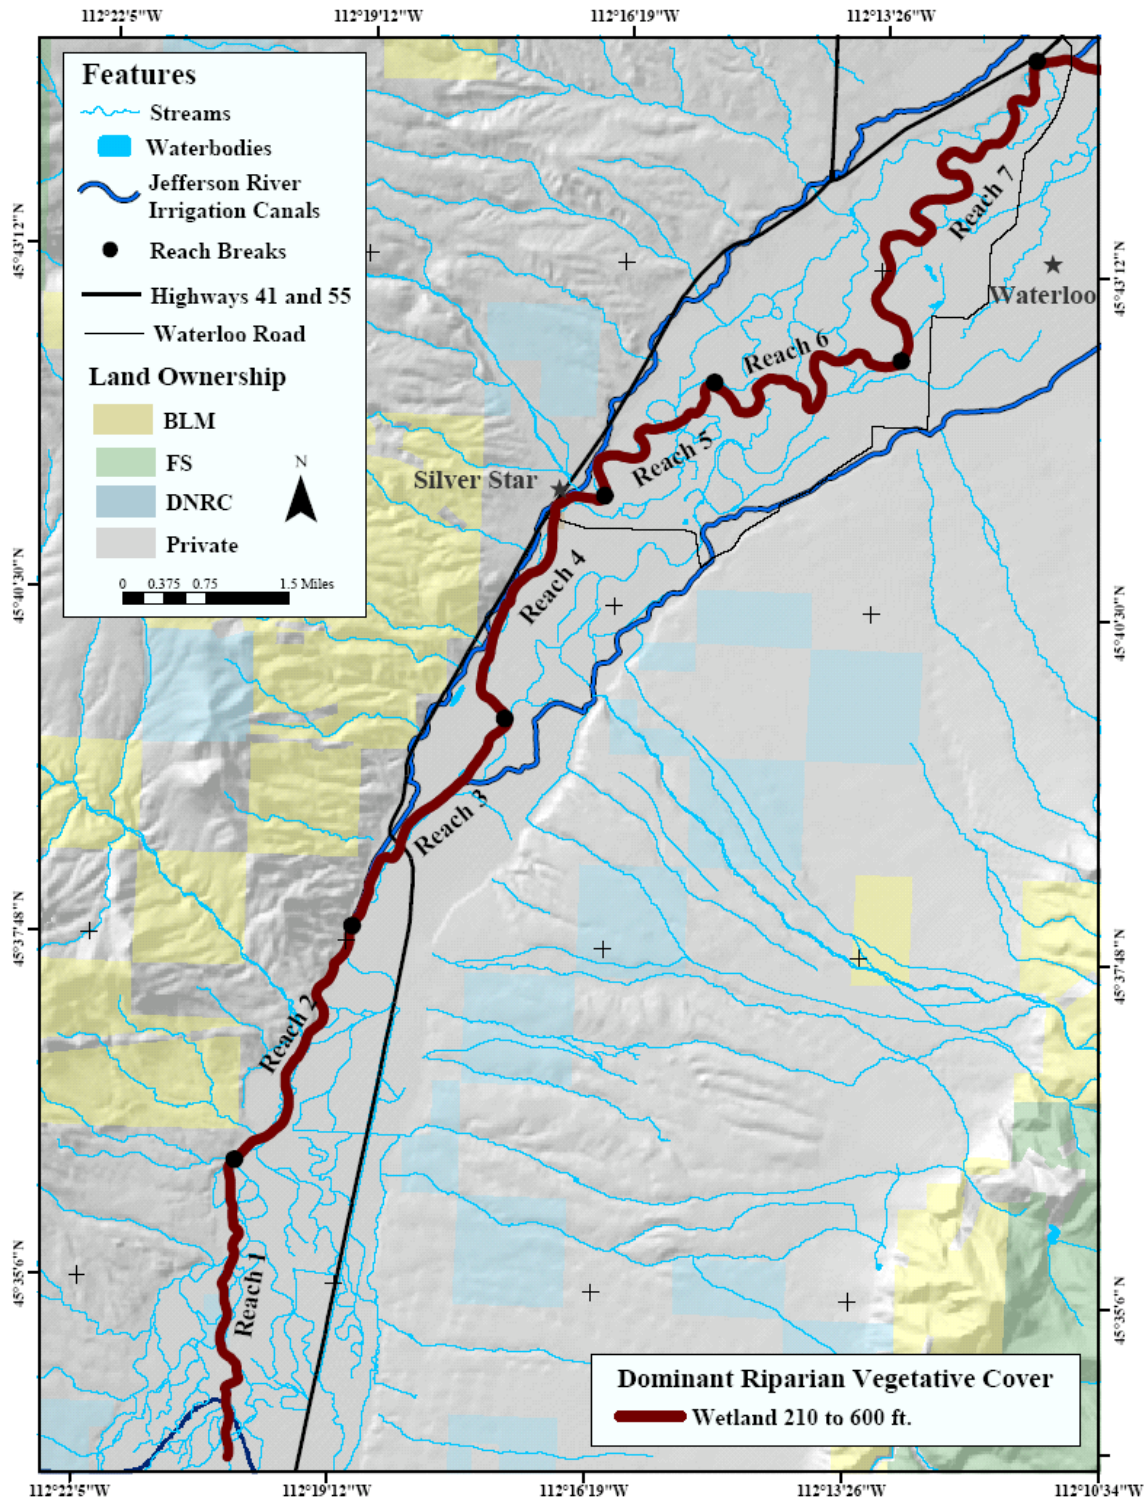
Figure 2-48. Upper Jefferson River Riparian Vegetation, Reaches 1 to 7

The dominant riparian cover along the Upper Jefferson River is wetland vegetation (**Figures 2-48 and 2-49**). Many types of cottonwoods, willows, shrubs and herbaceous plants were identified during the 2003 riparian inventory (Hoitsma Ecological, 2003). In general, wetland vegetation extended to 100 feet or more along both sides of the main river channel. Buffer widths for the 2002 photos were based on the GIS layer created by Hoitsma Ecological, but were measured from the aerial photographs for the 1983 analysis. Differences in riparian buffer widths between 1983 and 2002 should be interpreted with this in mind. Between 1983 and 2001, the riparian buffer width in Reaches 2, 3, and 4 appeared to increase by an average of 12 percent, 28 percent, and 26 percent, respectively. During the same time period, buffer widths appeared to decrease in Reaches 6, 7, and 14 by 25 percent, 57 percent, and 42 percent, respectively.

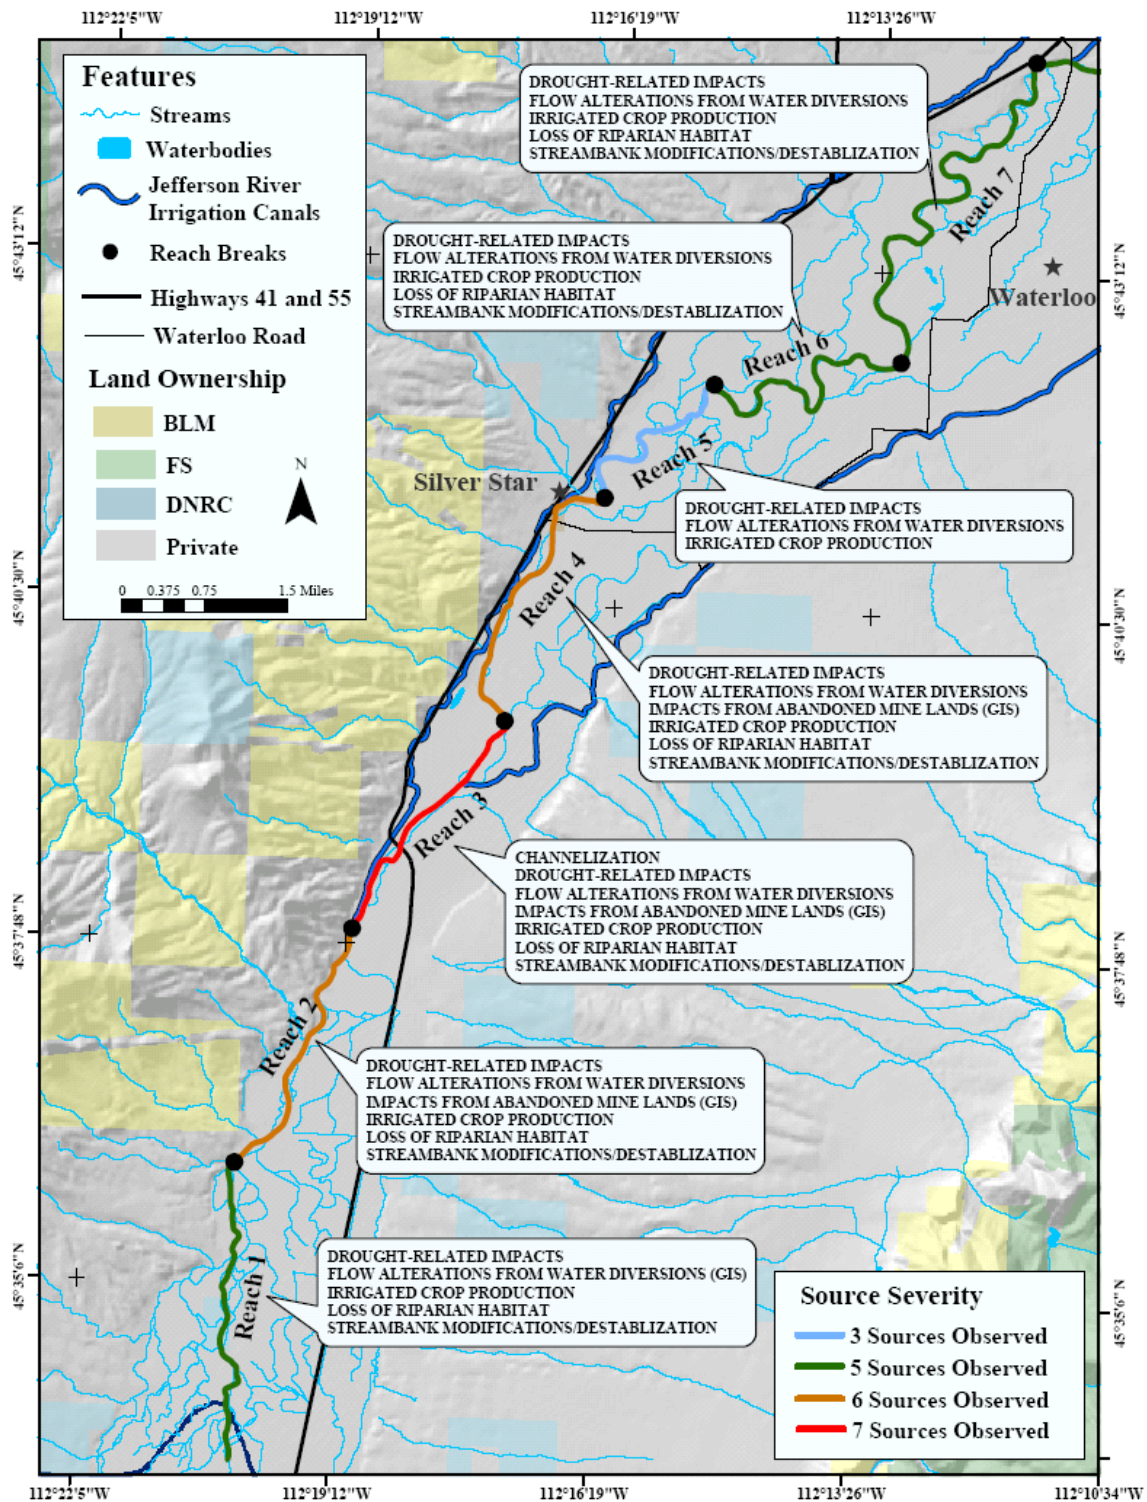
Figure 2-50. Upper Jefferson River Pollution Sources, Reaches 1 to 7

Figures 2-50 and Figure 2-51 display the pollution sources assigned to the upper reaches of the Jefferson River. Aside from visible observations on the aerial photos and information from GIS layers, much of the pollution source information for the Upper Jefferson River for the 2002 analysis was taken from information collected during the 2003 riparian inventory (Hoitsma Ecological, 2003). The source of impacts from abandoned mine lands was taken from GIS layers which located abandoned mines up tributary drainages which eventually drain to reaches of the Upper Jefferson River.

This GIS identified source was not field verified, and results of the 2004 metals monitoring revealed no water quality violations for copper and lead in this section of the Jefferson River. Many pollution sources observed along the Upper Jefferson River were related to agricultural operations (irrigated agriculture, water diversions, loss of riparian habitat). All of the reaches assigned for the source of streambank modifications/destabilization were done so on the basis of information collected during the 2003 riparian inventory, and represent rip-rap, eroding banks, and impaired banks. The most notable difference in sources between 1983 and 2002 was the effect of drought.
